# **ANALYSIS OF ARCHITECTURAL MORTAR SAMPLES FROM WEST RUIN AT AZTEC RUINS NATIONAL MONUMENT**

Gary M. Brown  
Archeologist  
Aztec Ruins National Monument  
Aztec, New Mexico

September 2001

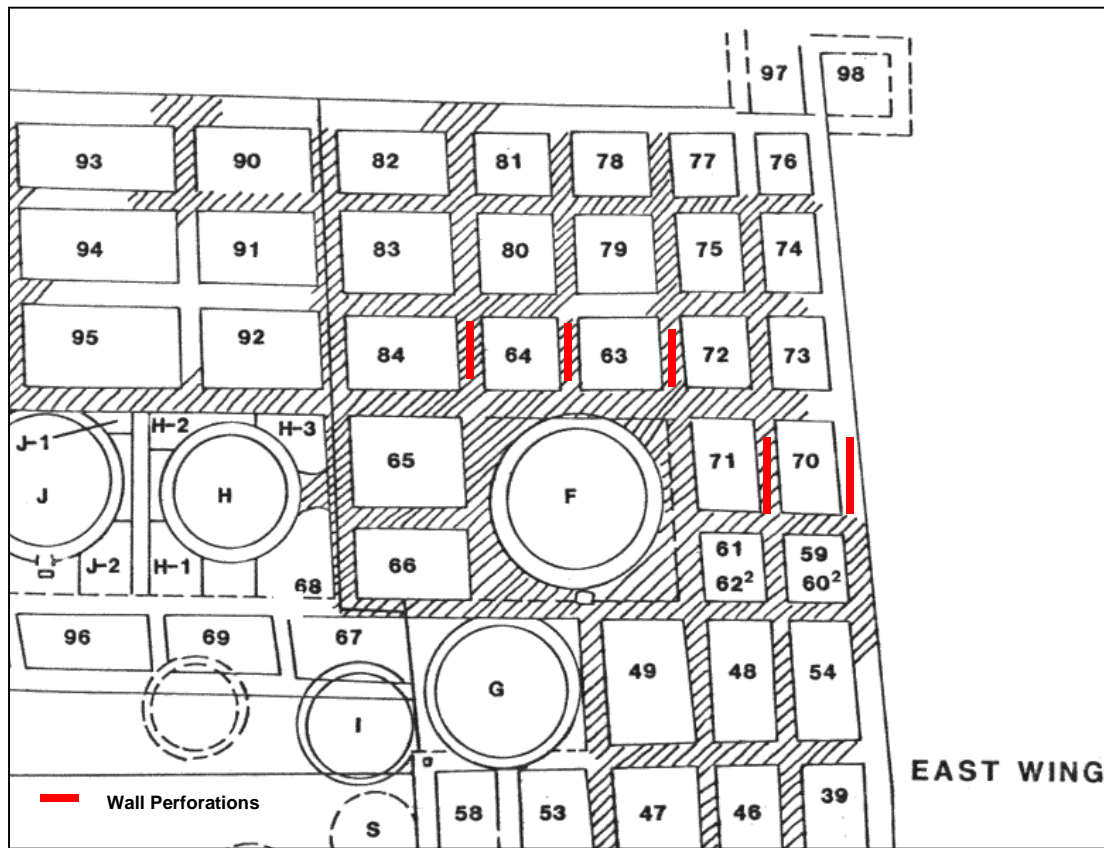
Figure A1. Location of wall perforations in FY00 backfill area.

Installation of a water drainage system at the West Ruin at Aztec Ruins National Monument required five penetrations through prehistoric masonry walls (Figure A1). The drainage system was installed as part of the Aztec West backfilling project during Fiscal Year 2000. This project is part of a long-term preservation program oriented toward backfilling some parts of the ancient Puebloan ruin that were excavated many years ago for research and display. Natural precipitation within the excavated rooms in the pueblo had no means of external drainage; the resulting water was a major cause of deterioration of the ancient masonry. In conjunction with backfilling, the drainage system was designed to collect water and transport it through PVC drain pipes to locations outside the pueblo. Most of the pipes were routed through prehistoric doorways, but wall perforations were made in five instances where no architectural passage existed.

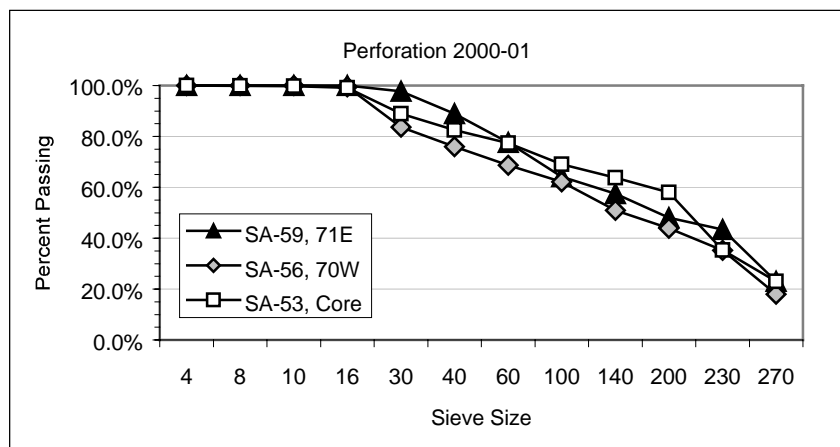
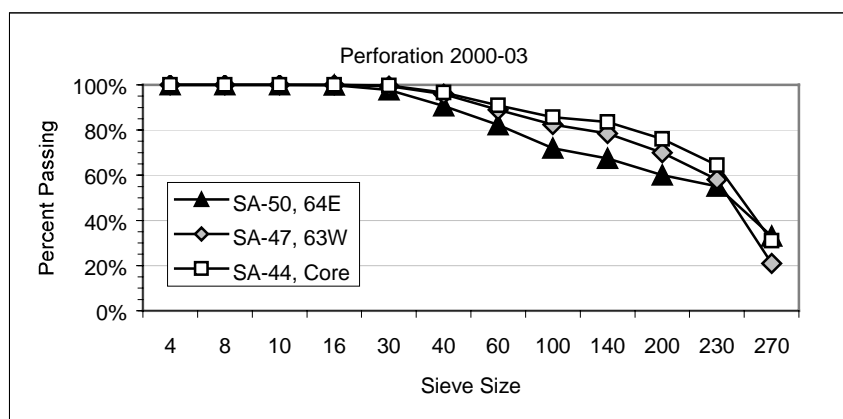
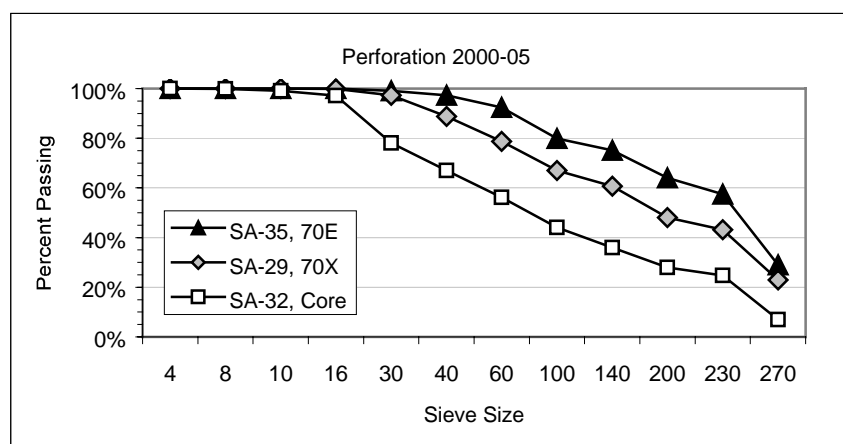
**Figure A2. Percentage of Sediments Passing through Graduated Sieves for Three Wall Perforations.**

The typical texture of these mortars is well suited to masonry work. Clay is essential for its plasticity and ability to bond with building stones, resistance to deformation when wet, and tendency to dry into a hard, cohesive mass. However, clay expands and contracts with changes in moisture, cracking as wet mortar becomes dry. This characteristic can be counteracted with the inclusion of aplastic particles of temper. Large amounts of sand tend to decrease the cohesion of mortar, though fine-grained sands in moderate proportions can temper it without great sacrifices in cohesion and plasticity. Silts lack significant plasticity, yet they are too fine to adequately temper mortar against cracking, especially because their “dilatancy” results in changes in volume with changes in shape (USDI 1974:13). As a result, silts are poorly suited to masonry work. The behavior of silt is also very difficult to control while wet, a characteristic that is especially problematical for masons trying to build straight walls of uniform thickness.

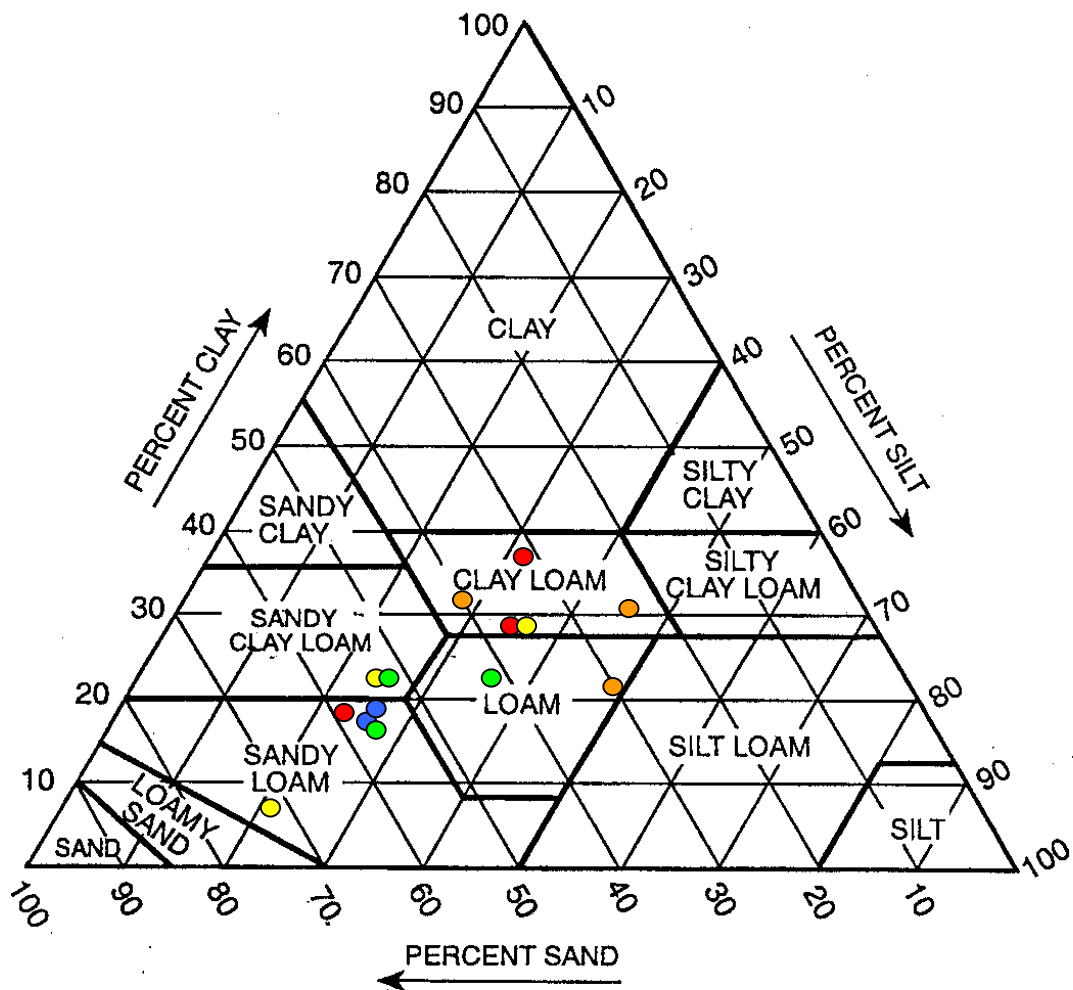
Figure A3. Three-Way Classification of Sand, Silt, and Clay Percentages within 14 Mortar Samples. Perforation 2000-01 = Green; 2000-02 = Blue; 2000-03 = Orange; 2000-04 = Red; 2000-05 = Yellow.

Most of the remaining samples form a tight cluster near the three-way separation point between loam, sandy loam, and sandy clay loam. Despite the number of terms used to describe them, all of these samples are characterized by a relatively high sand content (over 50 percent) and moderate quantities of clay and silt. The fineness of the sands in all of the samples insured that its abundance did not decrease integrity as long as a moderate quantity of clay was included. The hard, cohesive properties of most samples indicates

that clay fractions, while relatively low, were high in “fat” clays (i.e., those with high to very high dry strength and high toughness) that counteracted the silts, with just the opposite physical characteristics (USDI 1974:Figure 7). Clays of this type are highly plastic and compressible. The color values discussed in the previous section indicate further that these are inorganic sediments, which would tend to have less dry strength and toughness characteristics.

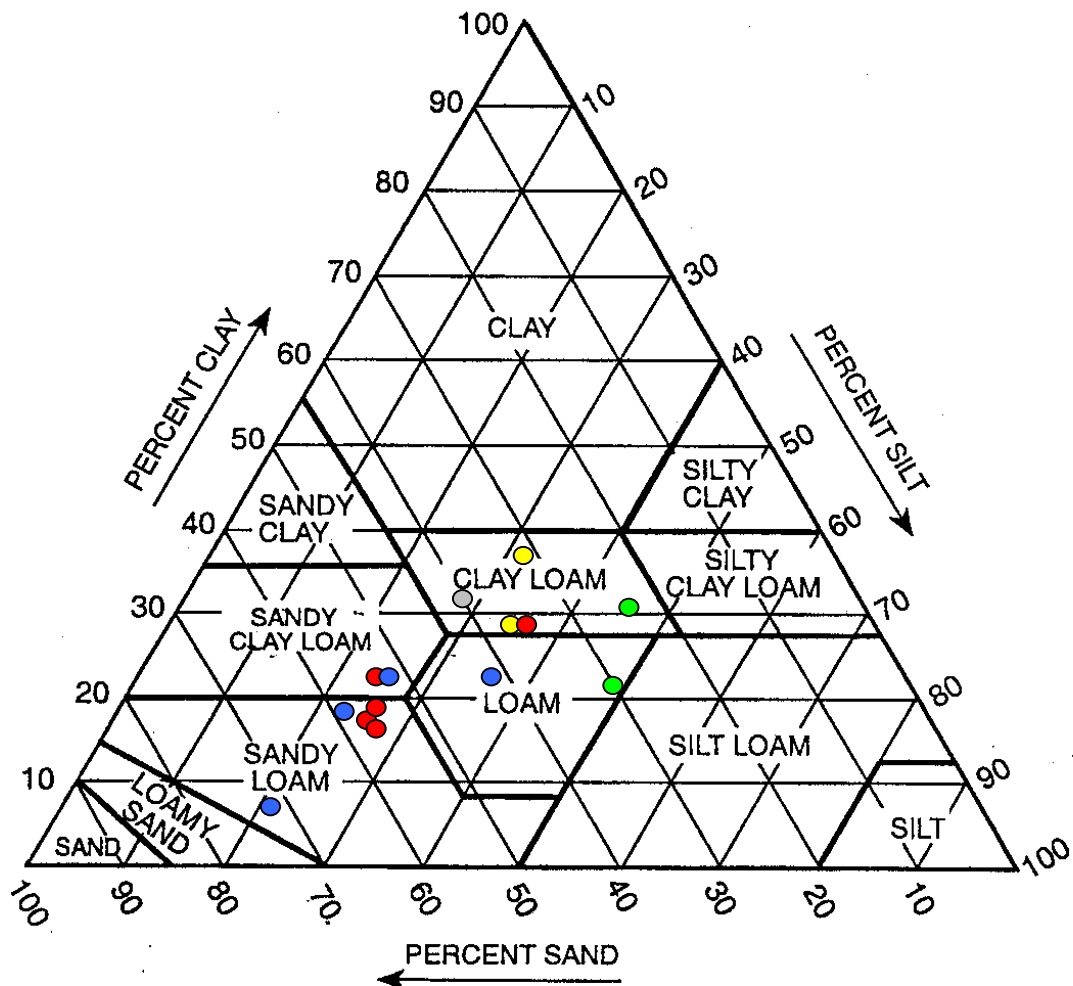
Figure A4. Mortar Types Plotted on Three-Way Classification of Sand, Silt, and Clay Percentages. Type 1A = Blue; Type 1B = Red; Type 2A = Yellow; Type 2B = Green; one heterogeneous sample with mixed mortars is plotted in gray.

occur in the following frequencies: Type 1A, 10YR 5/3 (four samples); Type 1B, 10YR 6/3 (four samples); Type 2A, yellowish-brown (three samples); and Type 2B, light yellowish-brown (two samples).

slightly, but that sand content may be a more definite discriminating factor. All Type 1 samples have sand fractions exceeding 40 percent, while sand in Type 2 samples comprises 35 percent or less. As might be expected, the one heterogeneous sample with admixtures of at least two mortar batches lands in the transitional area between the two types. Subtypes (at least those within Type 1) do not appear to separate in their distribution by texture. Obviously, more samples need to be analyzed before the value of distinguishing Type 1 brown and Type 2 yellowish-brown mortars can be evaluated, but the preliminary results presented here show this distinction is work exploring further.

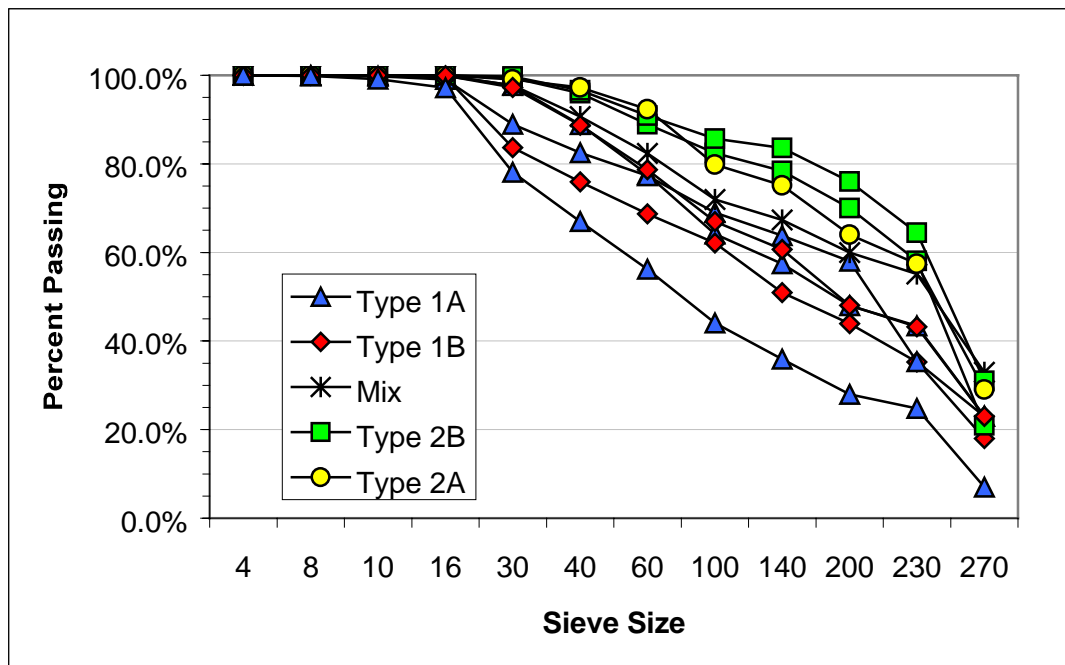
Figure A5. Percentages of Sediments Passing Graduated Sieves for All Nine Samples Distinguished by Mortar Type.

In addition to the sandier composition of Type 1 samples, Type 2 tends to be somewhat siltier, although this pattern is not as distinct. Inspection of the grain-size curves shows this pattern within the samples that were given full grain-size analysis (see Figure A2). The siltier samples are characterized by more convex curves in which large proportions of “fines” (particles passing #200 sieve) are retained by the #230 and #270 sieves. The Type 2 samples are the highest curves in the middle graph (SA-44 and 47, both Type 2B) and the highest one in the lower graph (SA-35, Type 2A). All nine of the grain-size curves are plotted in Figure A5, which clearly shows some separation between the lower Type 1 samples and upper Type 2 samples based on the siltier composition of the latter and the sandier composition of the former. In short, the brown mortars tend to have more fine-grained and medium-grained sands, while the yellowish-brown mortars tend to have more silts and clays.

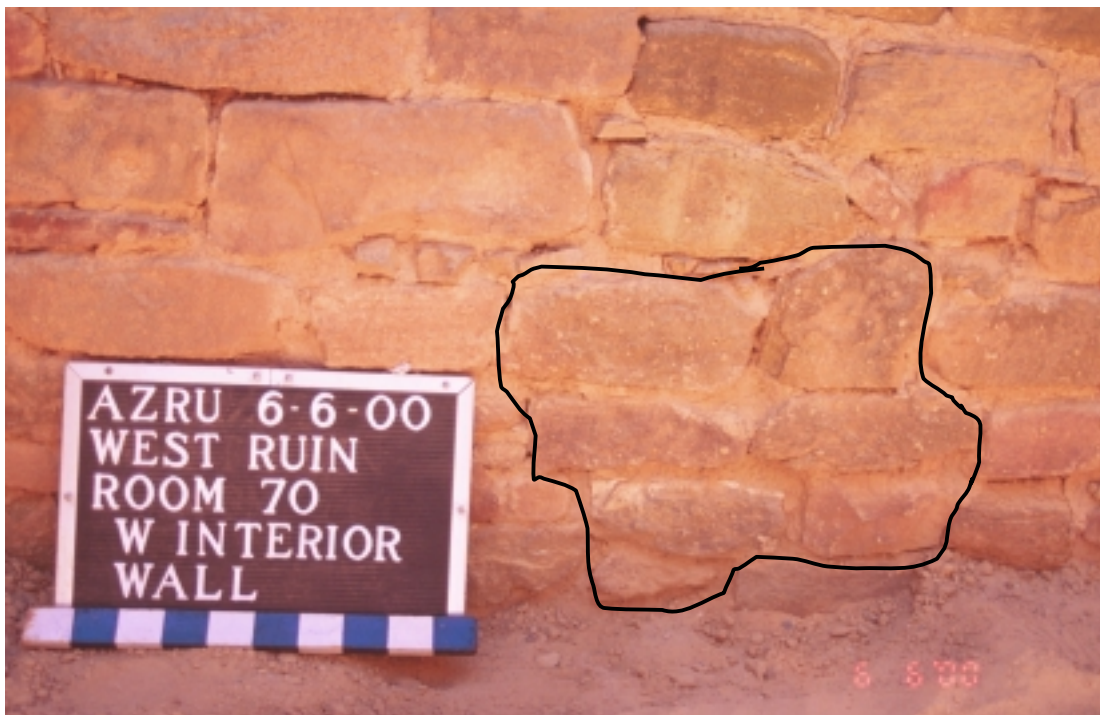
Figure 01B. West interior wall of Room 70, looking southwest, prior to removal of Perforation 2000-01 on June 6, 2000. Perforation is outlined.

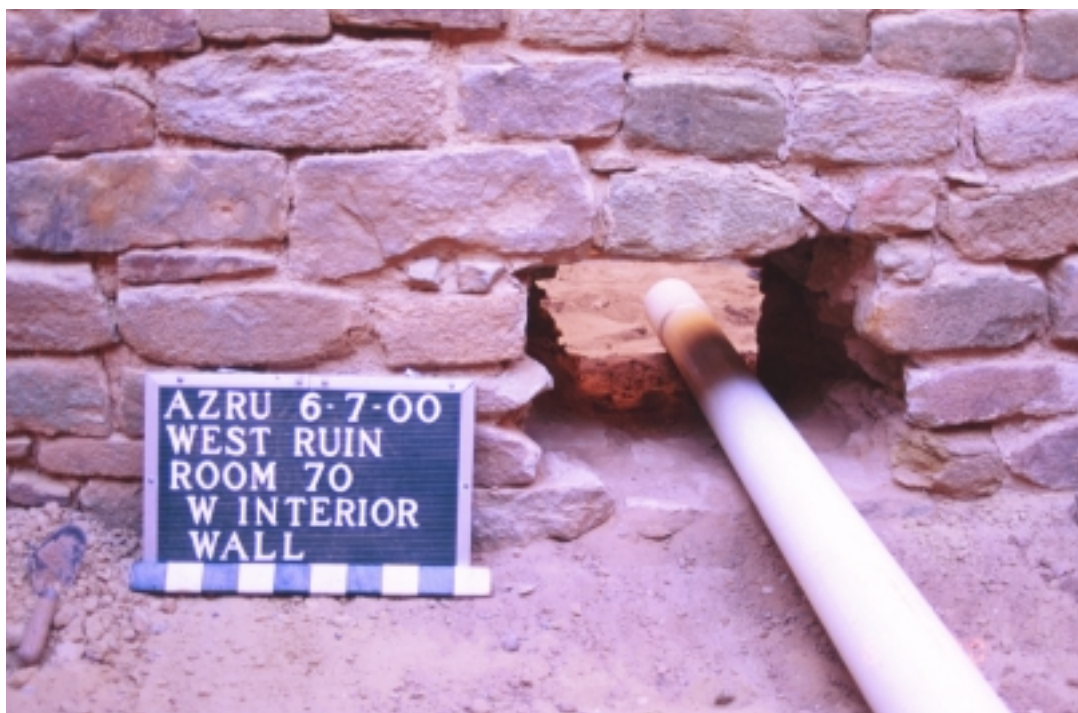
Figure 01C. West interior wall of Room 70, looking southwest, after initial wall penetration on June 7, 2001, showing initial placement of PVC pipe.

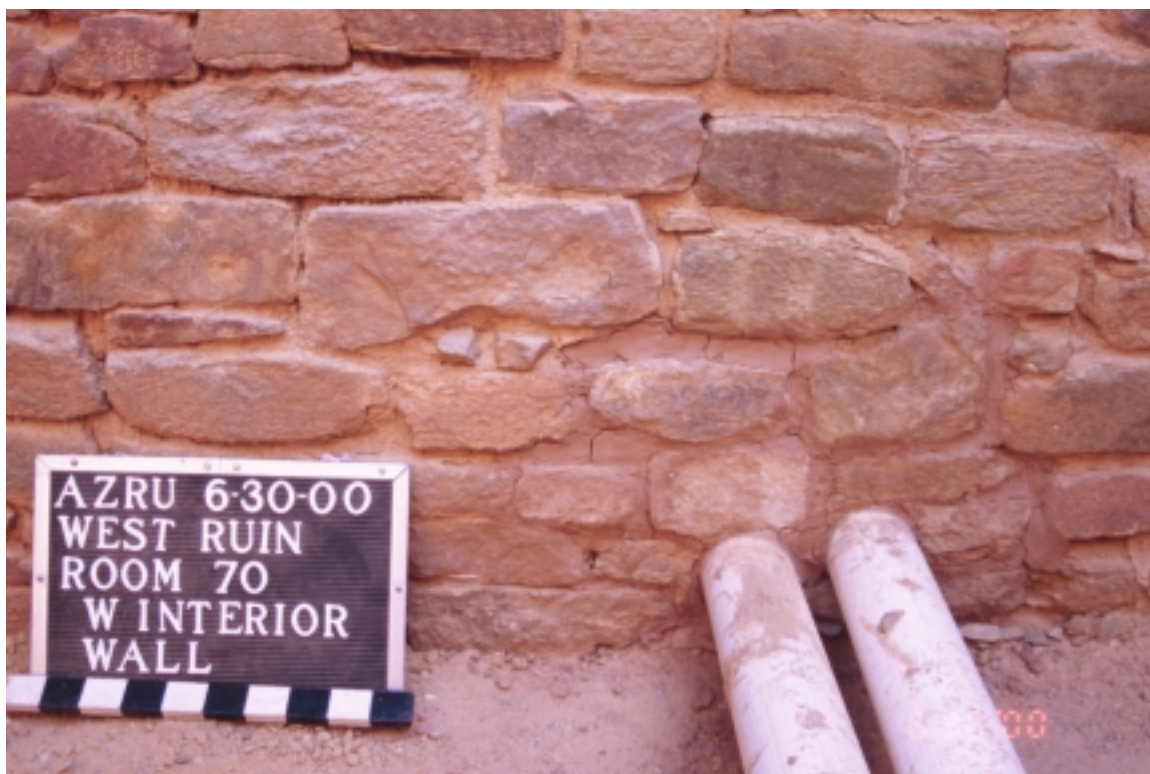
Figure 01D. West interior wall, looking southwest, after masonry closure around Perforation 2000-01.

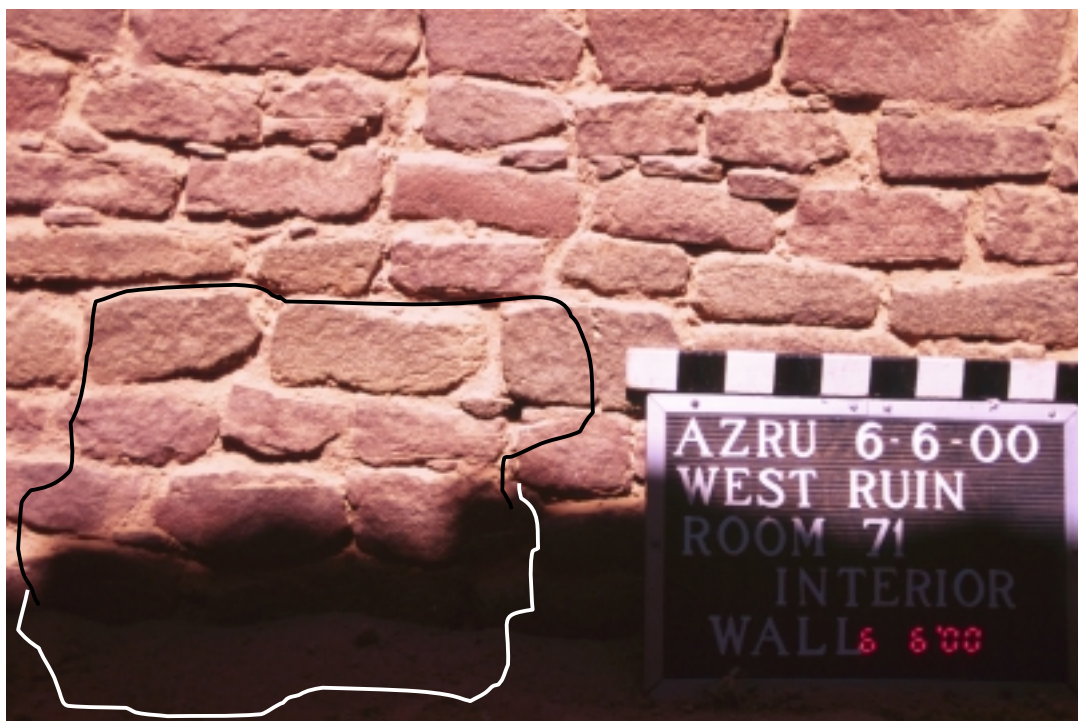
Figure 01F. East interior wall of Room 71, looking northeast, prior to removal of Perforation 2000-01 on June 6, 2000. Perforation is outlined.

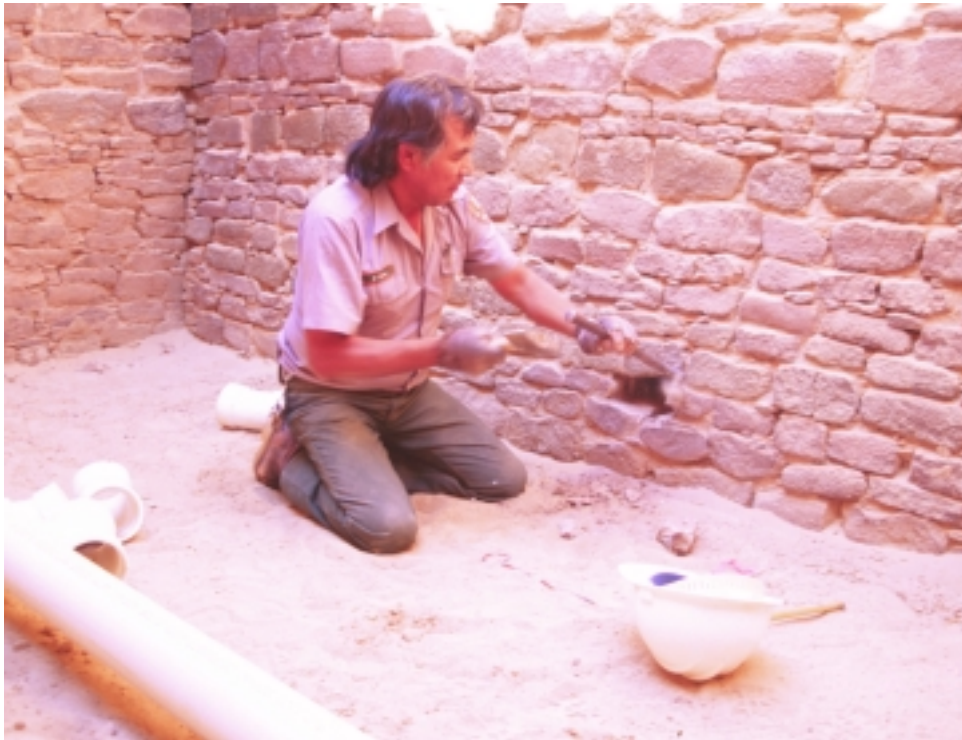
Figure 01G. James Brown chiseling out building stones for Perforation 2000-01 on east interior wall of Room 71.

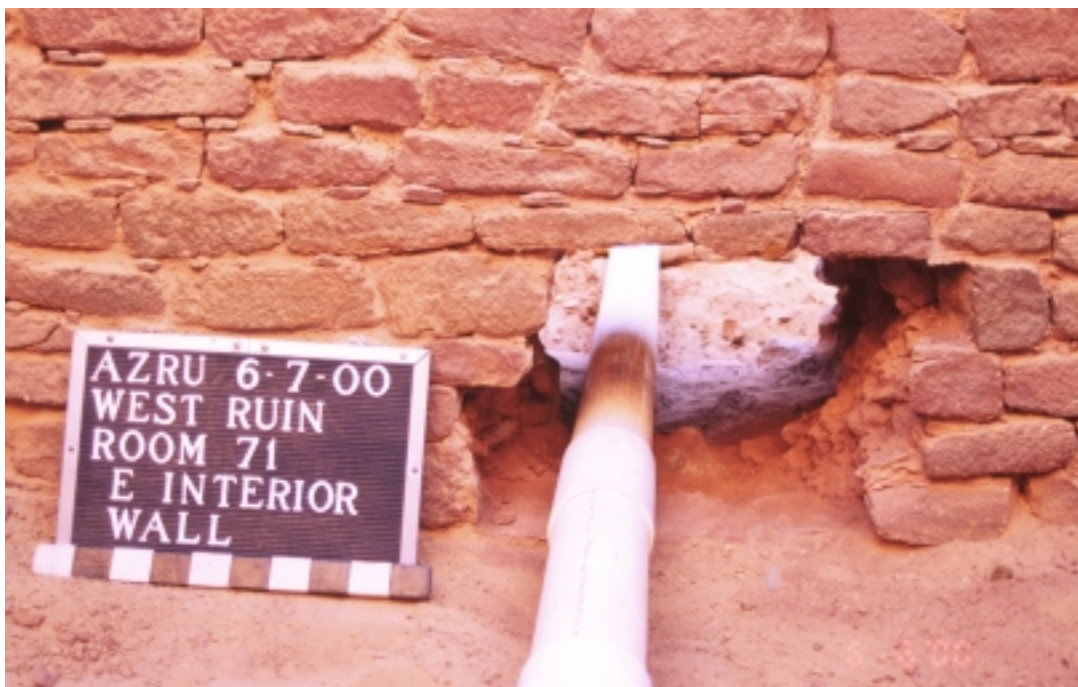
Figure 01H. East interior wall of Room 71, looking northeast, after initial wallpenetration on June 7, 2001, showing initial placement of PVC pipe.

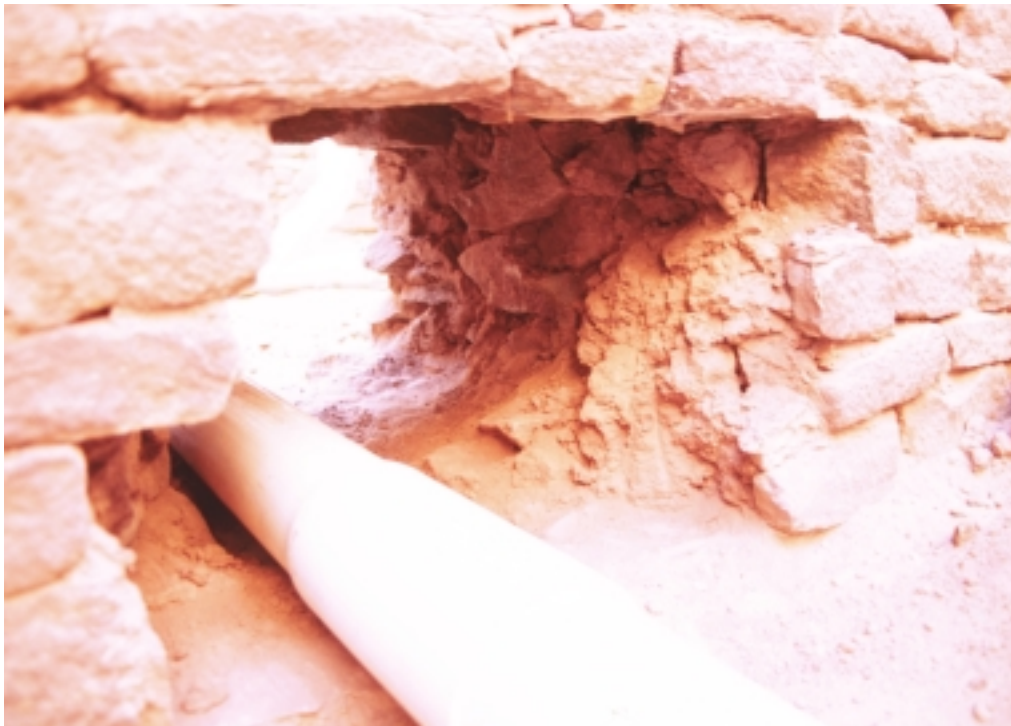
Figure 01I. Masonry-filled core construction in Perforation 2000-01, looking east from Room 71, after completion of penetration and installation of PVC drain pipe.

The perforation revealed an uncoursed masonry-filled core/veneer wall cross-section with sparse animal bone and an obsidian flake tool in the core mortar. A small, burned bone fragment was also recovered from the flotation sample associated with the

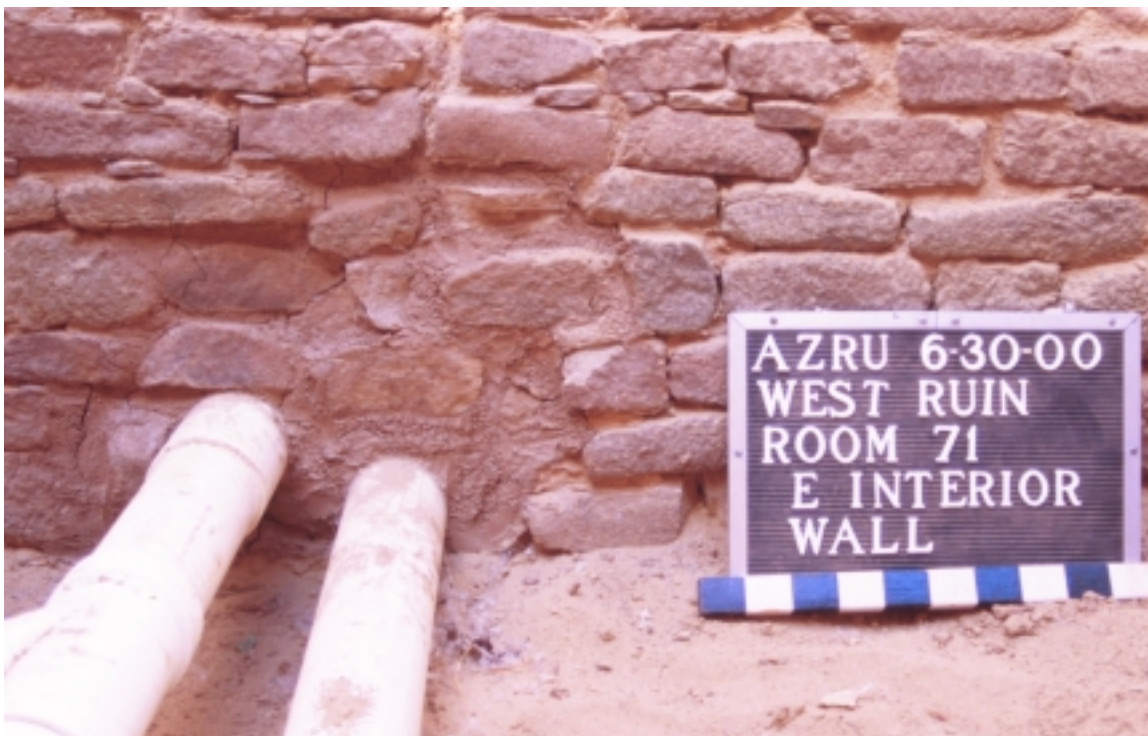
Figure 01J. East interior wall, looking northeast, after masonry closure around Perforation 2000-01.

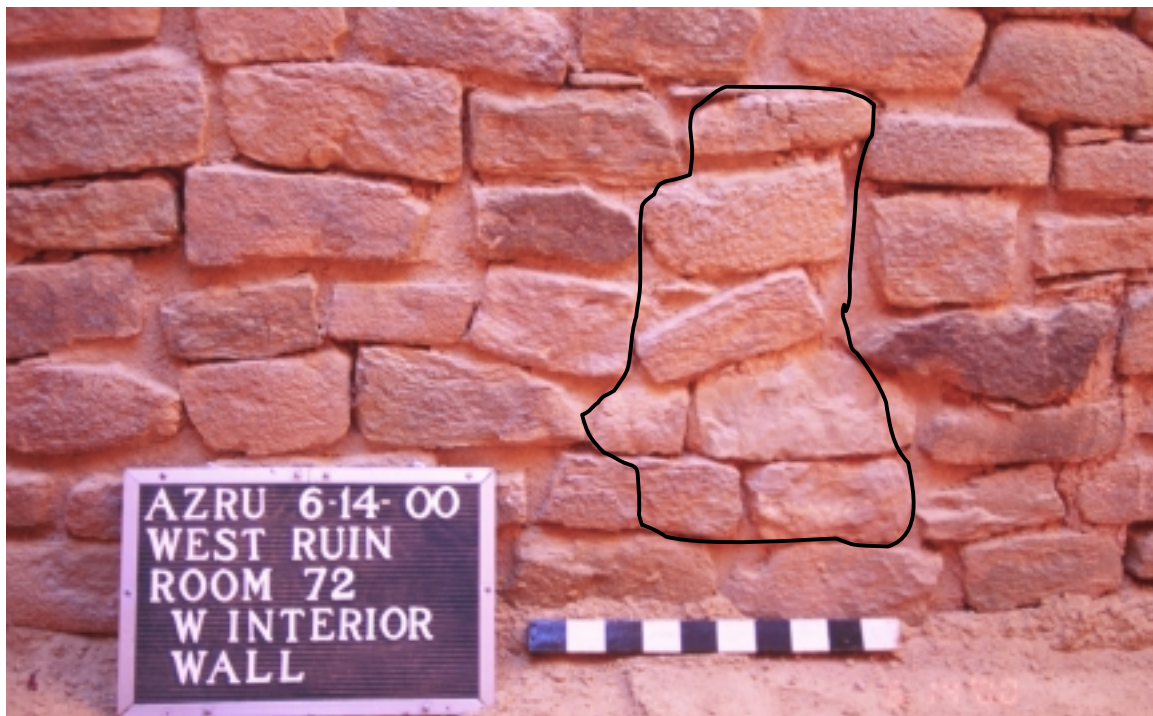
Figure 02B. West interior wall of Room 72, looking southwest, prior to removal of Perforation 2000-02 on June 14, 2000. Perforation is outlined.

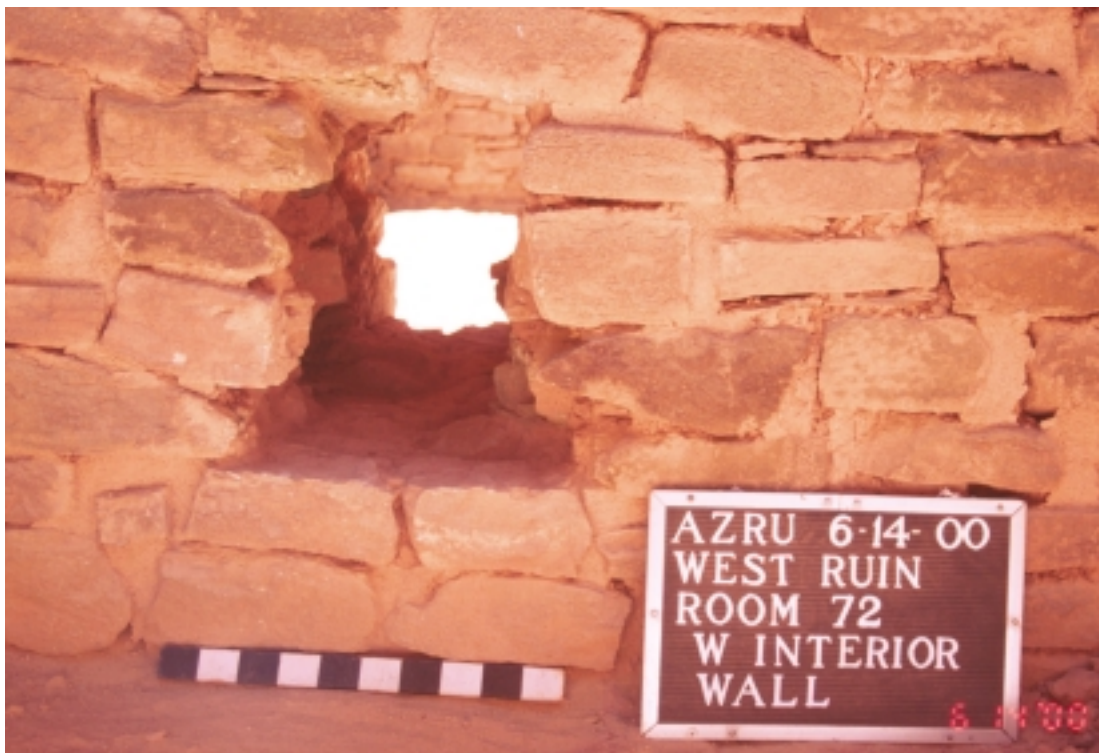
Figure 02C. West interior wall of Room 72, looking southwest, after initial wall penetration on June 14, 2000.

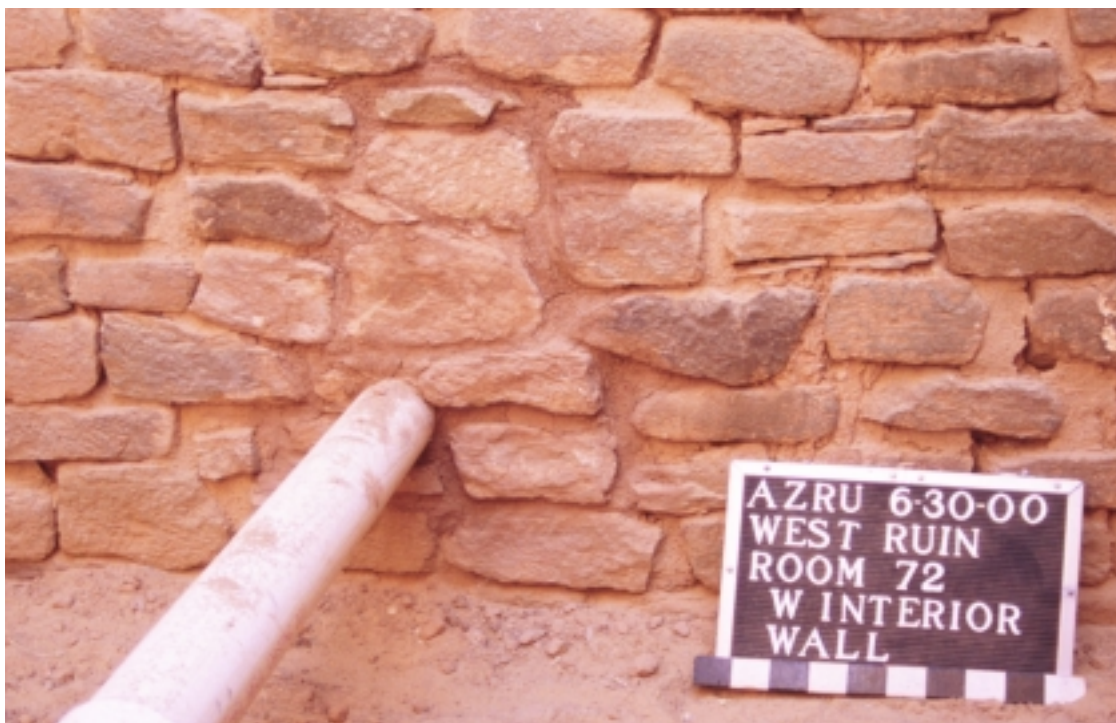
Figure 02D. West interior wall, looking southwest, after masonry closure around Perforation 2000-02.

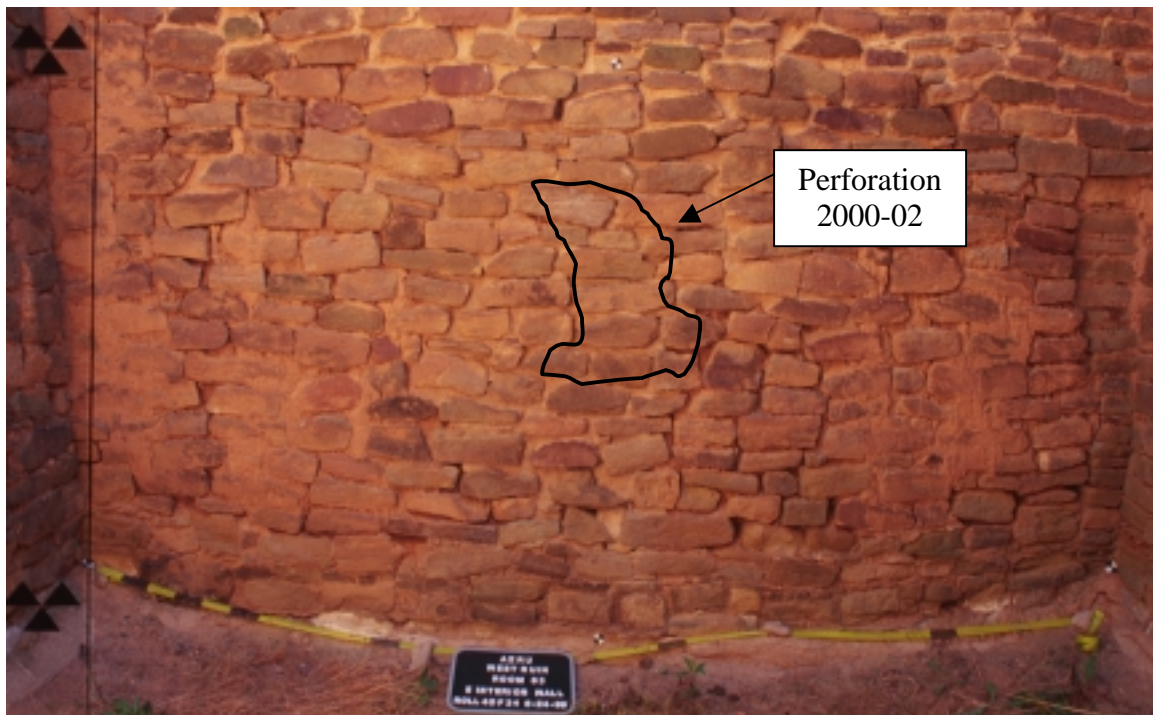
Figure 02E. East interior wall of Room 63, looking northeast at location of wall perforation that was opened during FY-2000 backfilling project. Pre-backfill photo taken June 24, 1999.

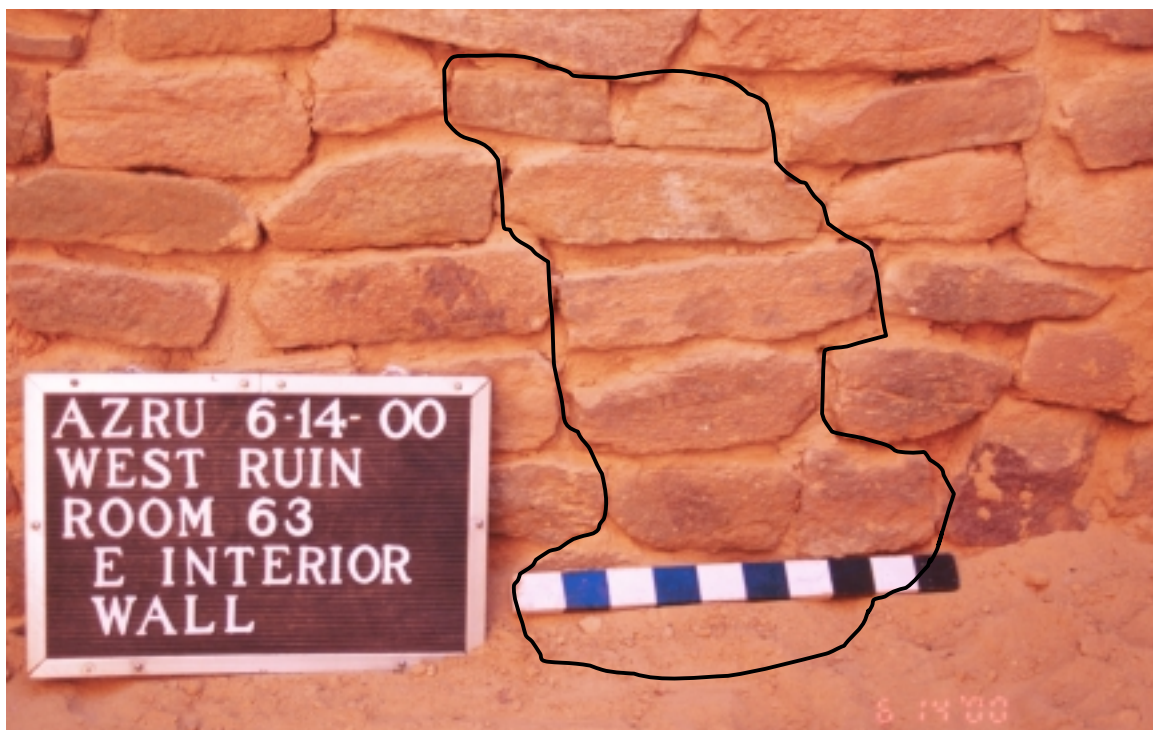
Figure 2F. East interior wall of Room 63, looking northeast, prior to removal of Perforation 2000-02 on June 14, 2000. Perforation is outlined.

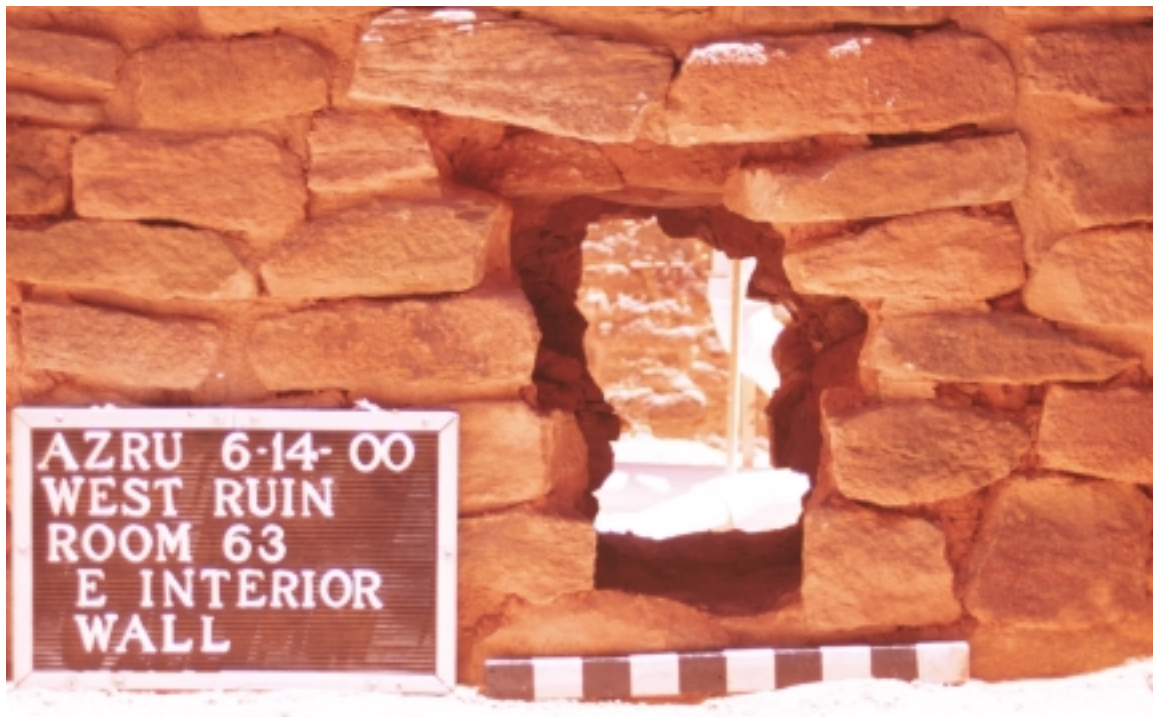
Figure 02G. East interior wall of Room 63, looking northeast into Room 72 through initial wall penetration on June 14, 2000.

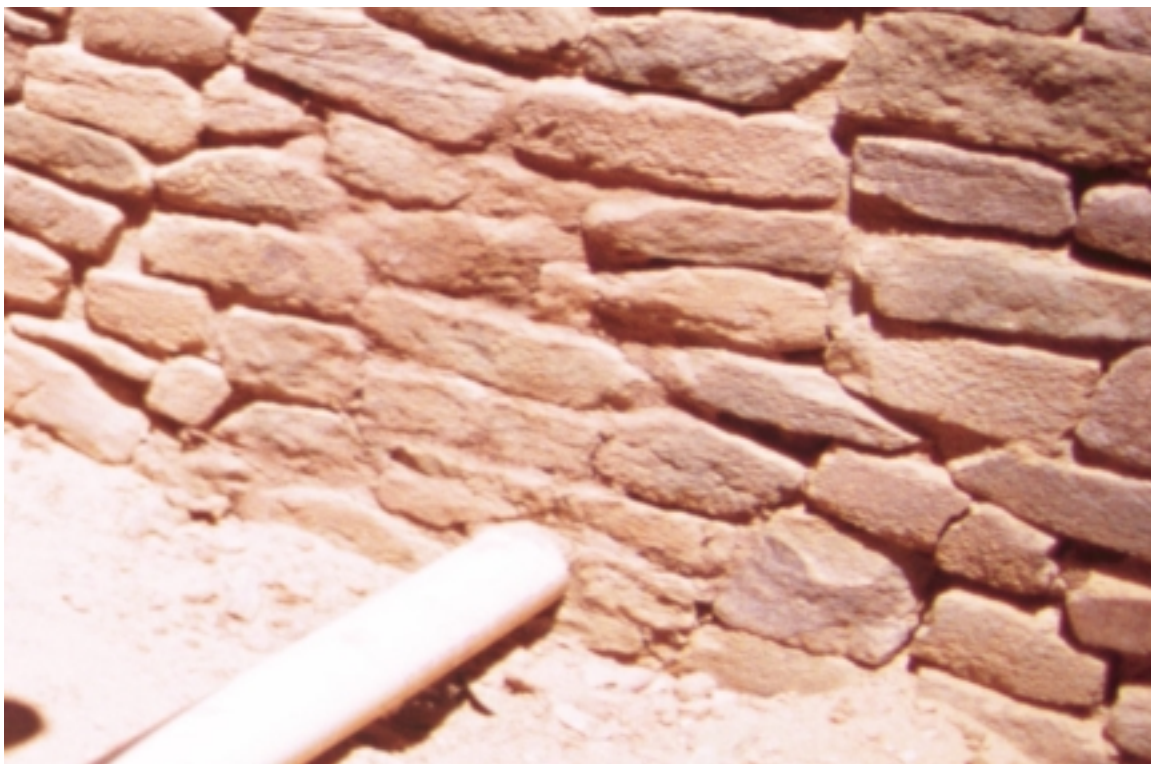
Figure 02H. East interior wall of Room 63, looking north, after masonry closure around Perforation 2000-02.

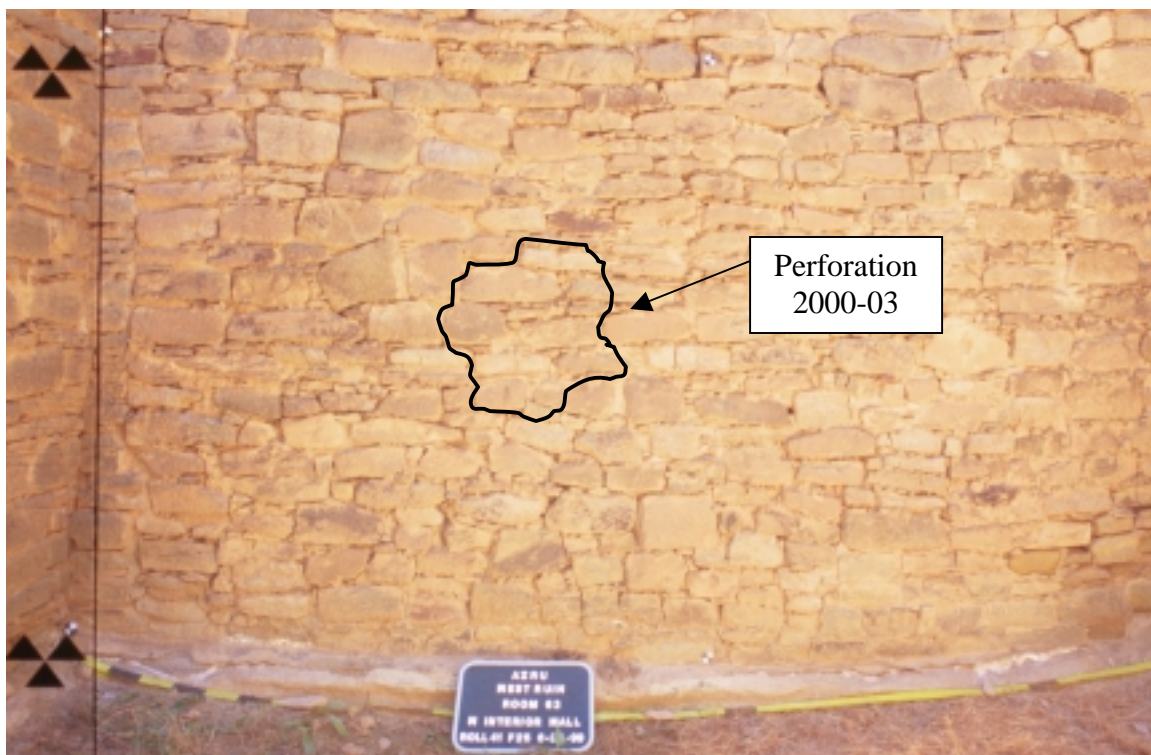
Figure 03A. West interior wall of Room 63, looking southwest at location of wall perforation that was removed during FY-00 backfilling project. Pre-backfill photo taken June 24, 1999.

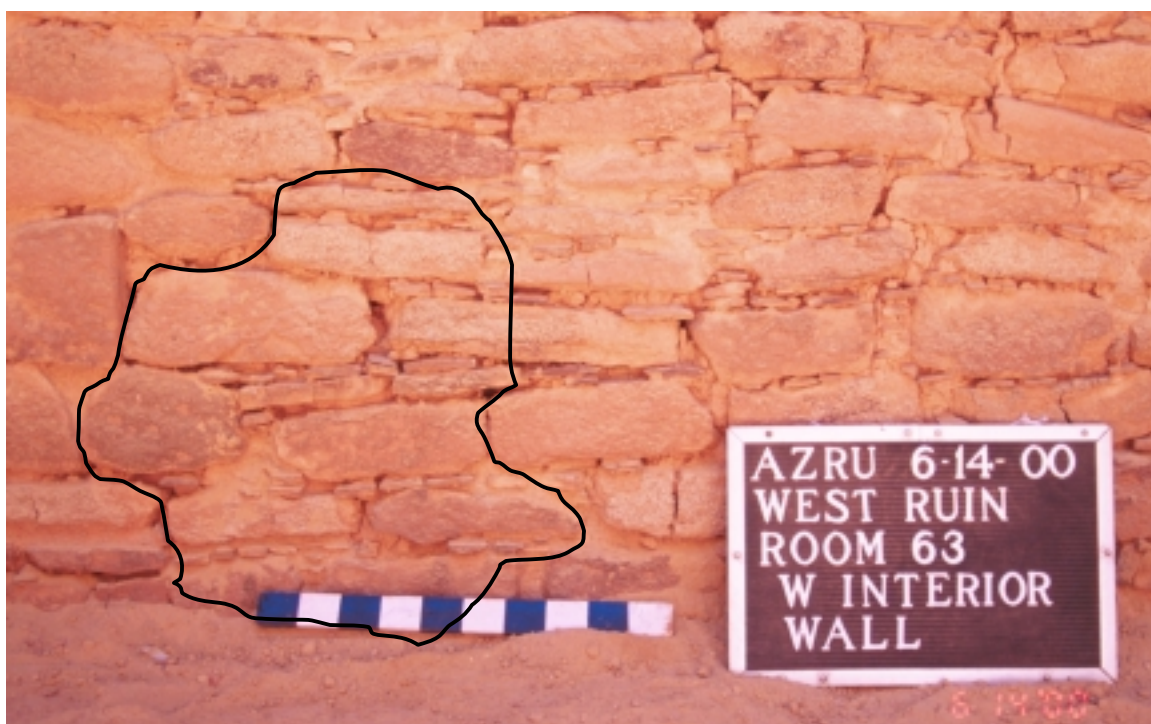
Figure 03B. West interior wall of Room 63, looking southwest, prior to removal of Perforation 2000-03 on June 14, 2000. Perforation is outlined.

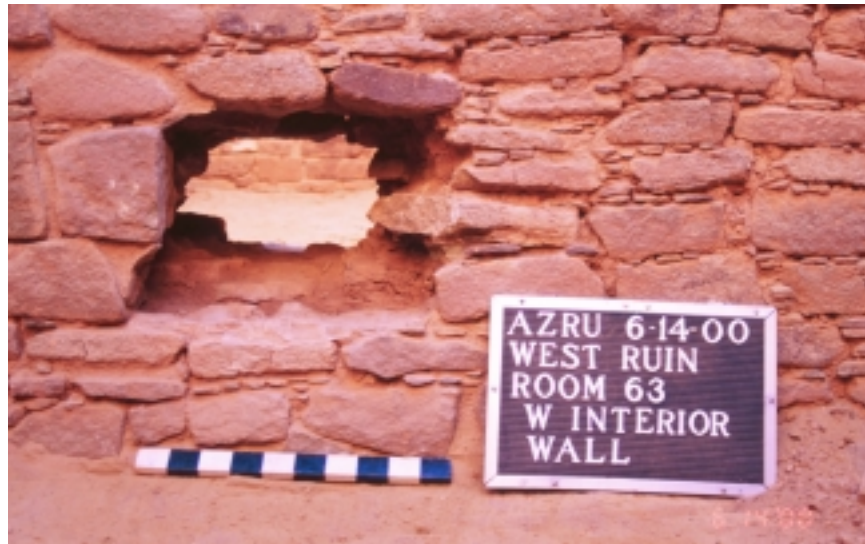
Figure 03C. West interior wall of Room 63, looking southwest after initial wall penetration on June 14, 2000.

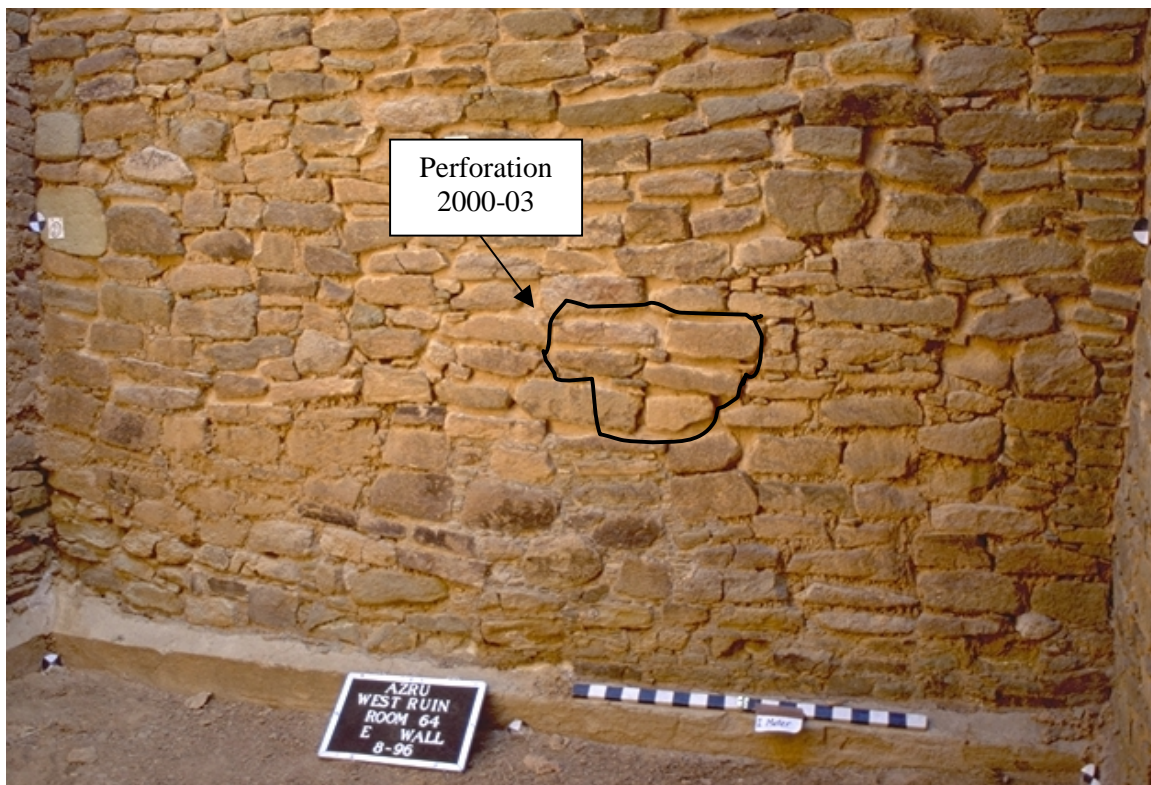
Figure 03D. East interior wall of Room 64, looking northeast at location of wall perforation that was removed during FY-00 backfilling project. Pre-backfill photo taken August 1996.
