# **ANALYSIS OF ARCHITECTURAL MORTAR SAMPLES FROM WEST RUIN AT AZTEC RUINS NATIONAL MONUMENT**

Gary M. Brown  
Archeologist  
Aztec Ruins National Monument  
Aztec, New Mexico

September 2001

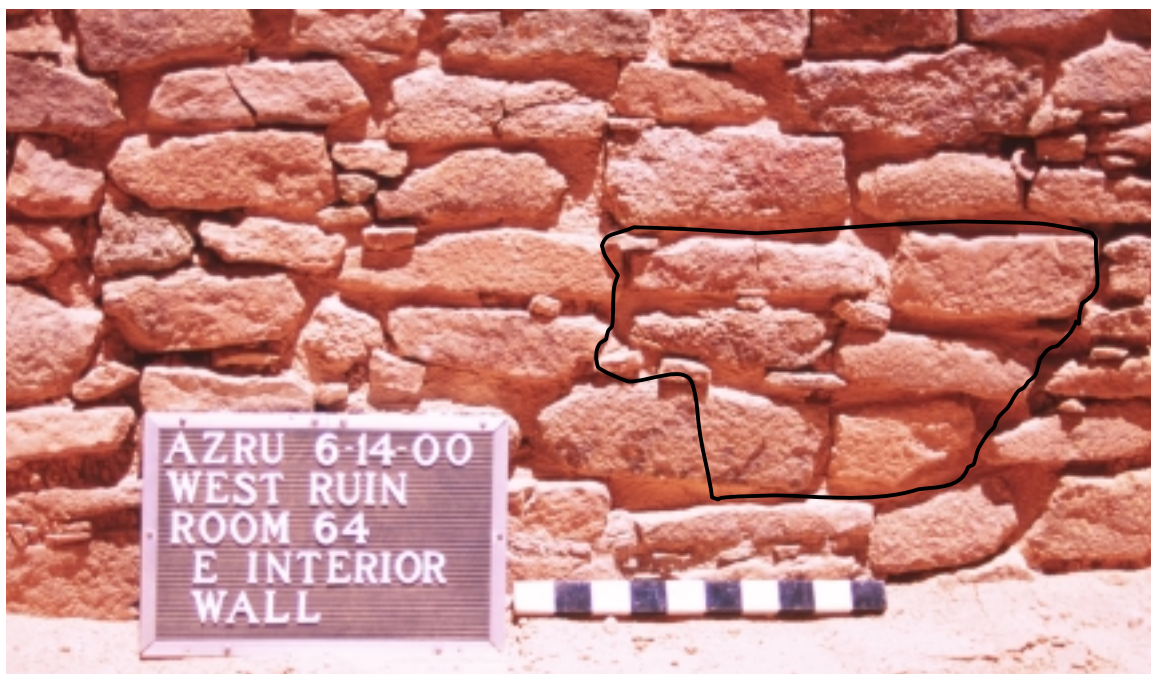
Figure 03E. East interior wall of Room 64, looking northeast, prior to removal of Perforation 2000-03 on June 14, 2000. Perforation is outlined.

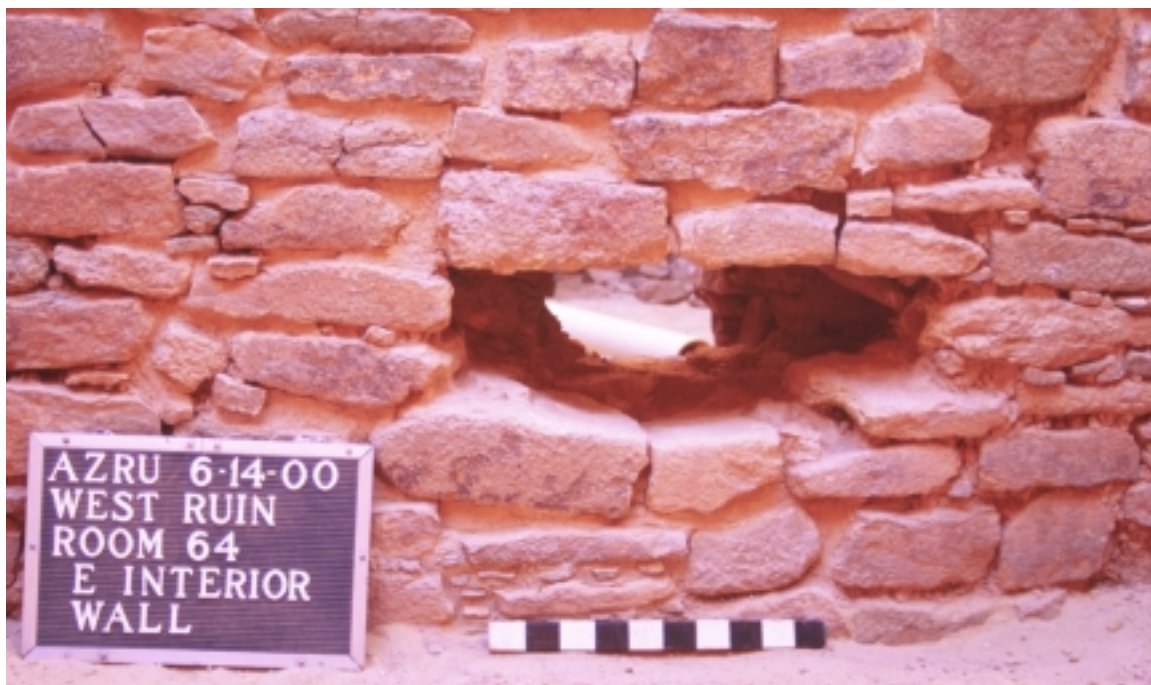
Figure 03F. East interior wall of Room 64, looking northeast, after initial wall penetration on June 14, 2000.

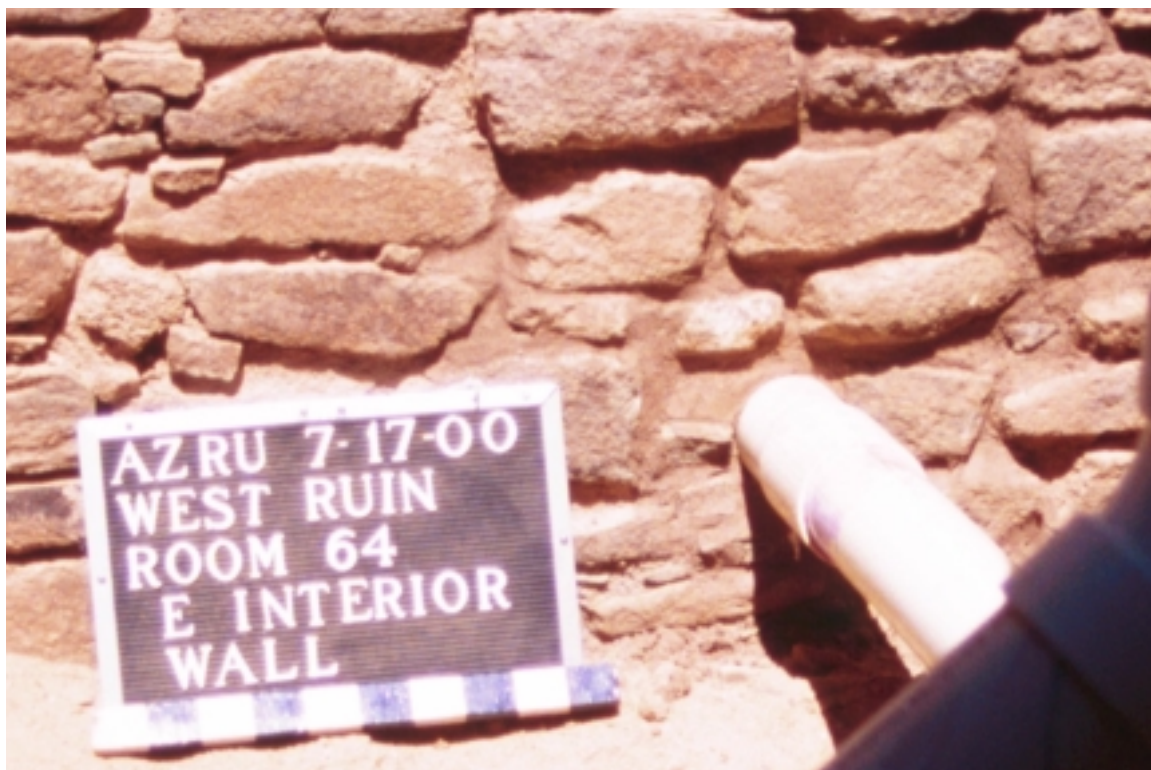
Figure 03G. East interior wall of Room 64, looking NE, after masonry closure around Perforation 2000-03.

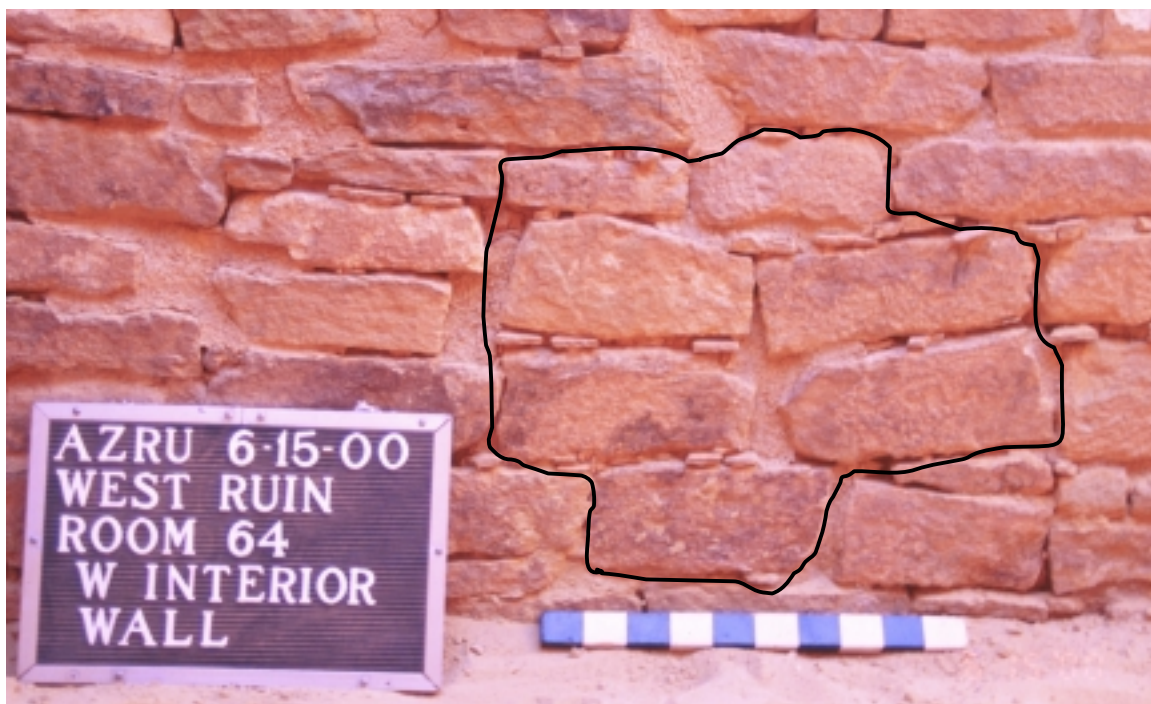
Figure 04A. West interior wall of Room 64, looking southwest, prior to removal of Perforation 2000-04 on June 15, 2000. Perforation is outlined.

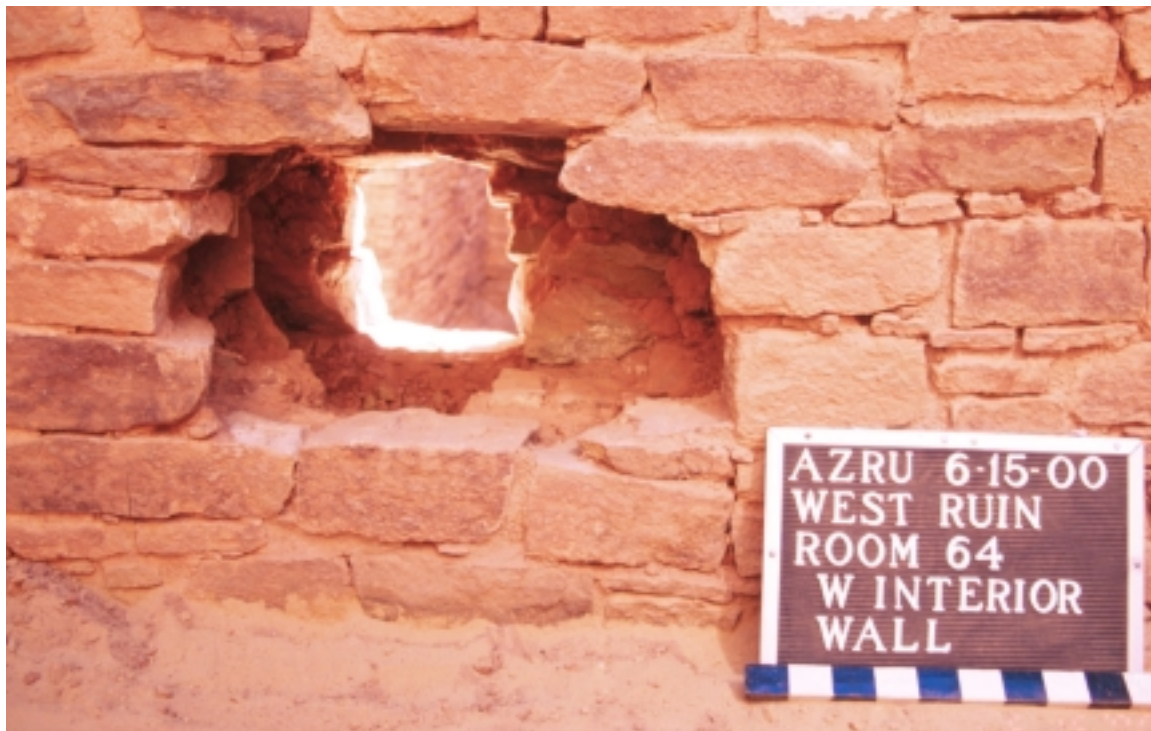
Figure 04B. West interior wall of Room 64, looking southwest, after initial wall penetration. The stone in center below the initial perforation was later removed to accommodate pipe.

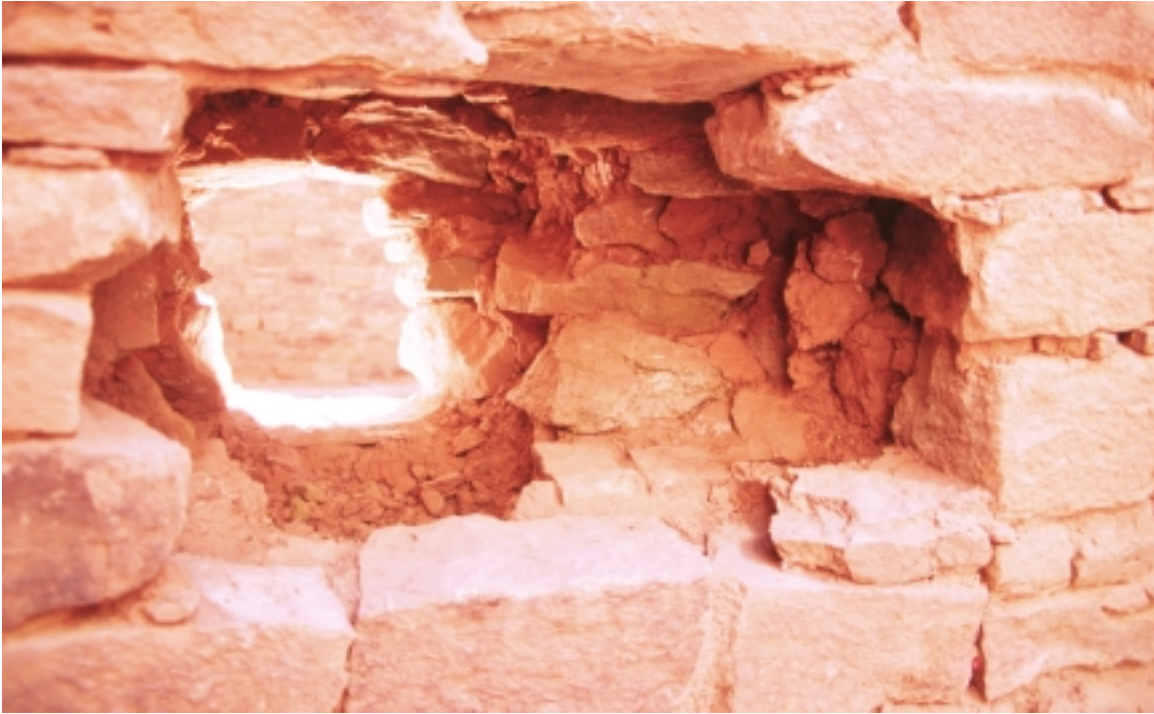
Figure 04C. Perforation 2000-04 through west interior wall of Room 64, looking west, showing semi-coursed masonry in solid core construction.

Rocks in the west-facing veneer average 20 by 18 by 9 cm, those in the east veneer average 28 by 19 by 13 cm, and those in the core average 30 by 15 by 12 cm. One exceptionally large stone was removed from the core. Evidence of shaping was noted only on the veneer stones which generally were faced on one side to provide a flat surface comprising the wall face. Mortar samples were collected from veneer joints on either side and from the core. Sparse charcoal and organics were noted in the mortars; no artifacts were found. The east veneer and the core mortar were yellowish-brown (10YR5/4) clay loam, while the west veneer (within Room 84) was a brown (10YR5/3) fine sandy loam. Total wall thickness is 85 cm, the east veneer averaging 19 cm in thickness and the west veneer 26 cm. Wall construction can be characterized as semi-coursed masonry core/faced veneer. The masonry on both faces is classifiable as McElmo style. It is well coursed and has sparse chinking.

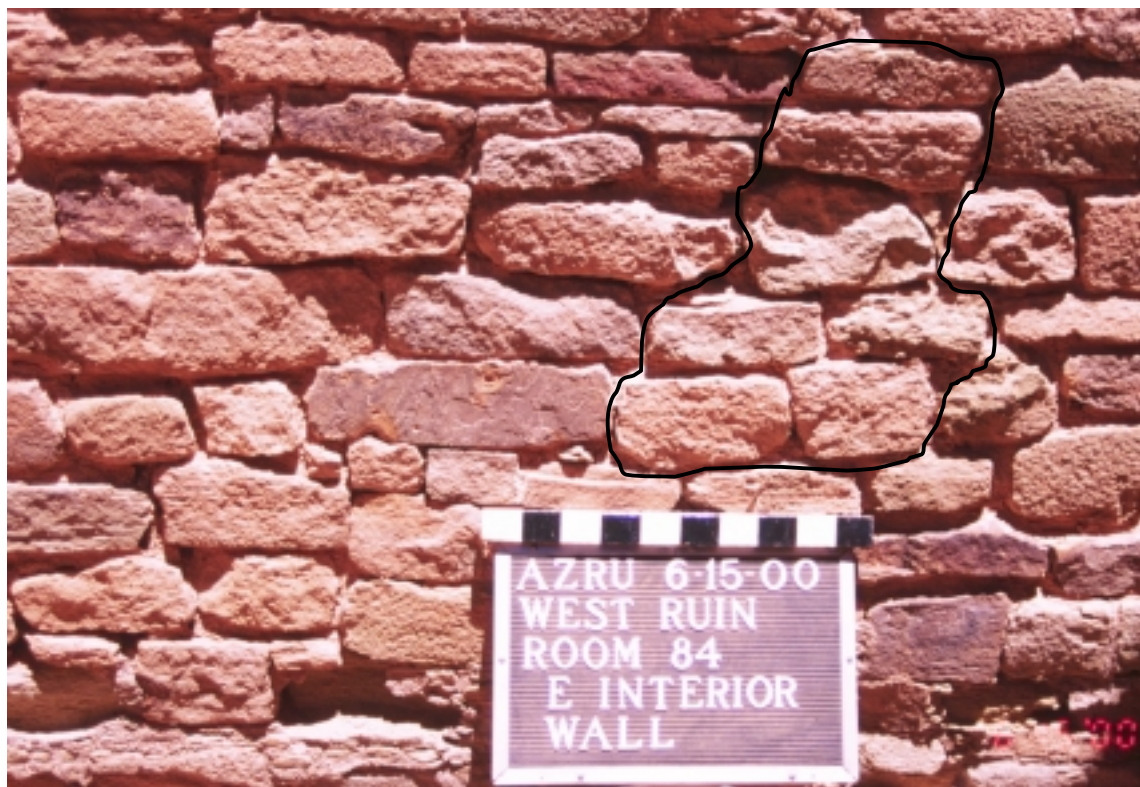
Figure 04F. East interior wall of Room 84, looking northeast, prior to removal of Perforation 2000-04 on June 15, 2000. Perforation is outlined.

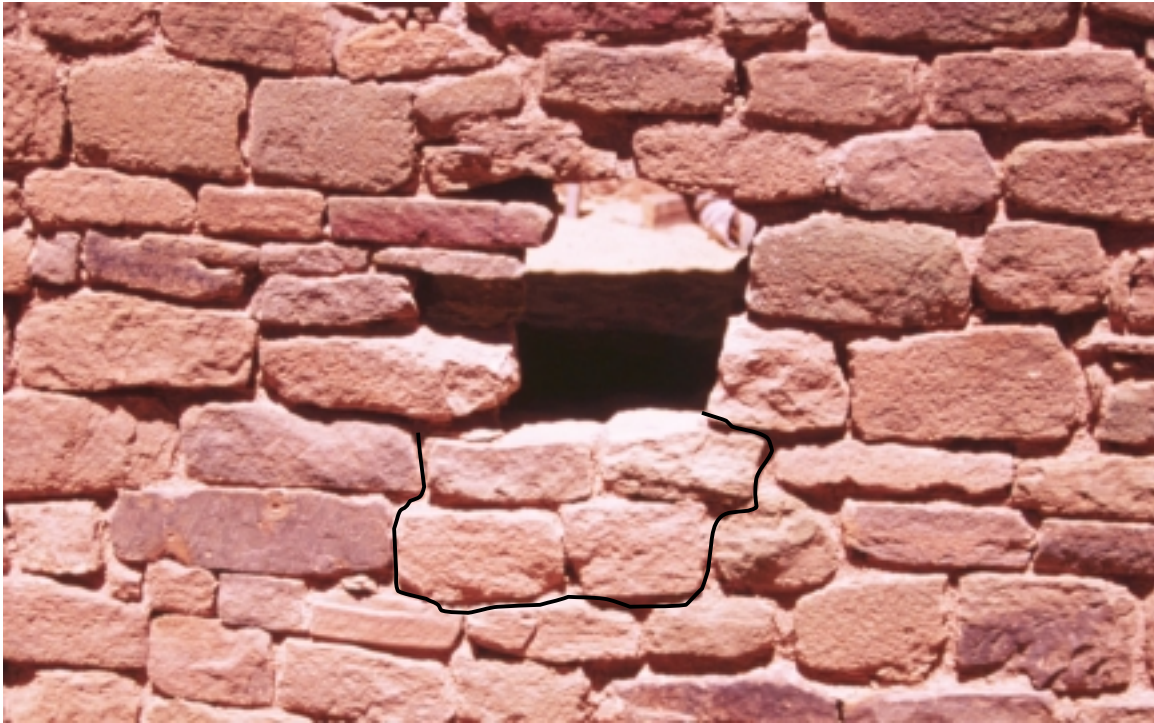
Figure 04G. East interior wall of Room 84, looking northeast after initial wall penetration. Area that was later enlarged to lower drainage pipe is outlined below initial perforation.

The perforation had to be enlarged in order to lower the PVC pipe when final adjustments were made to the drainage system. Three additional stones were removed from the bottom in the east interior wall of Room 63 and two more stones were removed from the bottom in the west interior wall of Room 72. Samples of both the original mortar and cement grouting were collected during archeological monitoring. The results show that the original wall was intact in the area that was perforated, and that Morris' description of a collapsed wall in this location did not affect the lower section of the wall that was involved.

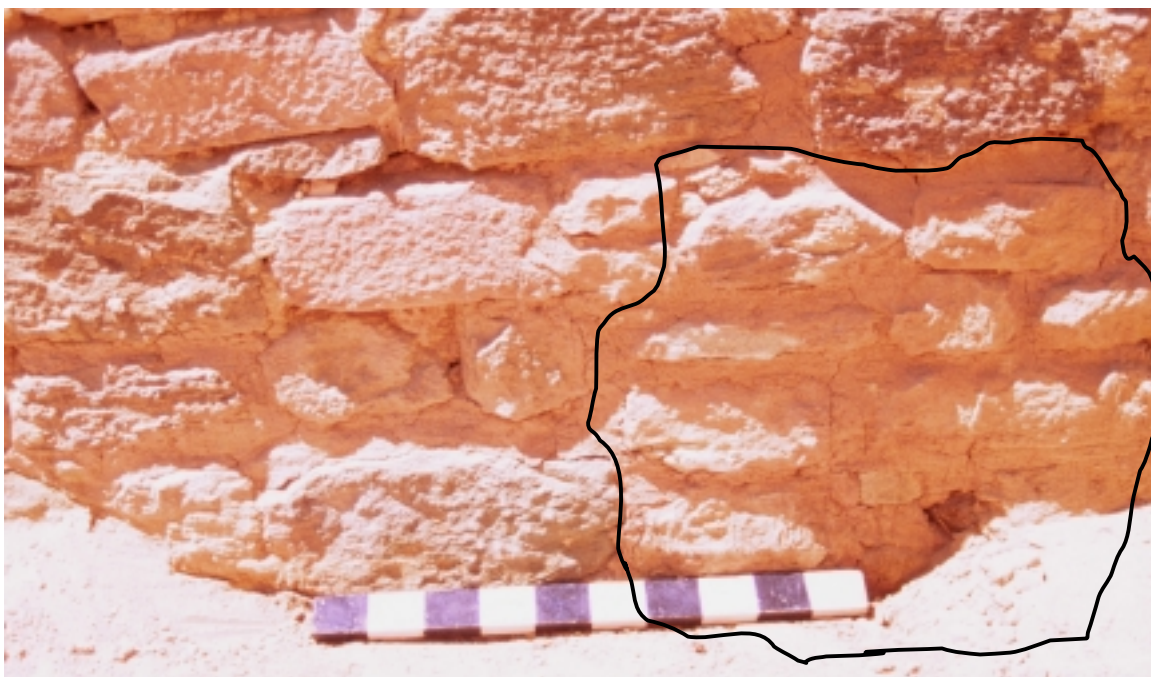
Figure 05B. East exterior wall of Room 70, looking southwest, prior to removal of Perforation 2000-05 on June 20, 2000. Perforation is outlined.

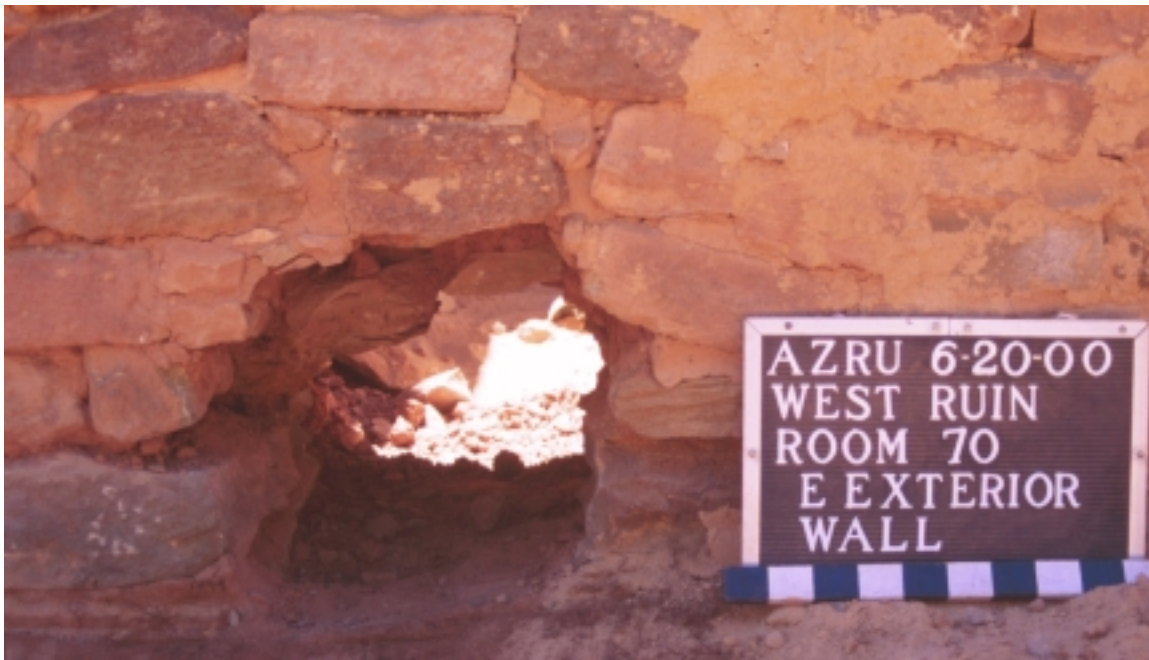
Figure 05C. East exterior wall of Room 70, looking southwest, after initial wall penetration.

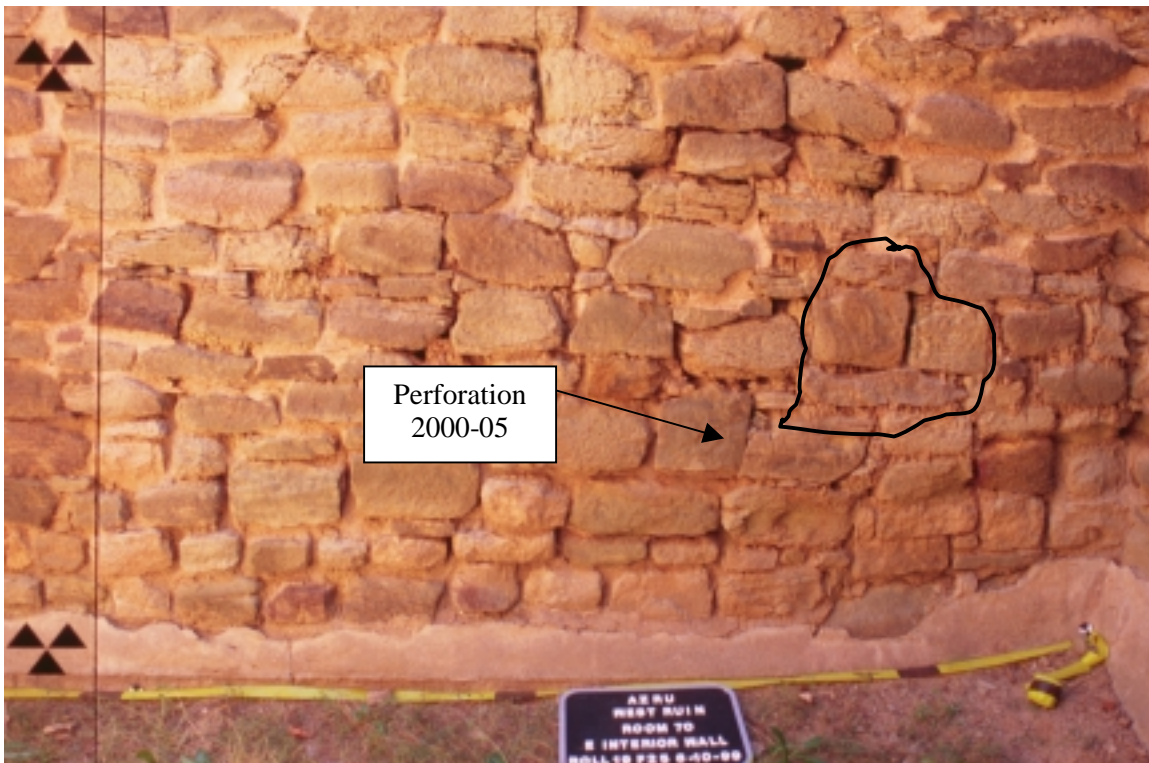
Figure 05D. East interior wall of Room 70, looking northeast at location of wall perforation that was opened during FY-00 backfilling project. Pre-backfill photo taken June 10, 1999.

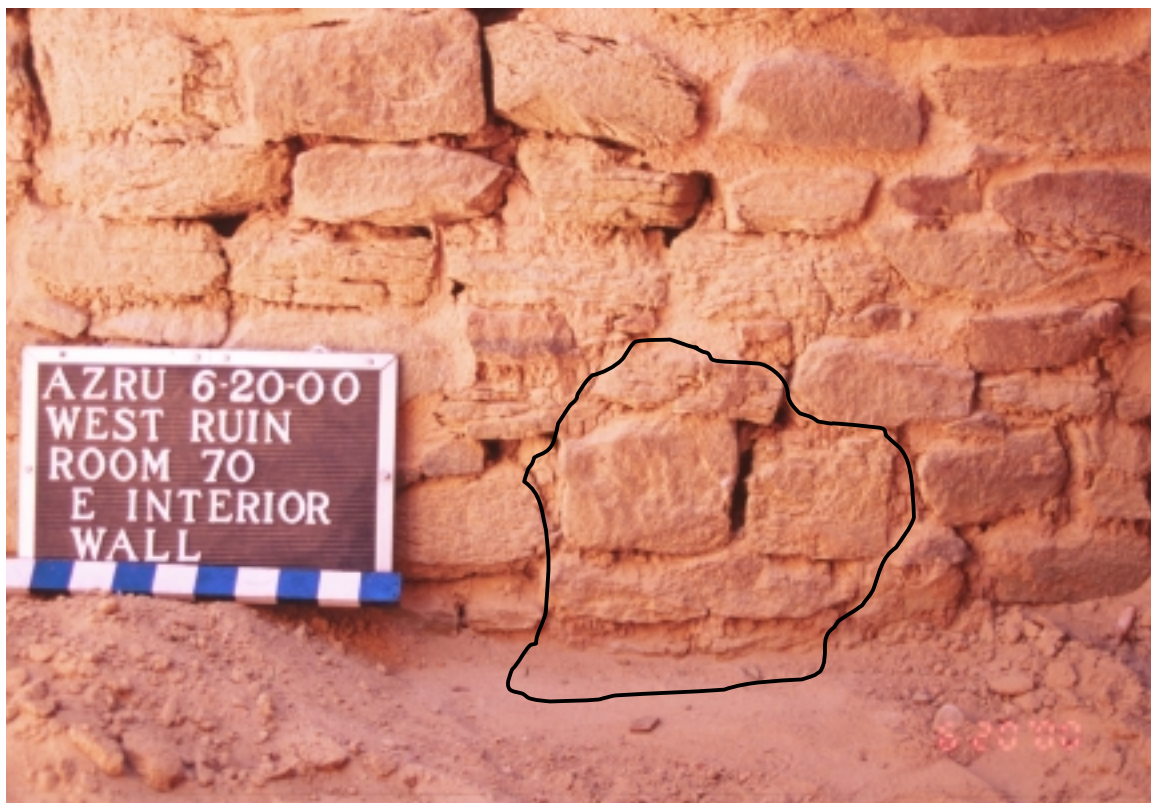
Figure 05E. East interior wall of Room 70, looking northeast, prior to removal of Perforation 2000-05 on June 20, 2000. Perforation is outlined.

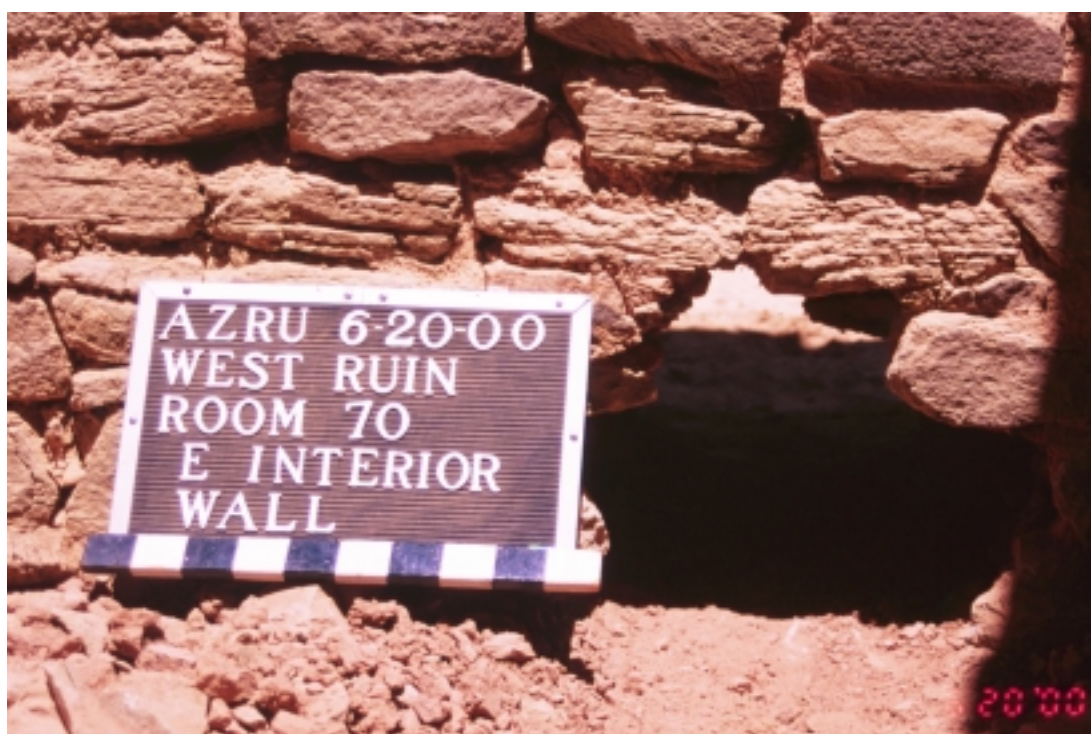
Figure 05F. East interior wall of Room 70, looking northeast after initial wall penetration on June 20, 2000.

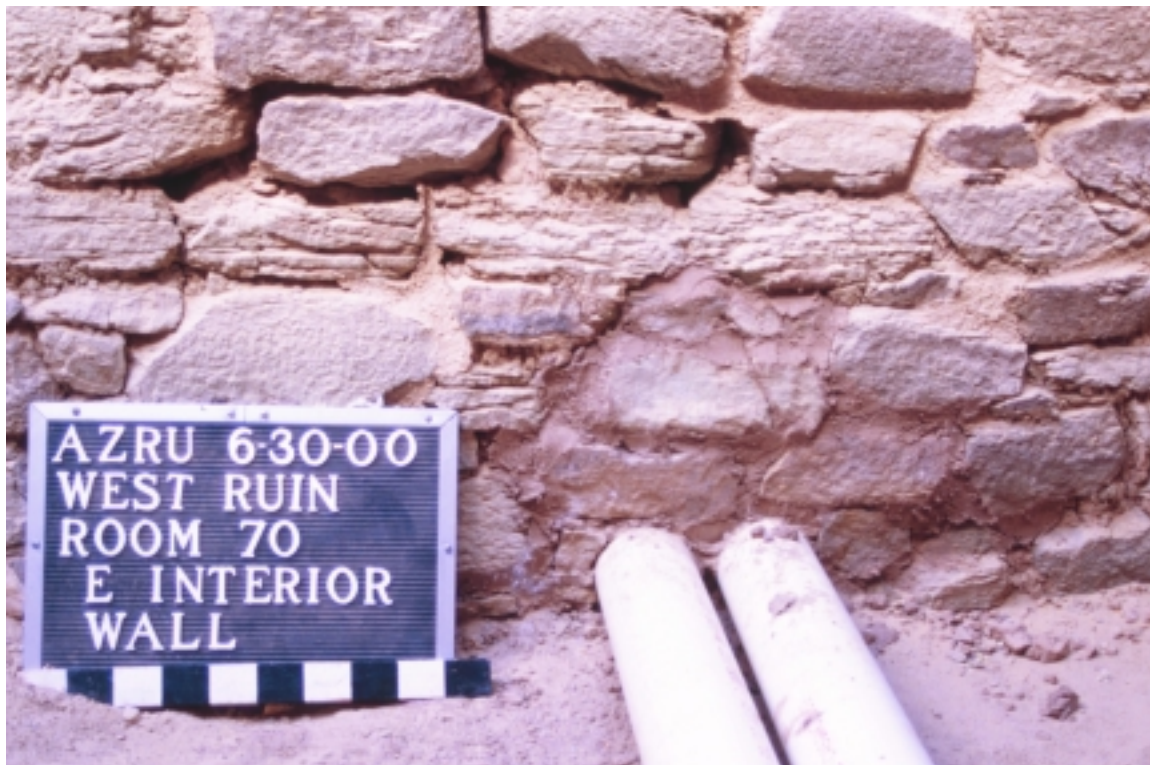
Figure 05G. East interior wall, looking northeast, after masonry closure around Perforation 2000-05.
