TECHNICAL INFORMATION CENTER DENVER SERVICE CENTER NATIONAL PARK SERVICE Investigations at the Pueblo Alto Complex

Chaco Canyon

New Mexico 1975-1979

ARCHITECTURE AND STRATIGRAPHY

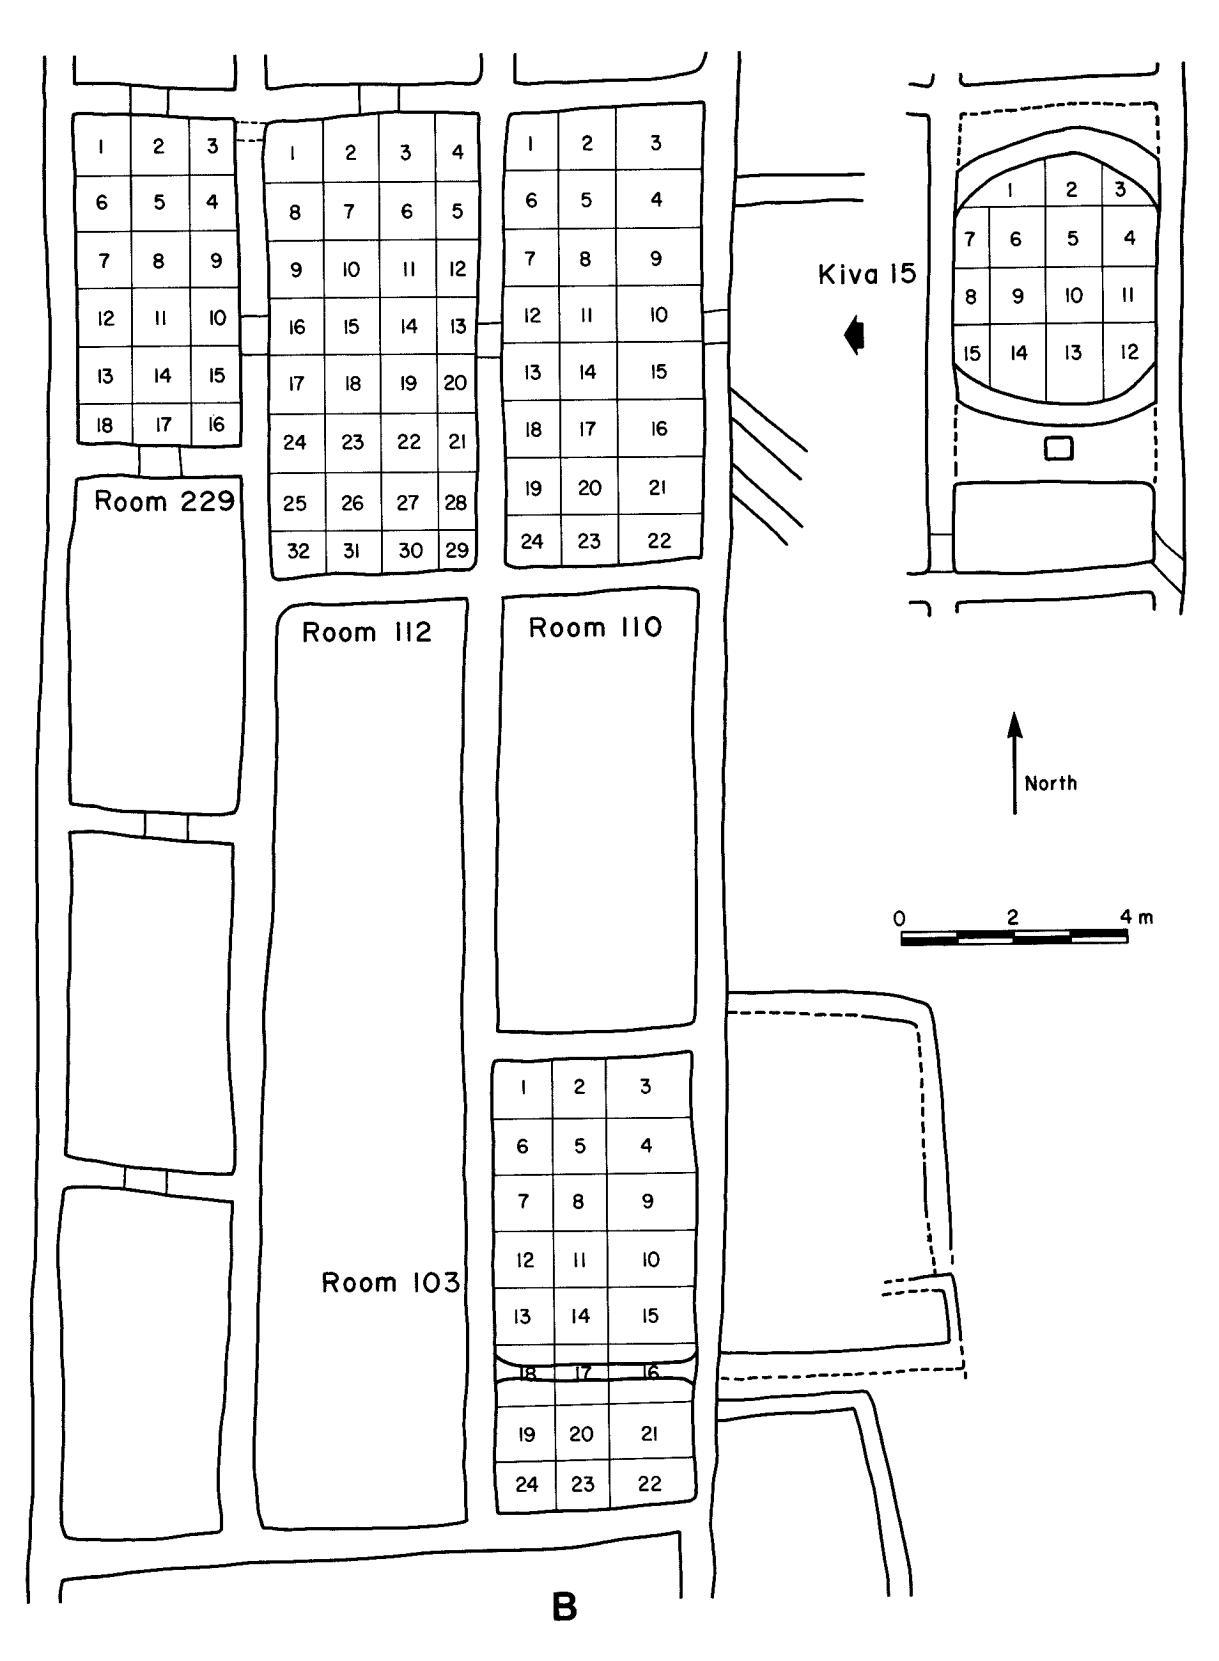
Figure 1.9B. Grid schemes for horizontal control on floors and in floor fill for excavated rooms and kivas in the West Wing.

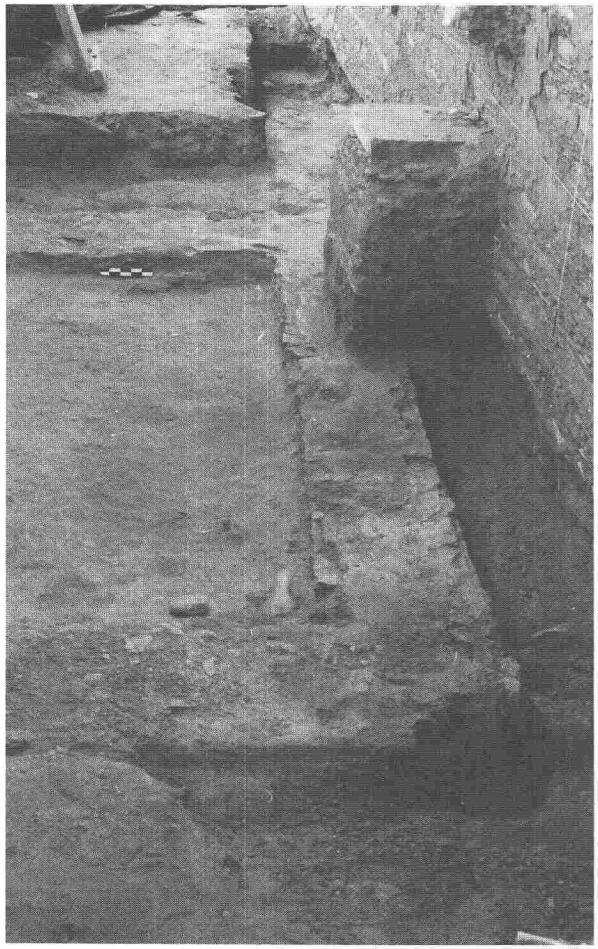
Plate 2.3. Part of Room 50, Floor 1, under Room 143/236. Note slab and masonry step below Door 14 of Room 143/236 that leads into the plaza. 15-cm north arrow. Looking east. (NPS#17928)

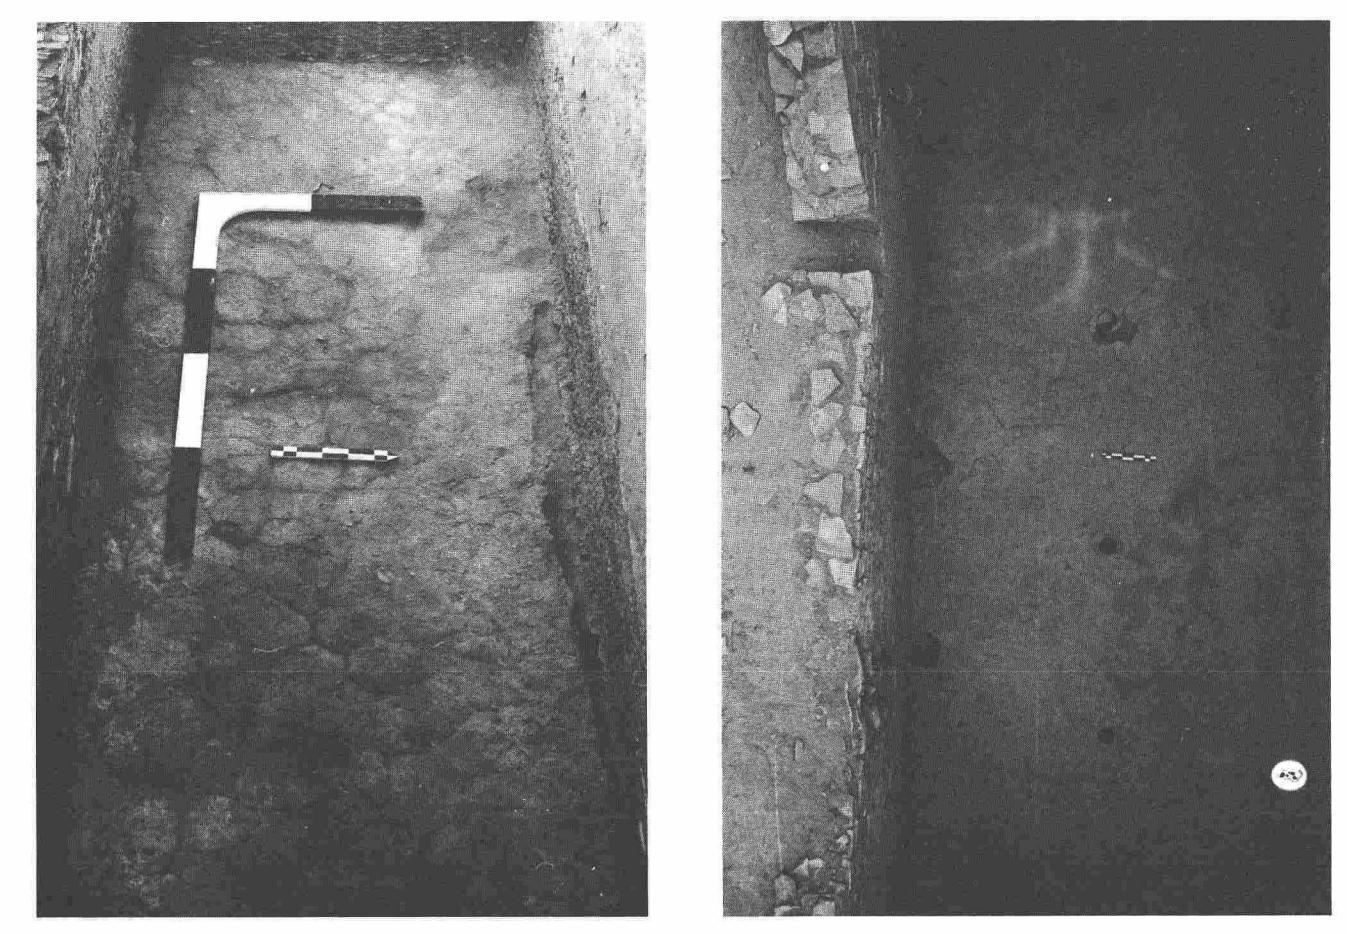
- Plate 2.5. Room 138, Floor 2. Note wall trenches along base of walls. Wall plaster extends to former Floor 1 position. 50-cm north arrow and a larger scale in 50-cm increments. Looking west. (NPS#17216)
- Plate 2.6. Room 139, Floor 1. Note roof support holes along median line and post-step holes against the walls under the unexcavated doors. Break in top of wall is a ventilator. 50-cm north arrow. (NPS#15780)

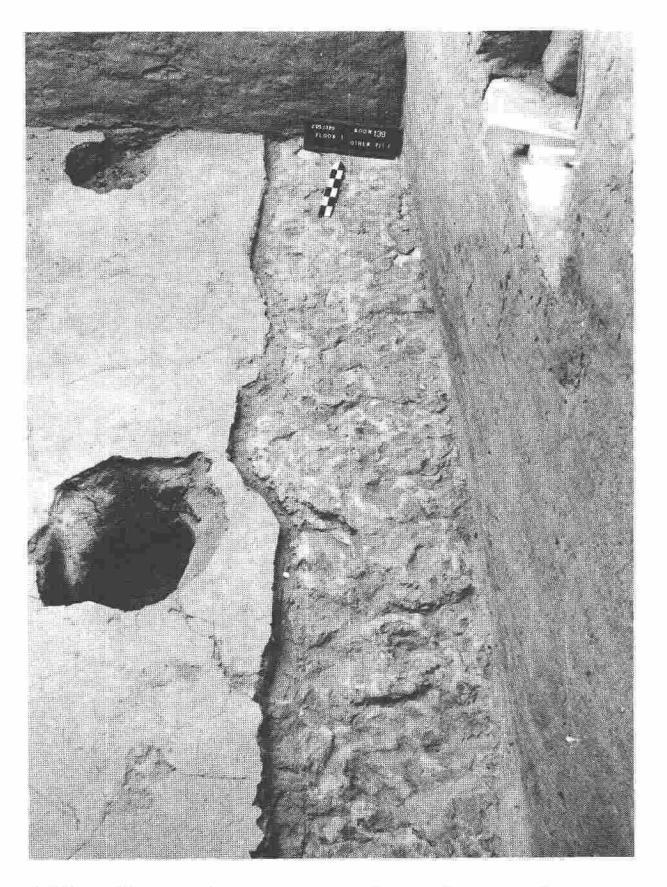
Plate 2.8. Room 139, Floor 1, east end. Floor plaster removed to reveal top of wall foundation extending west from east wall. Roof support Posthole 1 to left. Posthole (Other Pit 2) at top marks a post step for the new door entry into Room 144. 30-cm north arrow. (NPS#14629)

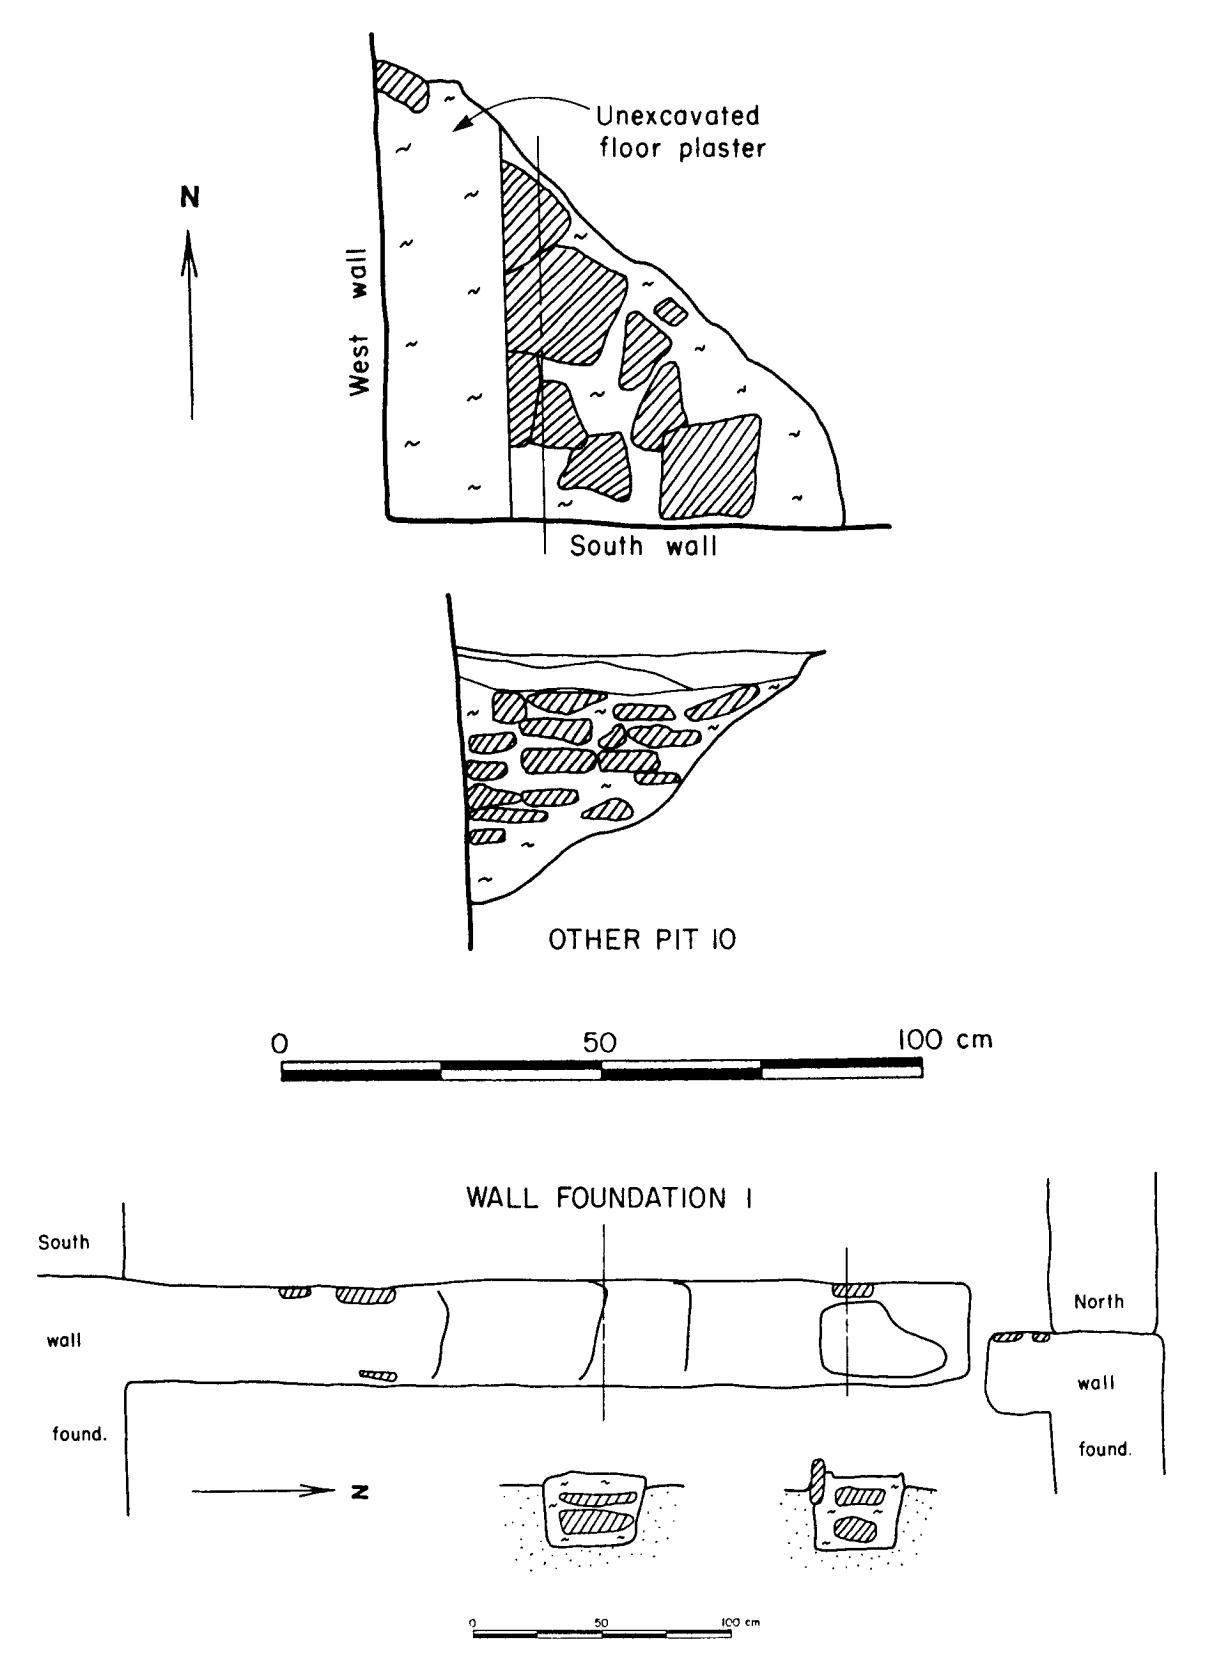
Figure 2.14. Room 139, plan and profiles of selected floor features. A) Floor 1, Other Pit 10 ("Wolky Feature"). B) Floor 2, Wall Foundation 1, part of the initial foundation complex but never used.

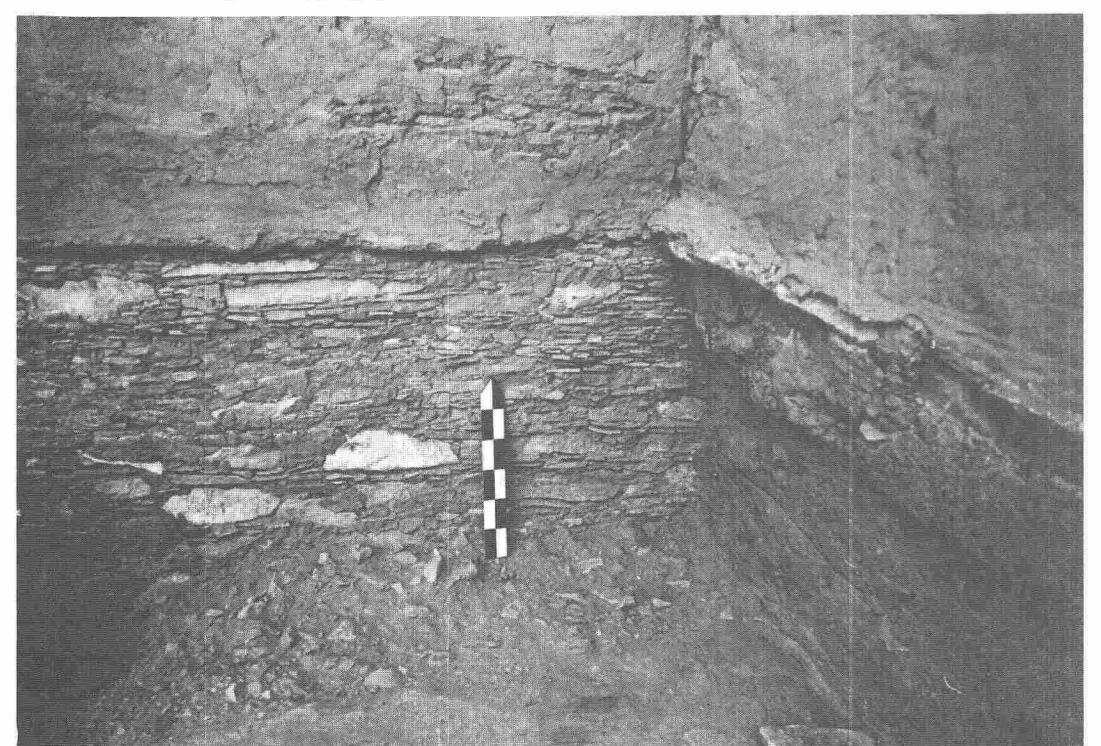
Plate 2.13. Room 139/145. Wall plaster stops at former juncture with uppermost floor (Floor 1 of Room 145). Mound of spalls under 30-cm scale lie in Wall Trench 6 (Floor 2 of Room 139) and were generated from wall construction. Note elevation above Floor 2 of wall foundation on left for wall that subdivided Room 145 from Room 139. (NPS#13576)

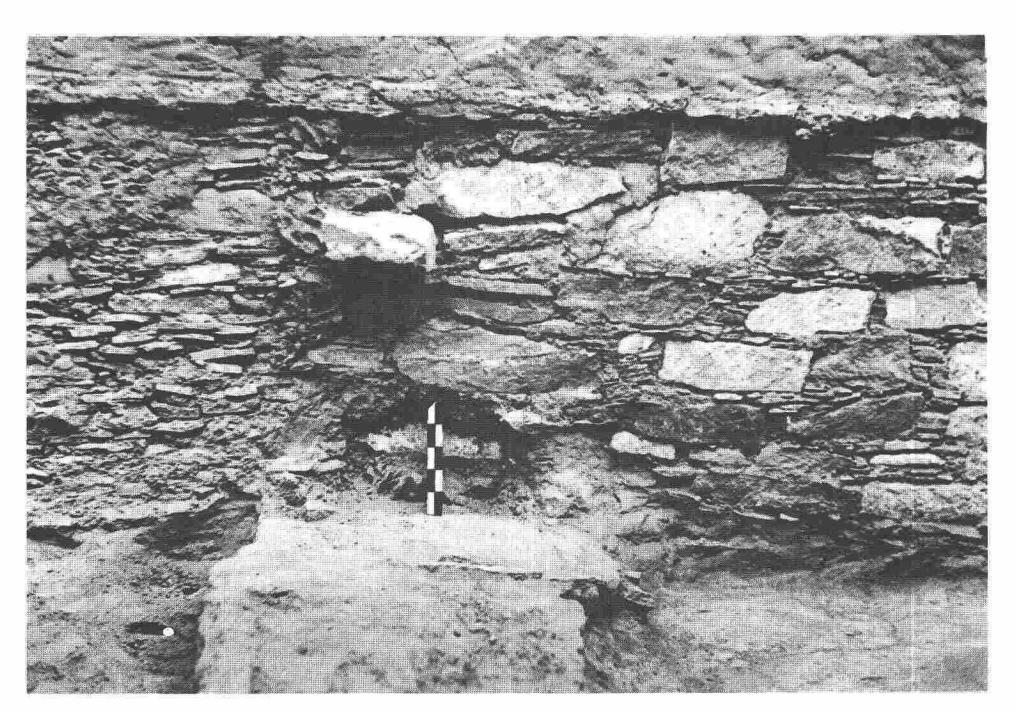
Plate 2.15. Room 139, Floor 2. Unused wall foundation (WF 1) at the base of the 15-cm scale. Note the discontinuity of the north wall foundation where WF 1 ties to it. (NPS#14884)

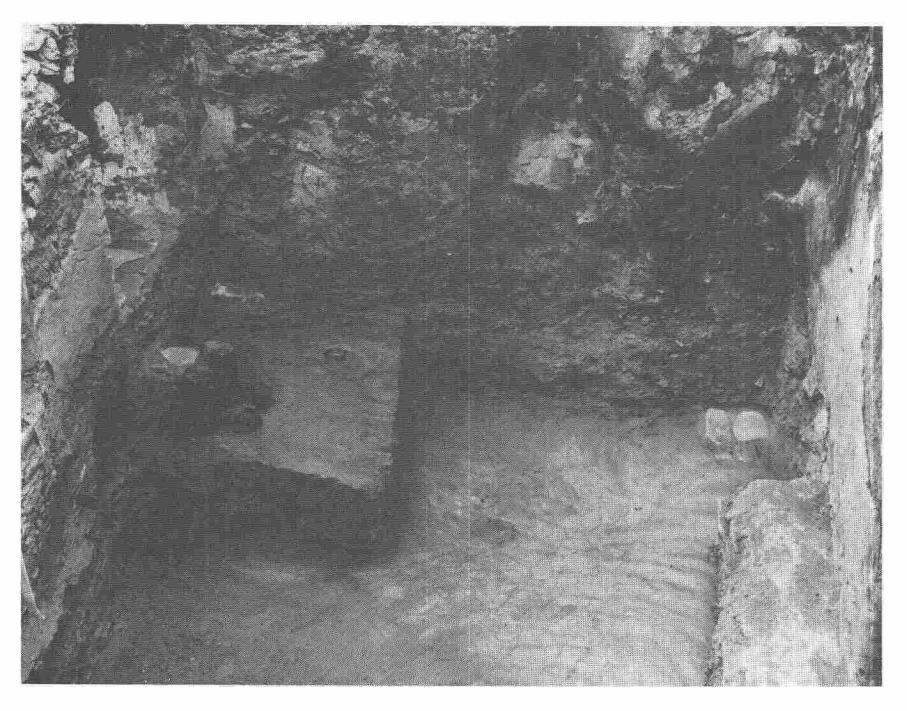
Plate 2.17. Pueblo Bonito, Room 83. Note the post steps leading to the door. Looking west. (Courtesy of the American Museum of Natural History, AMNH#275)

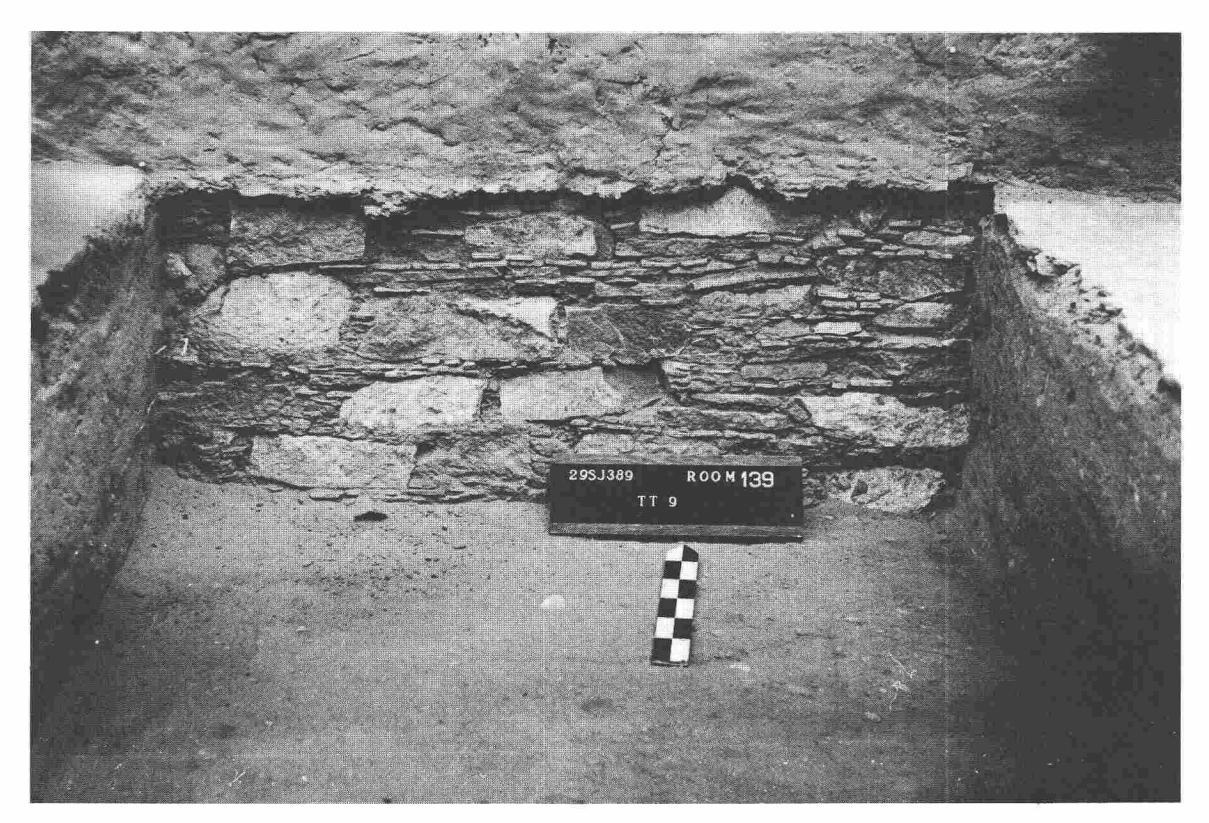
Plate 2.22. Room 139 with the upper floor (Floor 1) removed. The bottom of the trench reaches to Floor 2. Note the thick plaster coat that comprised Floor 1 and its overlap with the wall plaster. The masonry exposed is Type II. 30-cm scale. (NPS#14635)

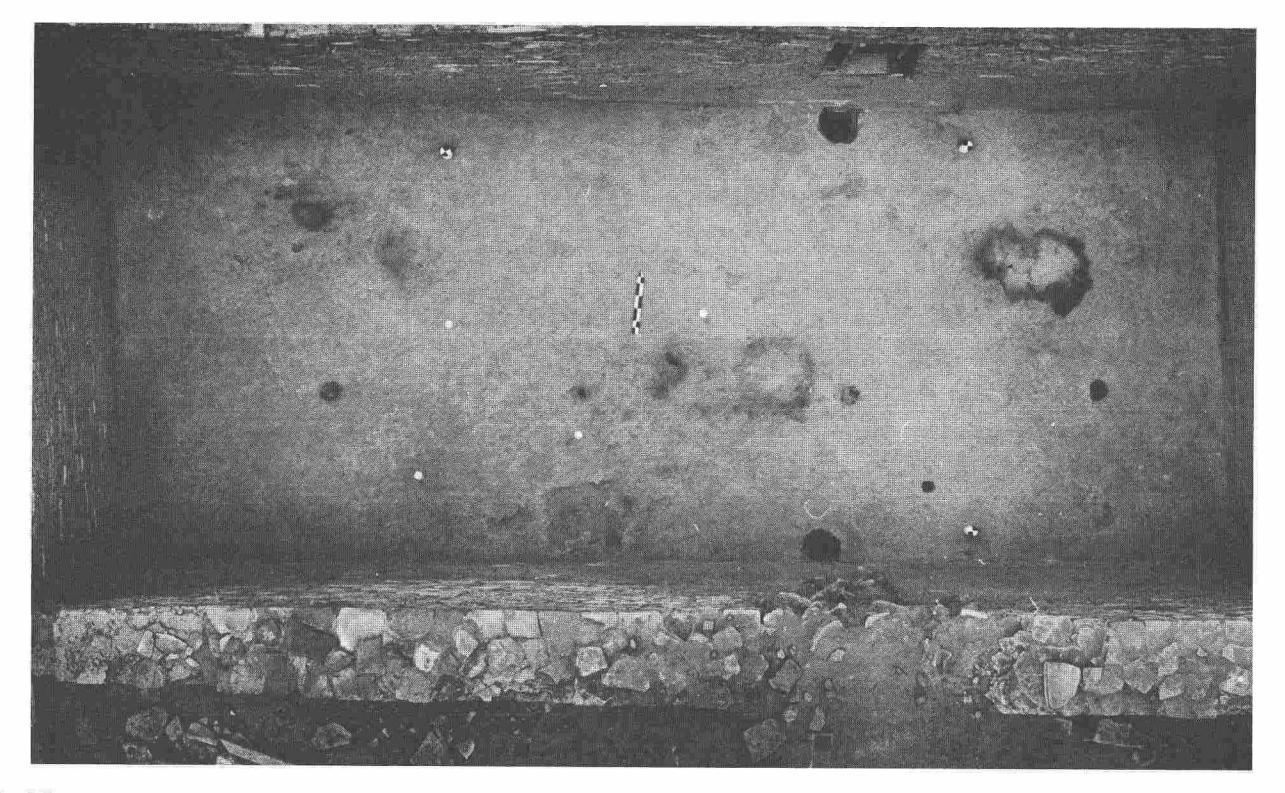
Plate 2.25. Room 142, uppermost floor (Floor 1). Note roof support and door step postholes and floor burns. 50-cm north arrow. (NPS#15806)

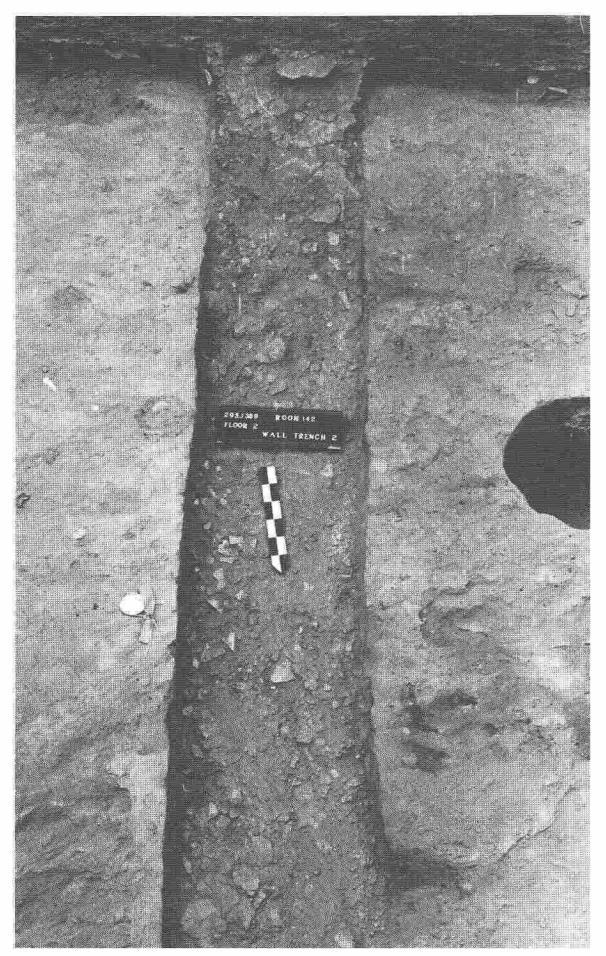
Plate 2.26. Room 142, Wall Trench 2 just under Floor 2. Trench was an unused wall foundation. 30-cm north arrow. (NPS#16258)

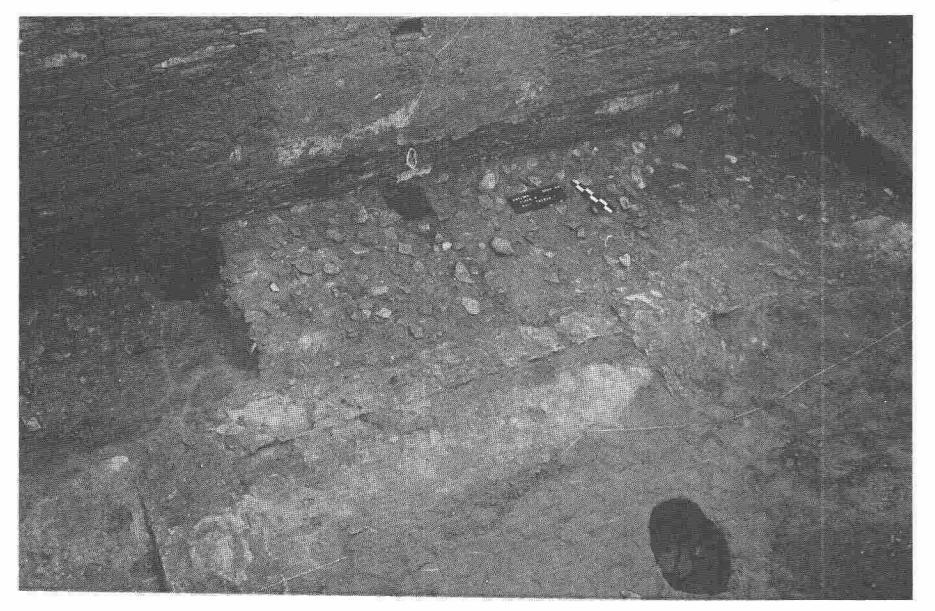
Plate 2.27. Room 142, Floors 2 and 3, northeastern corner. Note litter of construction spalls filling Wall Trench 1 and the tops of Rooms 50 and 51 walls. Wall plaster stopped where it joined Floor 1. 30-cm north arrow. (NPS#16163) bones (only two were burned), including those from the usual species of rabbits and prairie dogs as well as a golden eagle's ulna. Chipped stone debris was also relatively common (23 pieces) along with ceramics from a Red Mesa Black-on-white assemblage dating to the early A.D. 1000s. The trench had been filled and covered with Layer 7 material and apparently immediately preceded the intentional filling and leveling of Room 142 for permanent use.

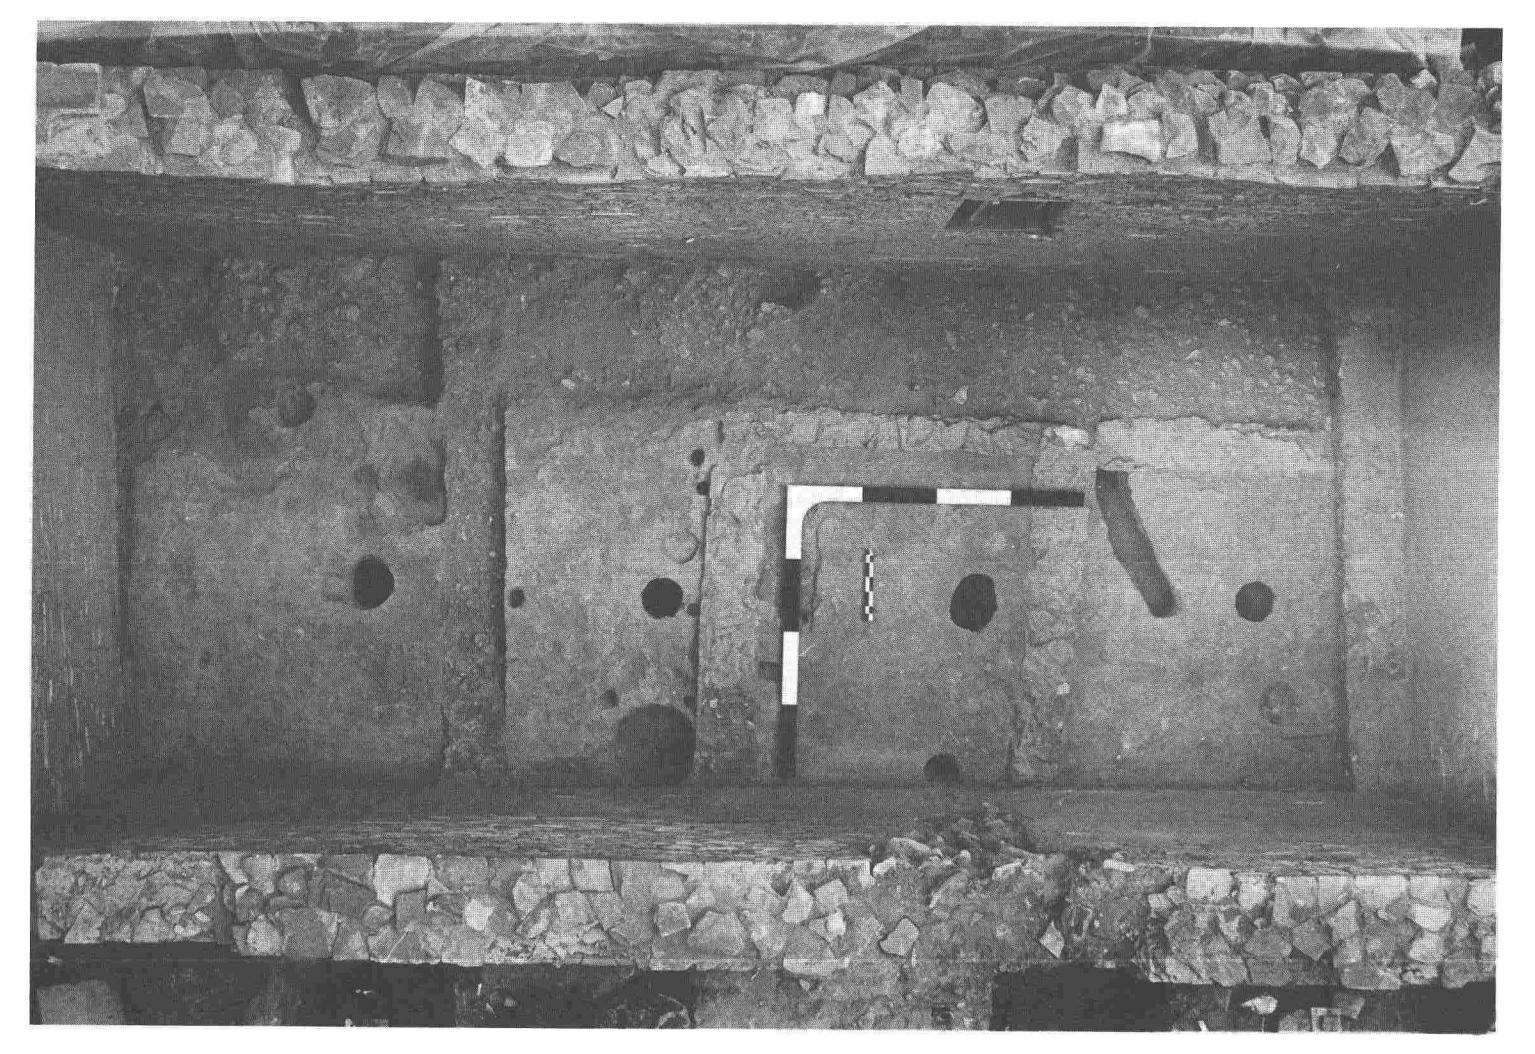
Plate 2.28. Room 142, Floor 3, with tops of razed walls from Rooms 50 and 51, Wall Trench 2 foundation, and construction spalls filling Wall Trench 1 along north wall exposed. 50-cm north arrow and 2-m board. (NPS#17969)

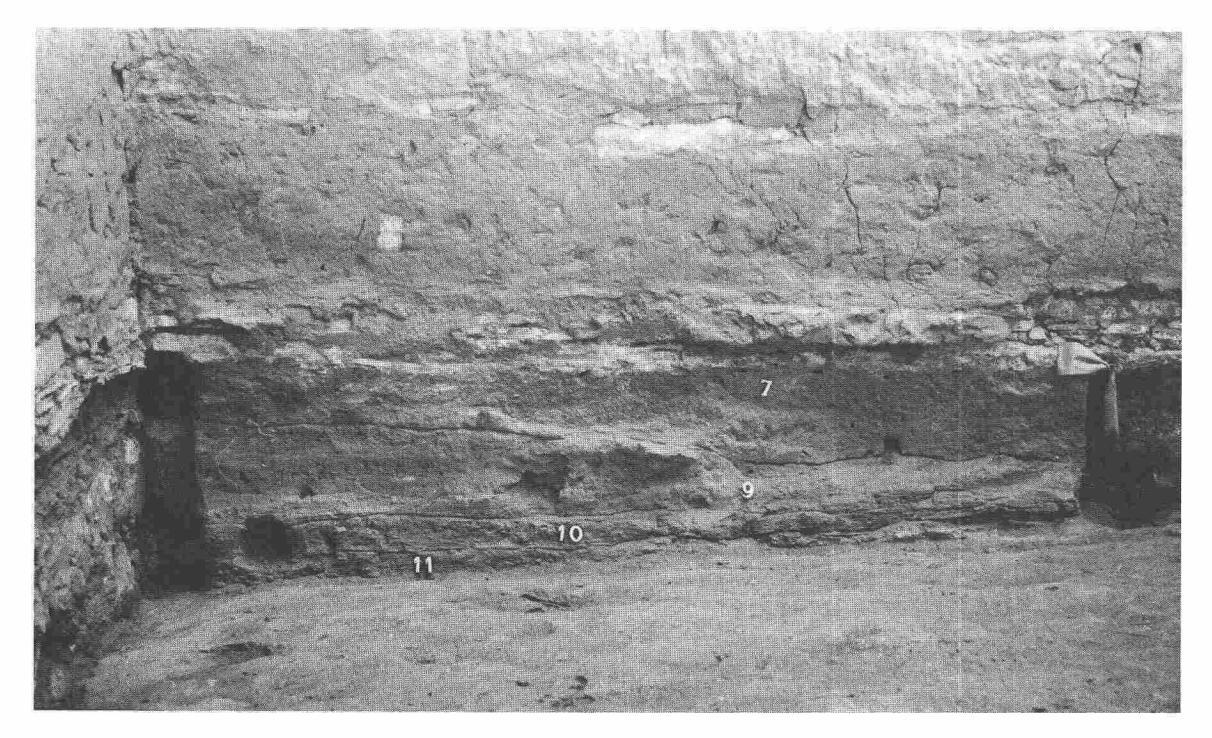
Plate 2.29. Room 142, Floor 5 and Layers 7-11 in profile against and under the south wall foundation. (NPS#16519)

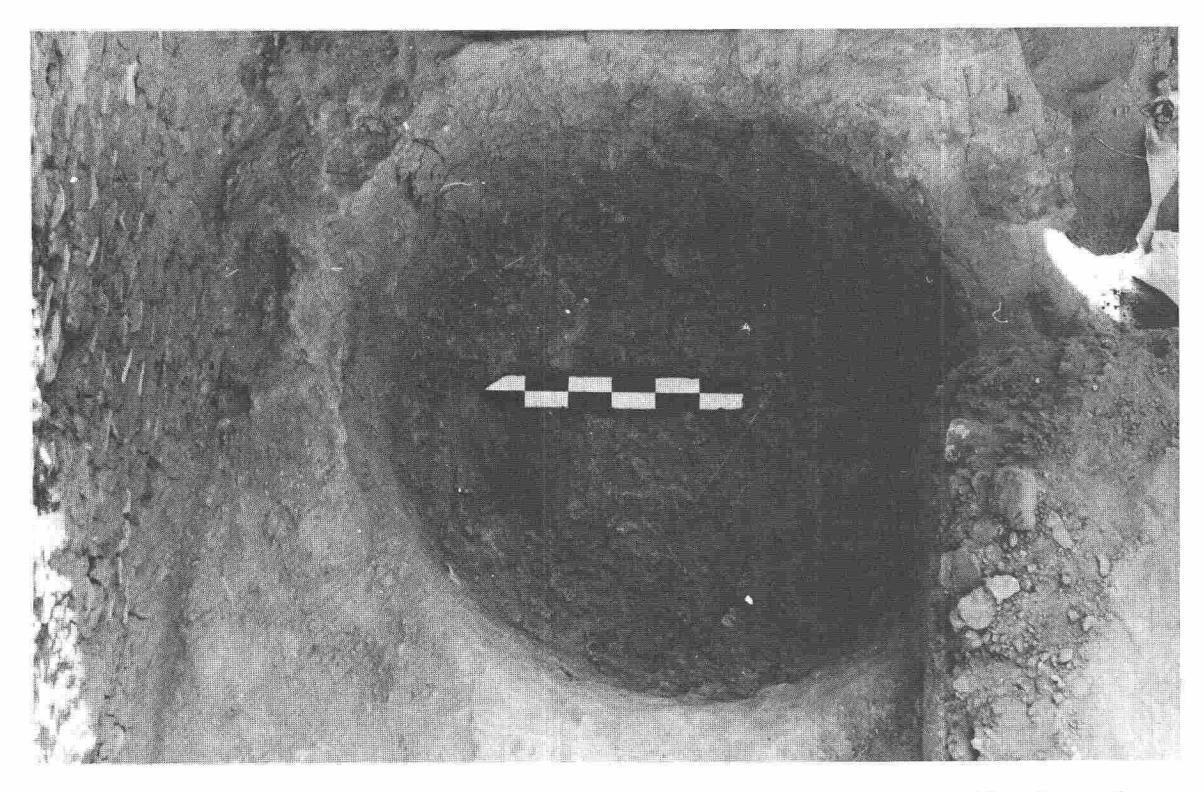
Plate 2.30. Room 142, Floor 9, Other Pit 1 sunk into sterile deposits. Note cracked mud in bottom attributed to remains of mixed mortar. 30-cm north arrow. (NPS#16763)

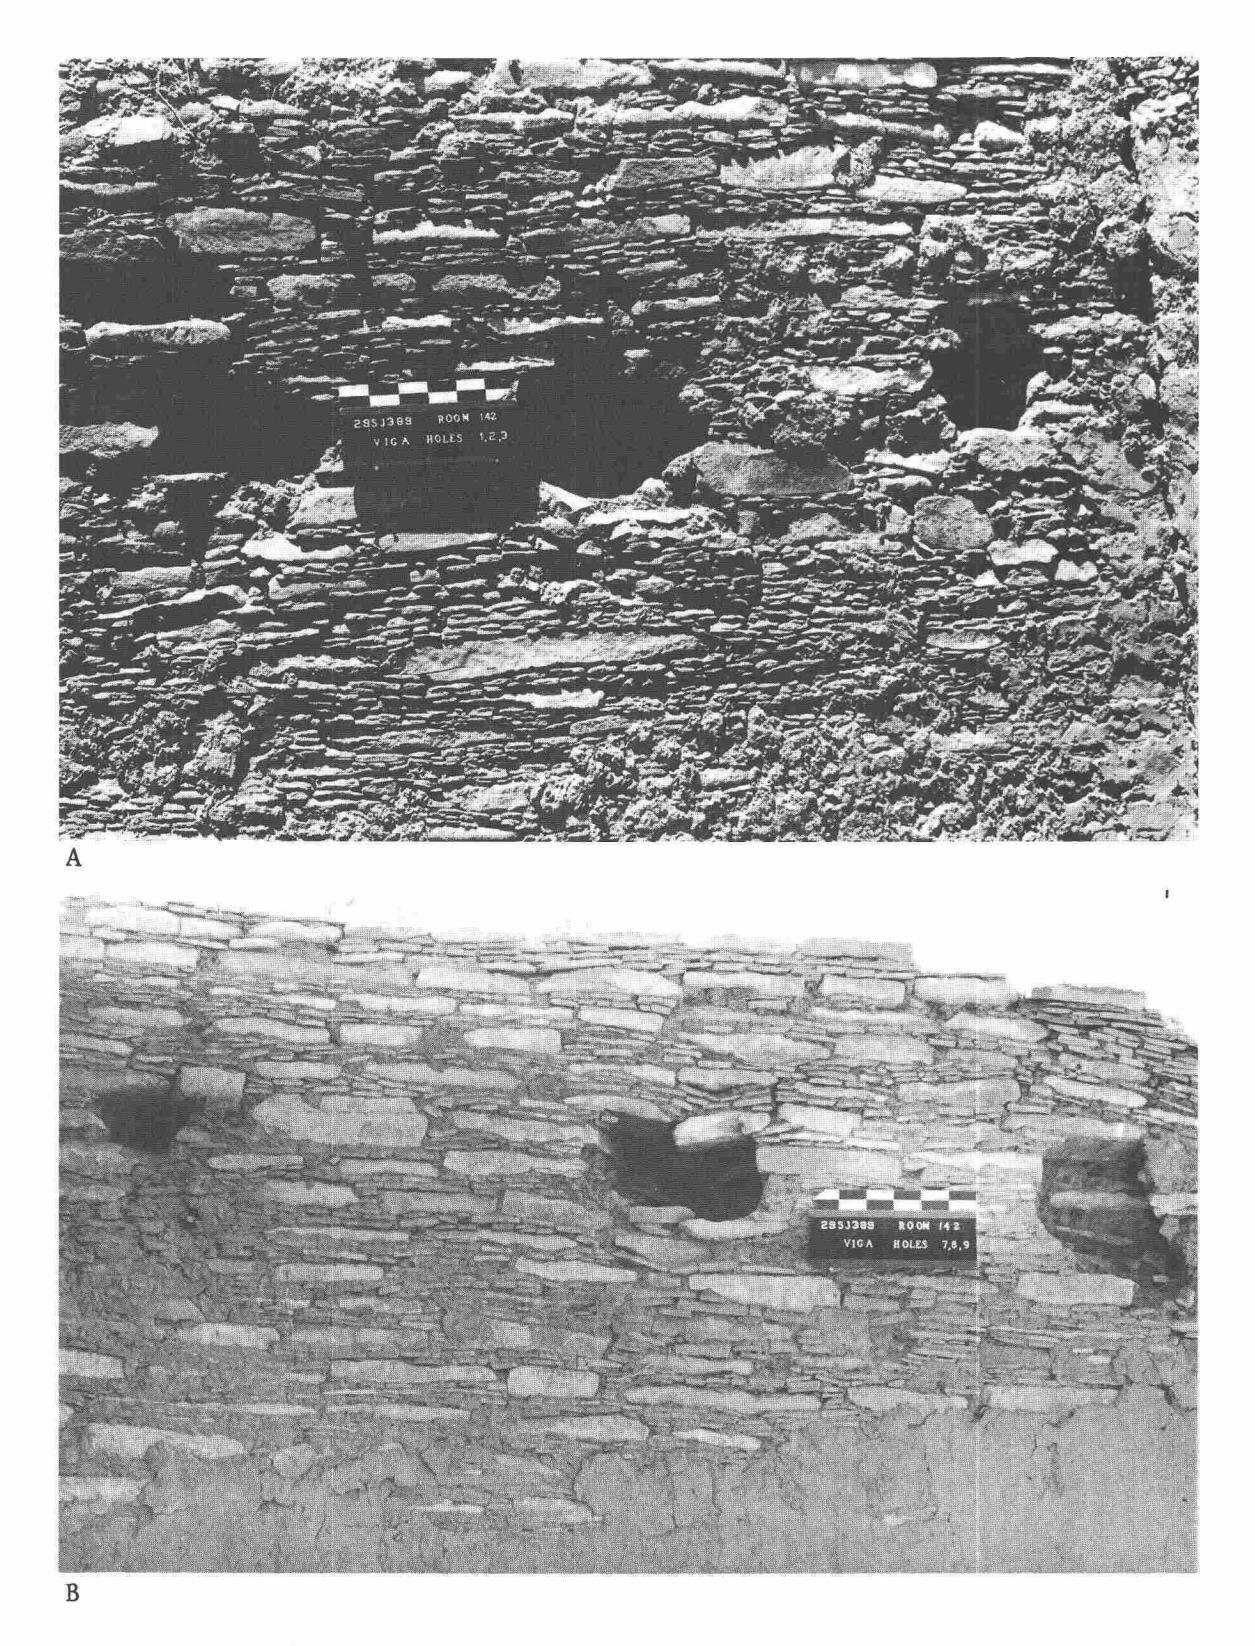
Plate 2.31. Room 142, "viga holes" that are probably late modifications to the walls for supporting a room-wide platform. Note Type II masonry veneer. 30-cm scales. A) "Viga Holes" 1-3. (NPS#16684) B) "Viga Holes" 7-9. (NPS#16687)

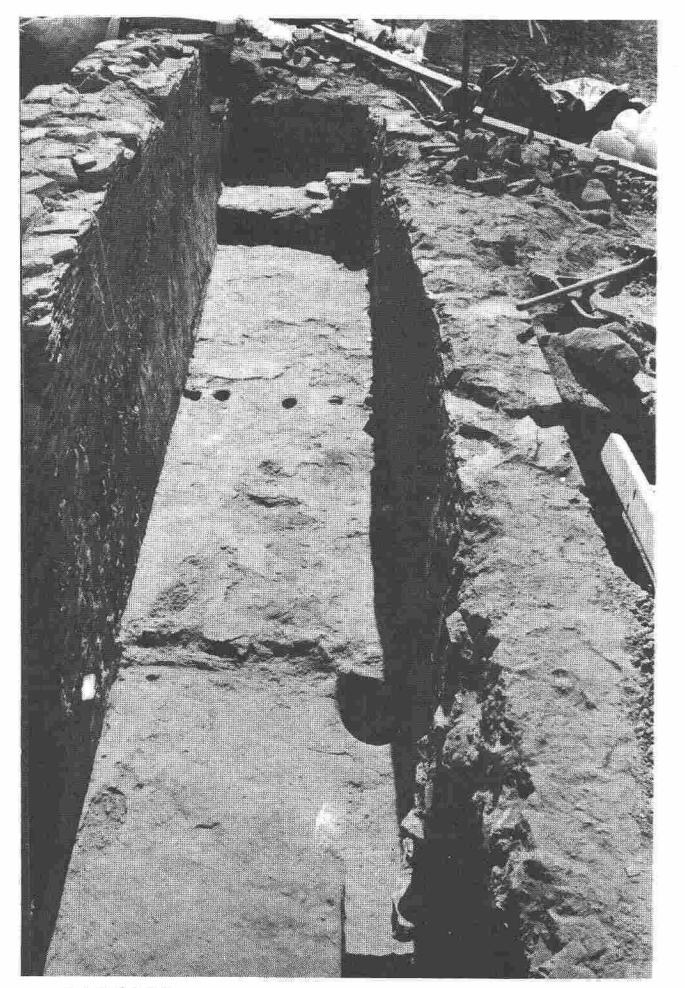
Plate 2.33. Room 143/236, uppermost floors (Floor 1). Trench and postholes across room mark former jacal walls. Elevated floor in background is Grid 13. Looking east. (NPS#16857) series of thirteen 1-m-long grids starting at the western end of the room with Grid 1 and terminating with Grid 13 at the eastern end. Because of the narrow width of the room (130 cm), a longitudinal profile of the postoccupational fill was not made. Some problems were encountered in identifying layers and floors because of very wet conditions in the room caused by a roof over Room 142 that directed water into Room 143/236 during the winter of 1977-1978.

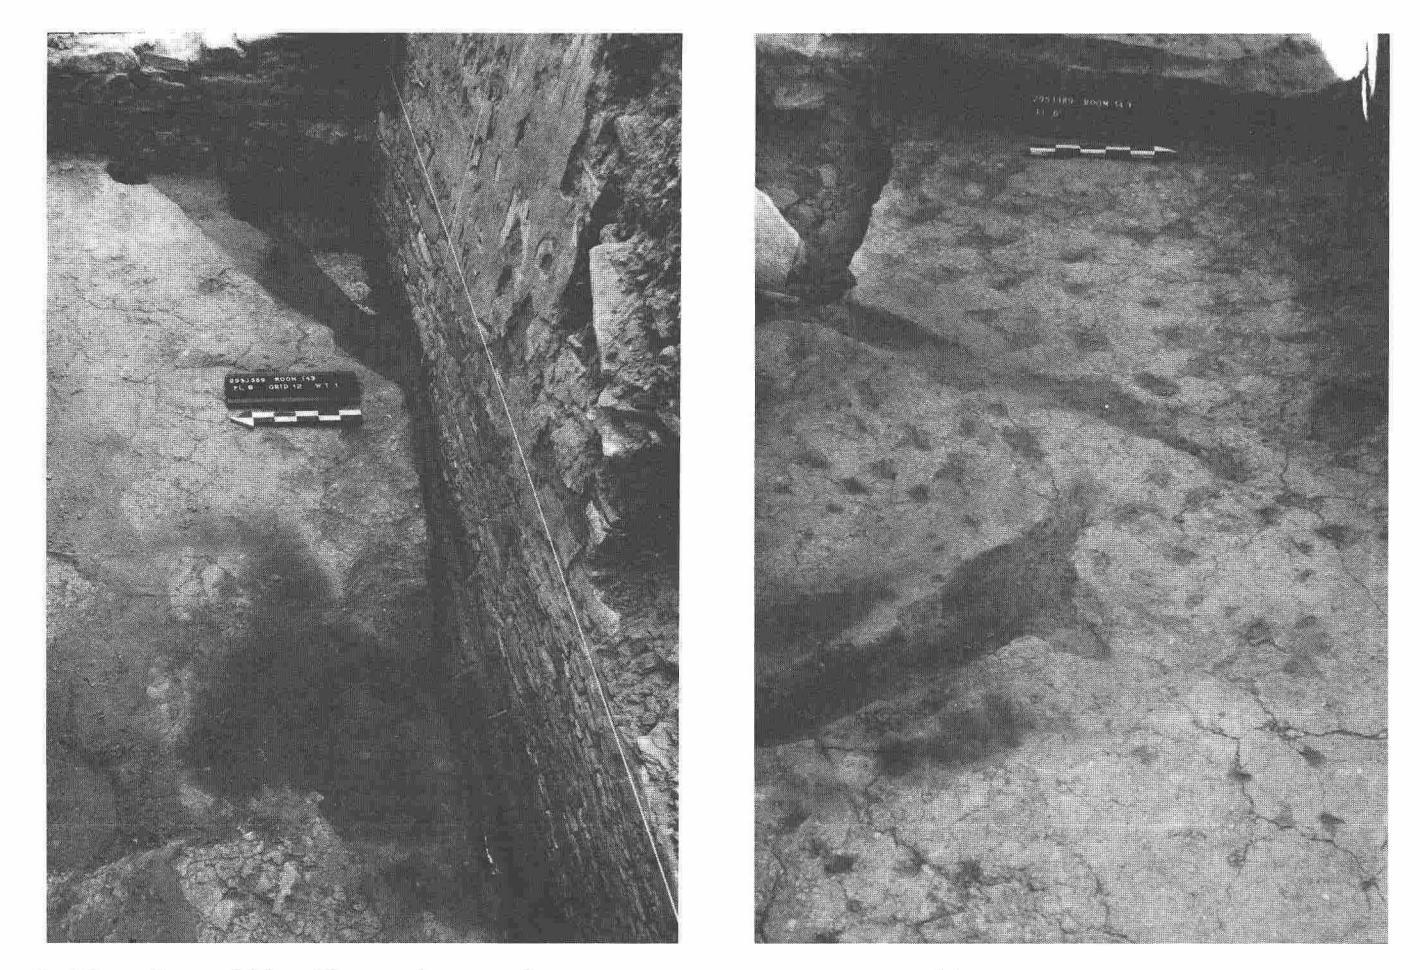
- Plate 2.34. Room 143, Floor 6, southeastern corner. Note Wall Trench 1 against south wall and the two falt stones, above the 30-cm north arrow, marking the initial Kiva 10 wall. (NPS#17645)
- Plate 2.35. Room 143, Floor 6, Grids 8-10. Odd indentations in the floor. Compare with those found in Plaza 1, Grid 302 (Plate 3.49). 30-cm north arrow. (NPS#17633)

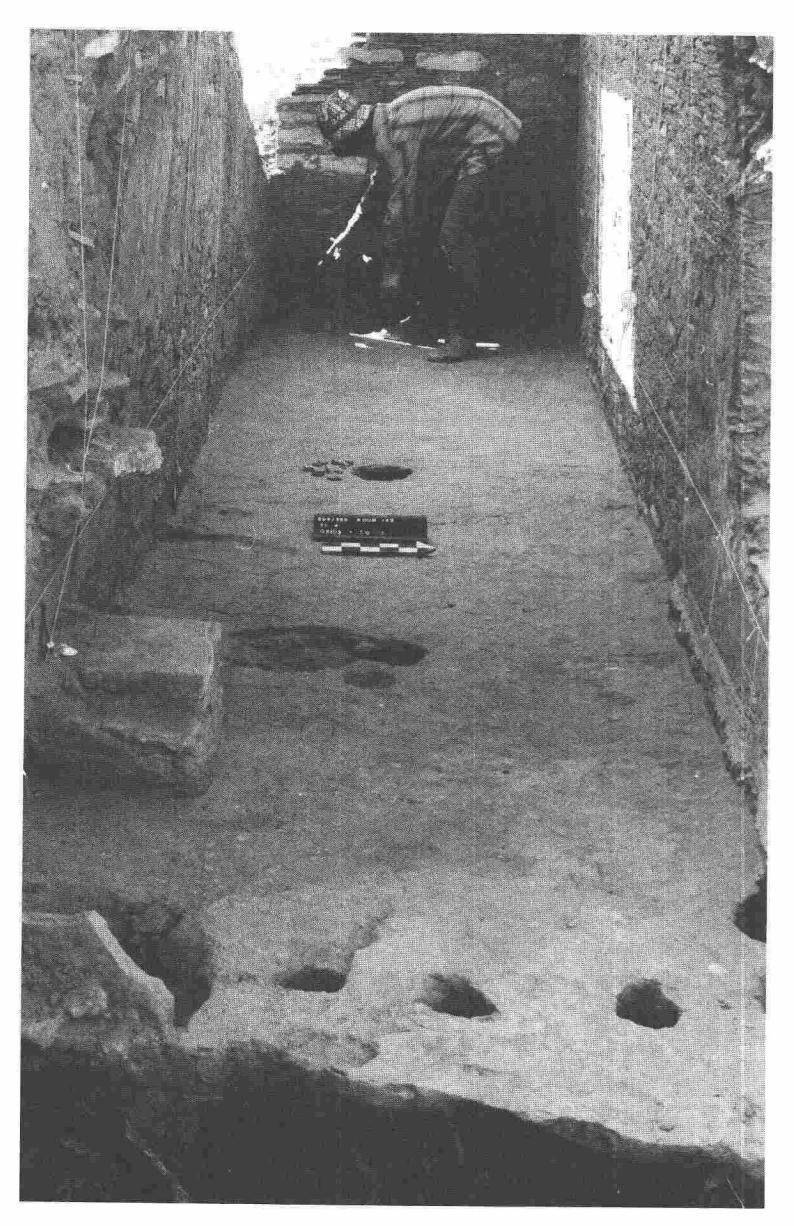
Plate 2.36. Room 236, Floor 4, Grids 1-7, looking west. Postholes in foreground mark former jacal wall. Note Step 2 access to Door 14 and plaza. Nancy Akins in background. 30-cm north arrow in front of roof support posthole. (NPS#17730)

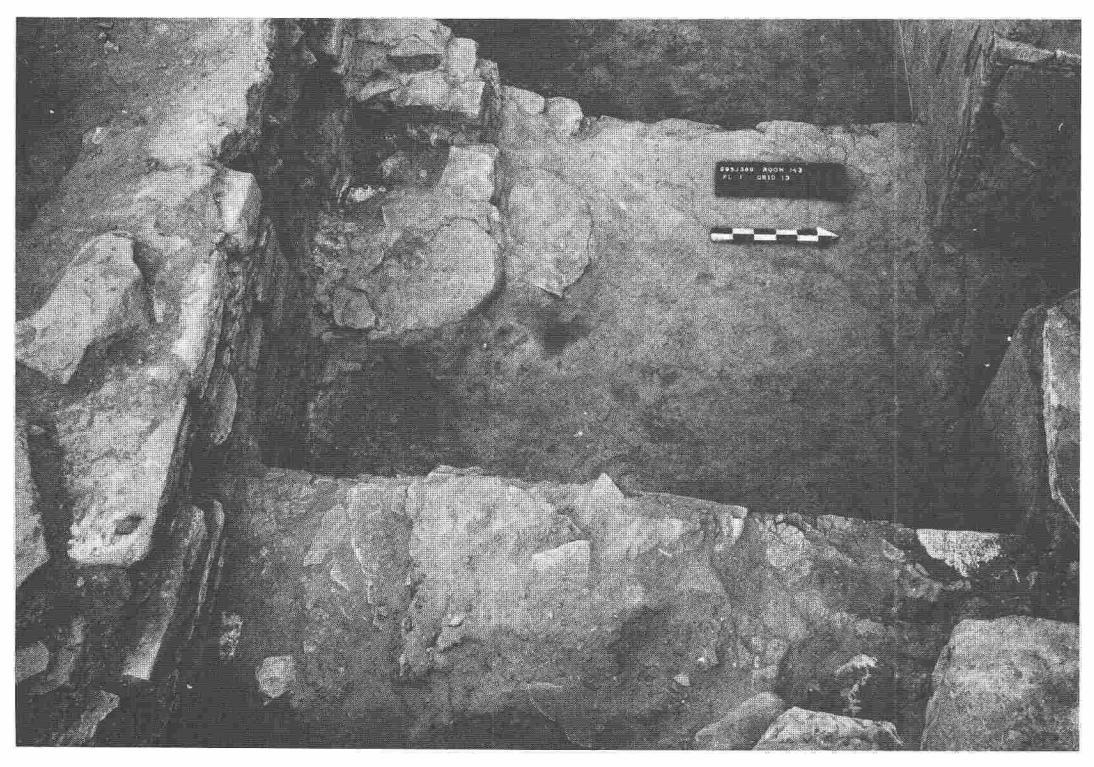
Plate 2.38. Room 143, Floor 1, Grid 13, looking west. Elevated walkway between Room 147 and the roof of Kiva 10. Door 12 (right) connected with Room 147, and Door 13 (left) led to the roof of Kiva 10. 30-cm north arrow. (NPS#17641)
