TECHNICAL INFORMATION CENTER DENVER SERVICE CENTER NATIONAL PARK SERVICE Investigations at the Pueblo Alto Complex

Chaco Canyon

New Mexico 1975-1979

ARCHITECTURE AND STRATIGRAPHY

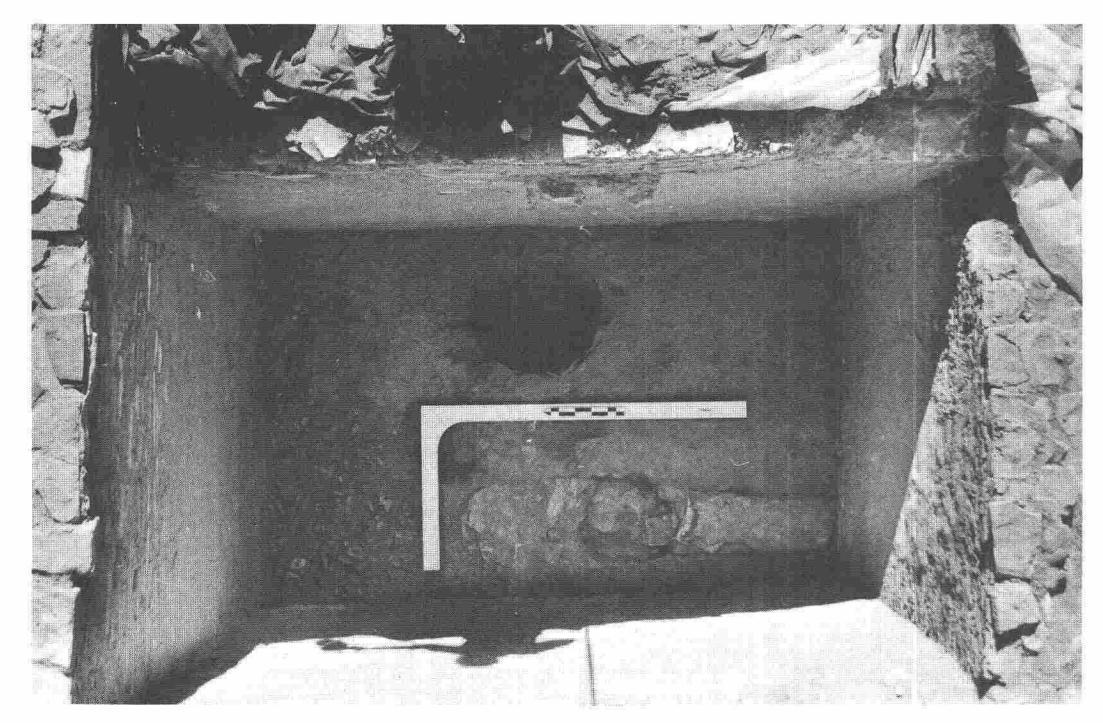
Plate 2.44. Room 146, Floor 3. Note remains of the Room 51 wall with a posthole through its center. Construction spalls fill Wall Trench 1 and a large firepit. 50-cm north arrow rests on 2 by 1 m board. (NPS#17964)

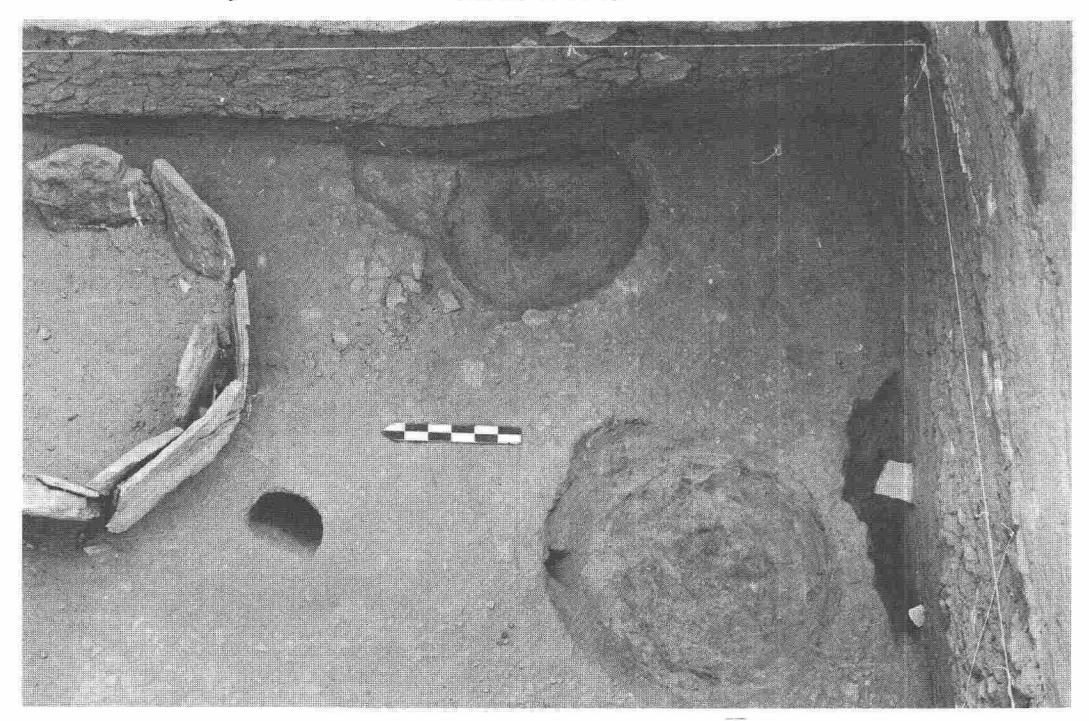
Plate 2.45. Room 146, Floor 8 (an outdoor surface), the southeastern corner showing Heating Pits 1 (behind arrow) and 2 (under east wall), Other Pits 1 (under south wall) and 2, Floor 3's slab-lined Firepit 1, and Floor 6's Heating Pit 1 (under east wall, cutting Heating Pit 2). Odd slant-walled Other Pit 2 is just below 30-cm north arrow. Looking east. (NPS#16757)

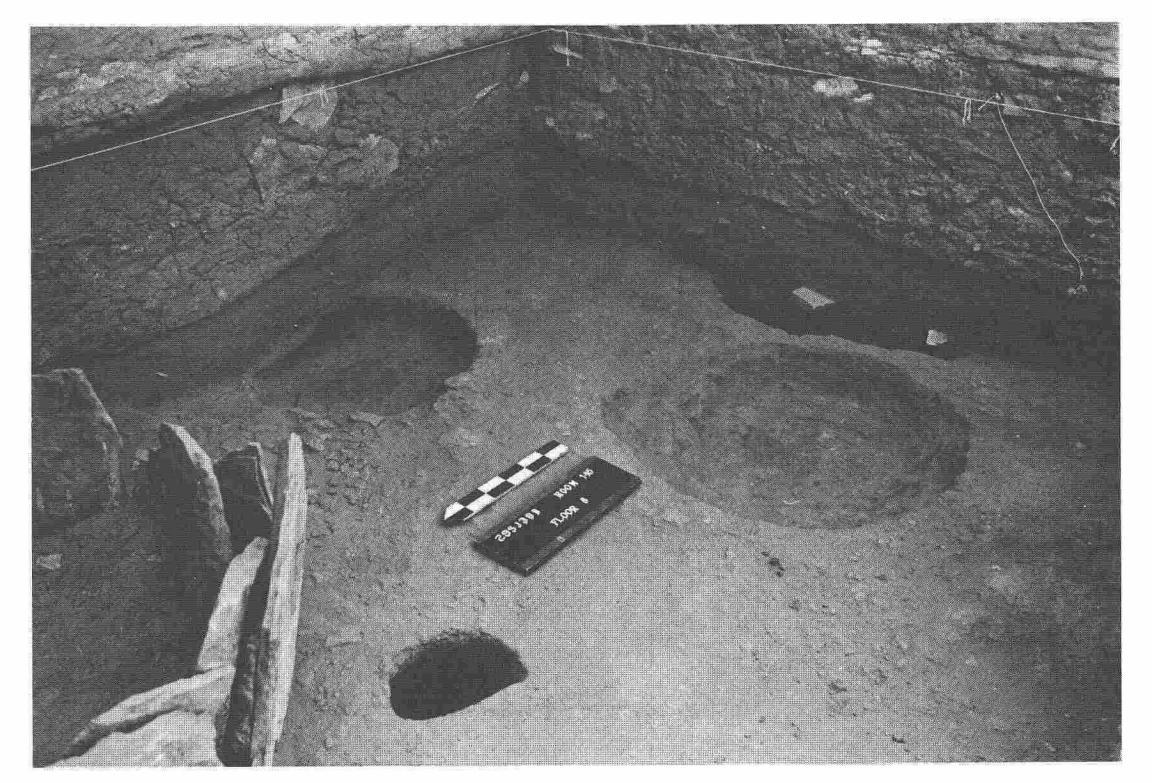
Plate 2.47. Room 146, Floor 8, Heating Pits 1 and 2, Other Pits 1 and 2, and slab-lined Firepit 1 (Floor 3). Note elevation of room wall foundations (starting below the string), above this outside surface (Floor 8). 30-cm north arrow. (NPS#16758)

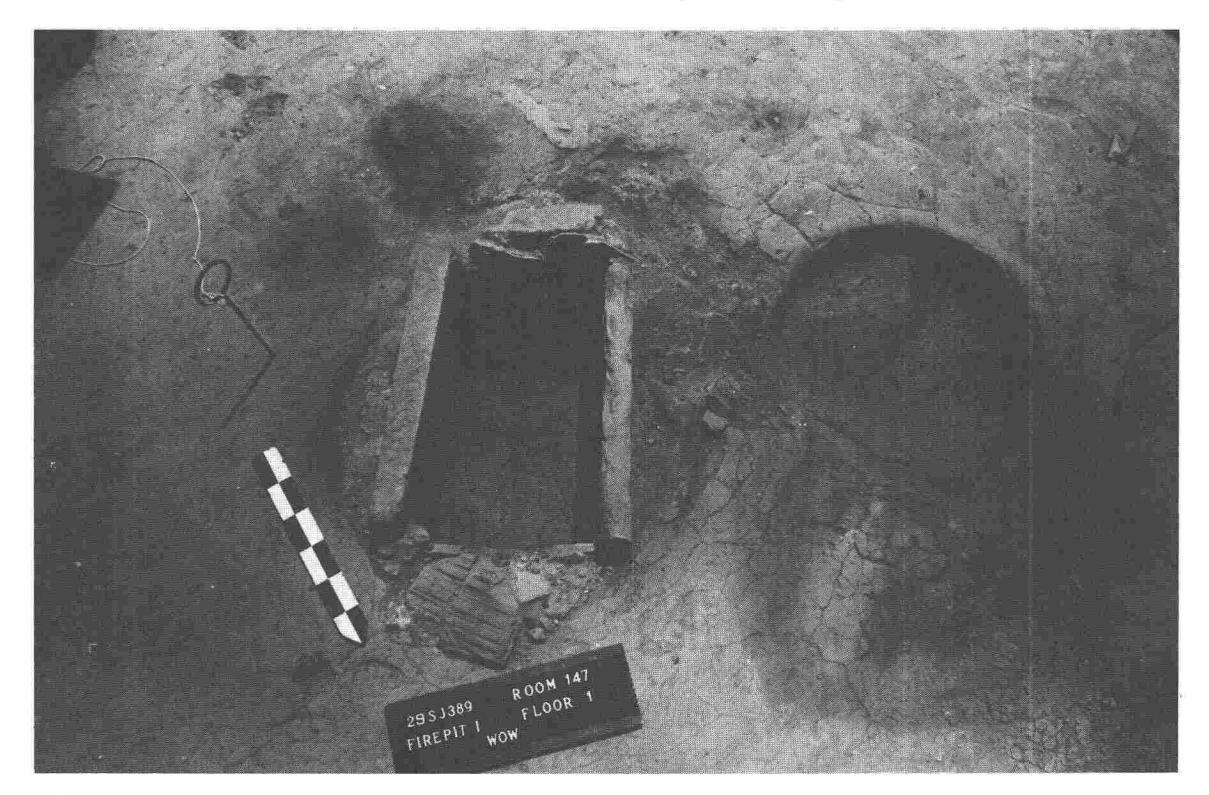
Plate 2.49. Room 147, Floor 1. Firepit 1 (center) and plaster-lined Heating Pit 2. Note extent of floor burns around features and reed-impressed roofing adobe built into firepit lining. 30-cm north arrow. (NPS#16656)

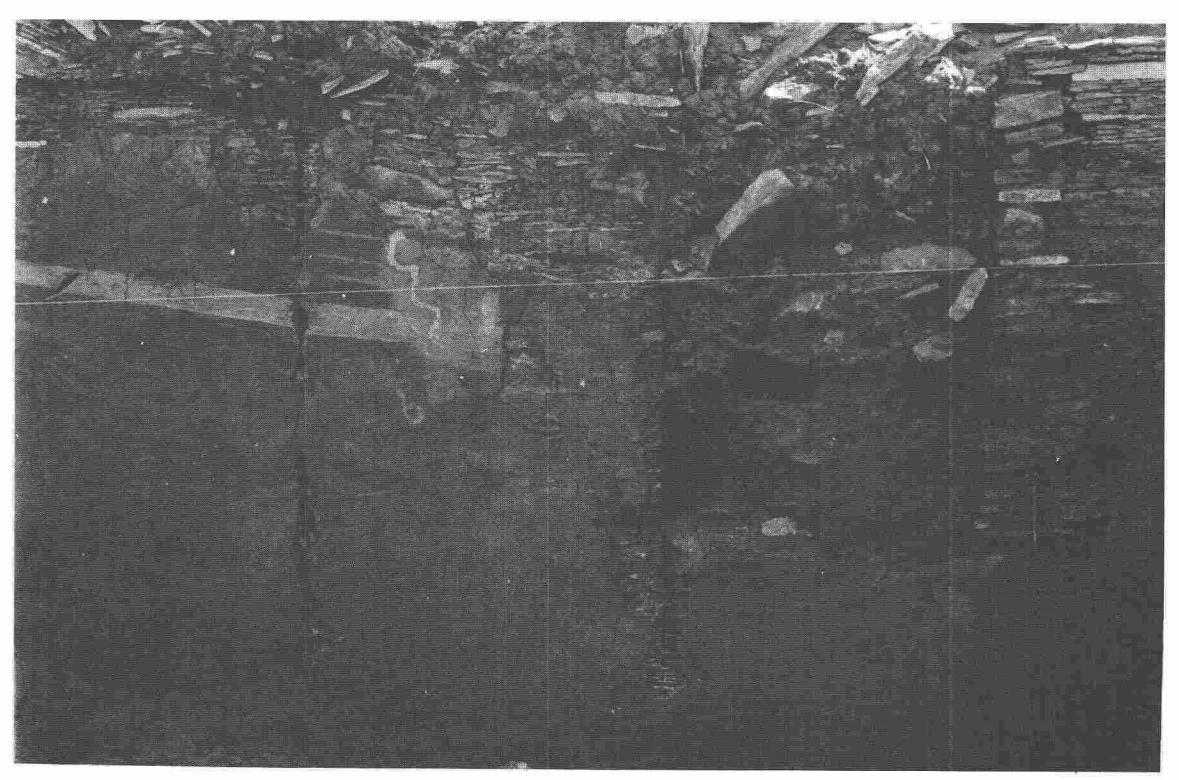
Plate 2.50. Room 147, east wall doors. Original Door 10 filled with masonry and exhibits squiggle-line pictograph in white paint. Door 11 filled with rubble. (NPS#17495)

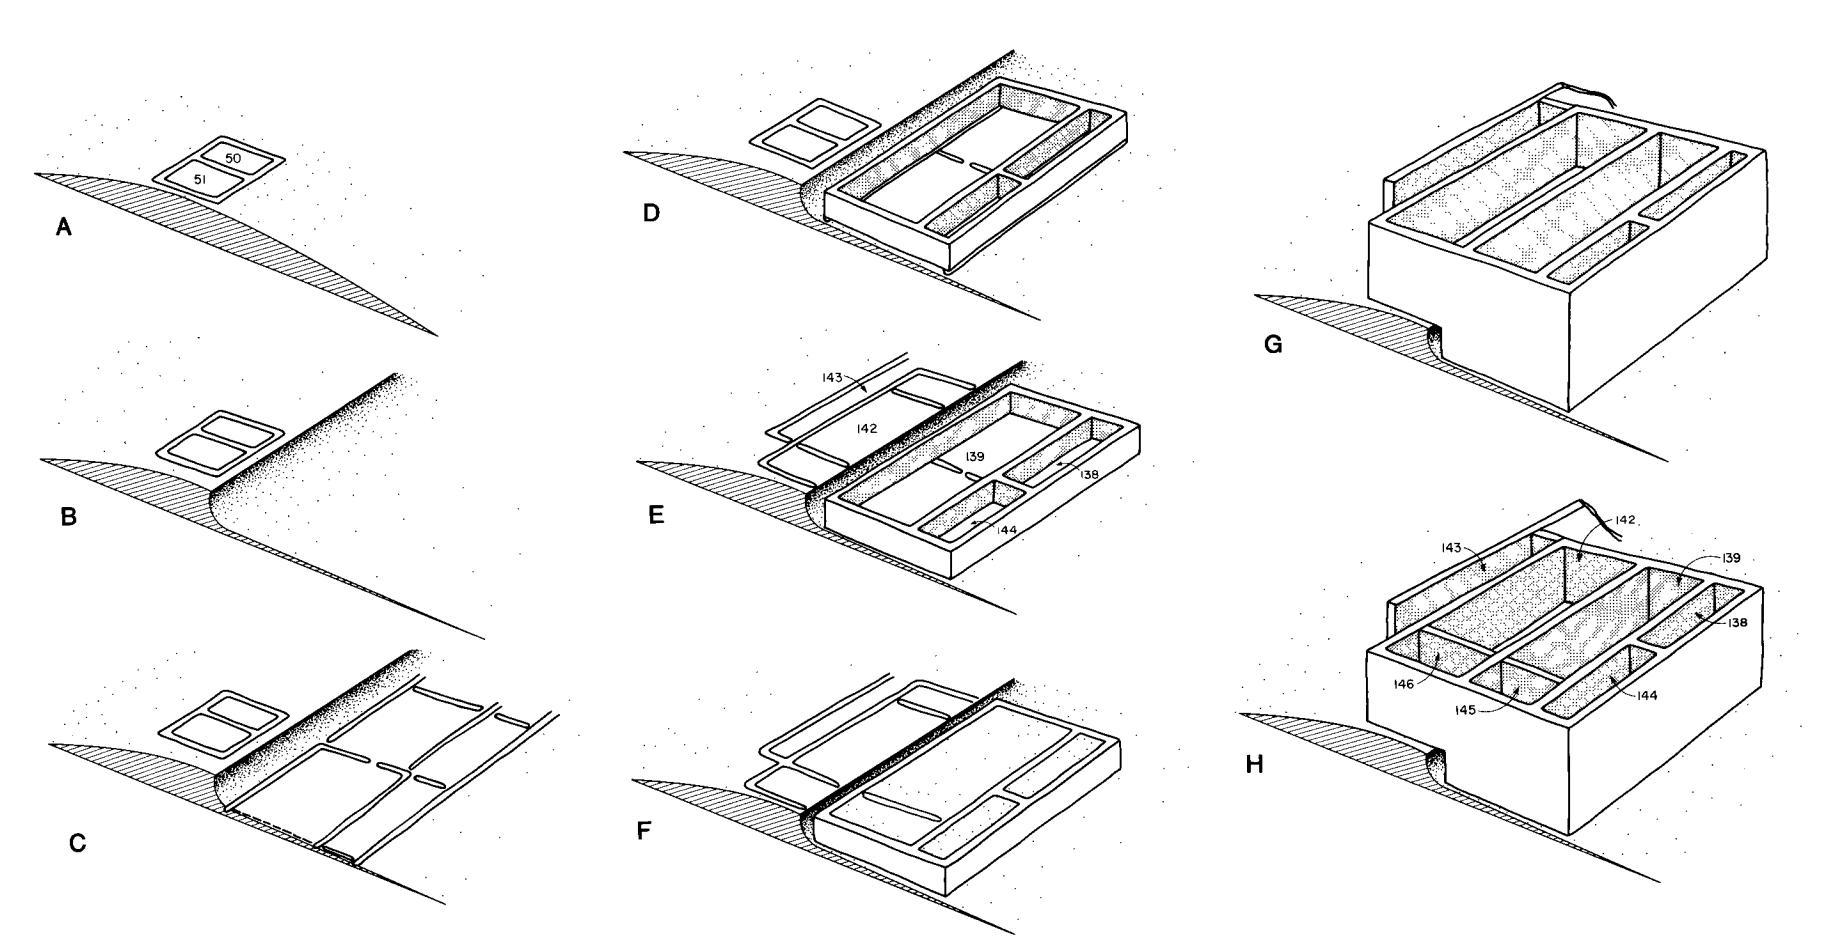
Figure 2.41. Central Roomblock, schematic of construction sequence: A) Pre-greathouse construction of Rooms 50 and 51 over earlier deposits. B) Rooms razed and the deposits north of the two rooms stripped to sterile soil. C) Construction of wall foundation trenches for Rooms 138, 139, and 144. D) Walls partly built from a modified plan that does not mirror the foundation layout. E) Construction of wall foundation trenches for Rooms 142 and 143 built over former Rooms 50 and 51, and F) Rooms 138, 139, and 144 filled with sand to elevate the floors. G) Walls completed for Rooms 138, 139, 142, 143, and 144. H) Cross walls added to subdivide Rooms 139 and 142. volume of refuse in the Trash Mound and by habitation rooms in the West Wing. The suite is essentially without features that suggest habitation activities except in Rooms 143/236 and 147. Perhaps the primary function of the room suite for storage, then, is responsible for the lack of physical remains that might mark the period in question. Exploring the storage issue provides a number of alternatives to the possible hiatus in suite use.

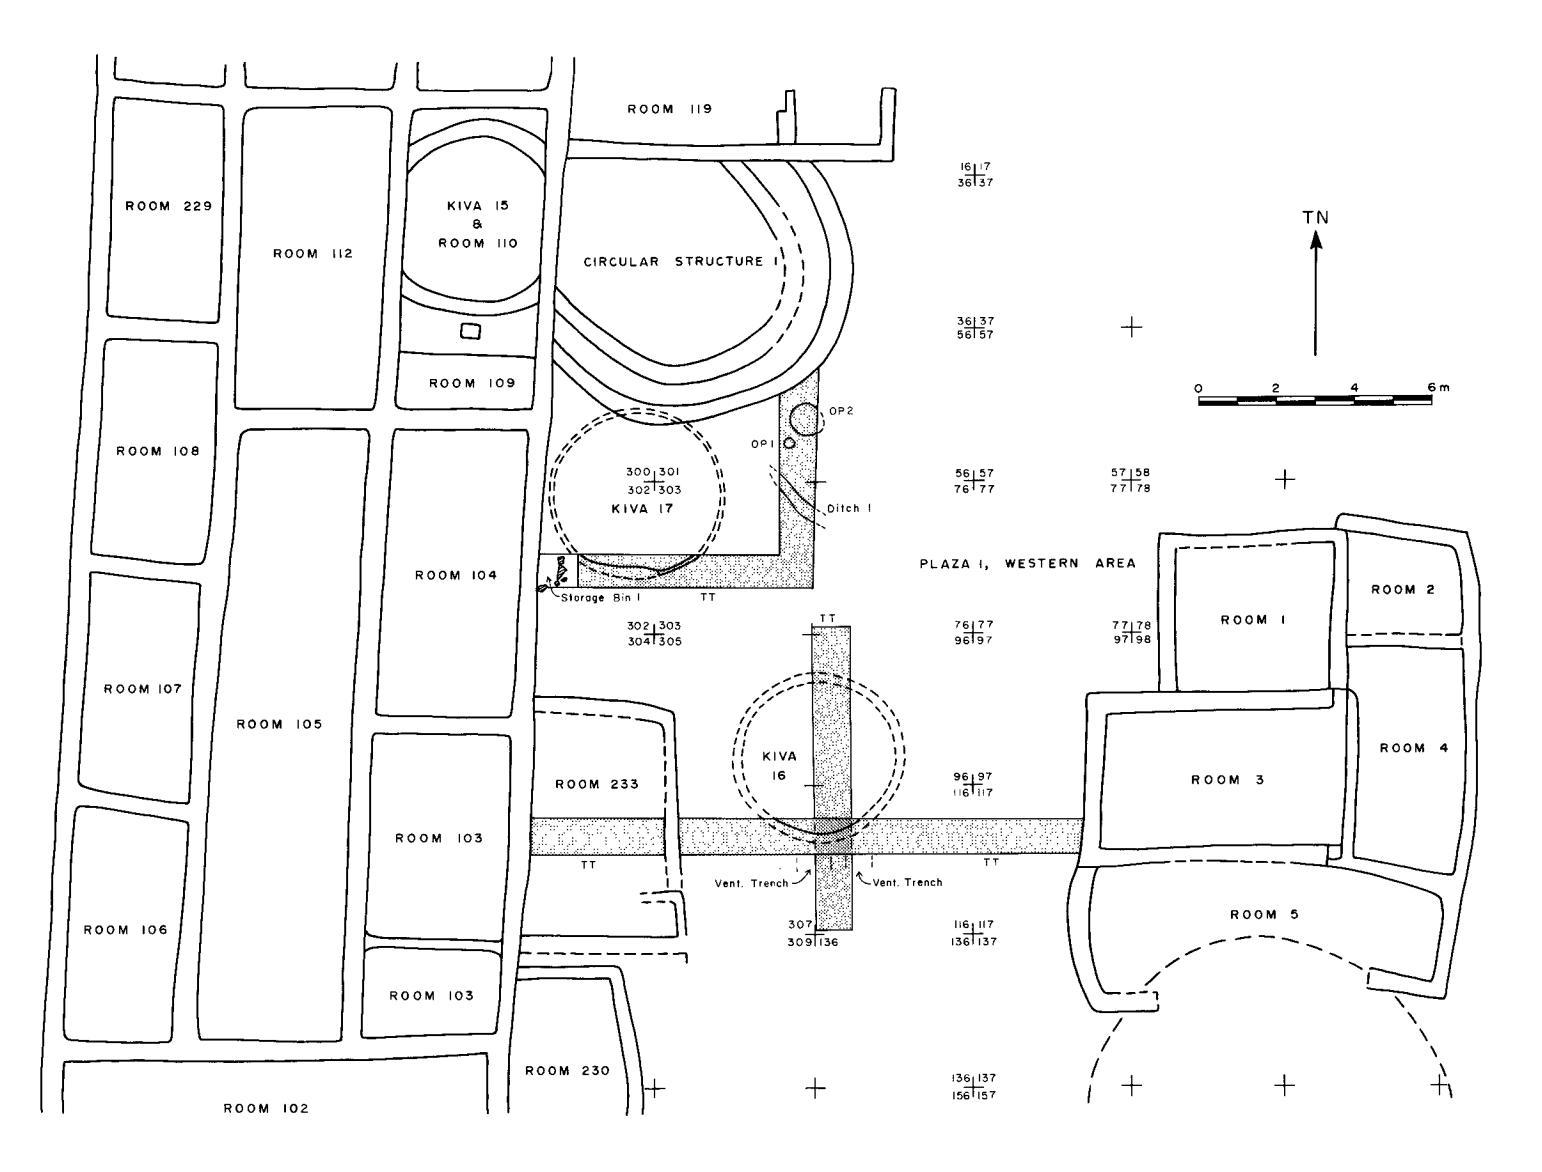
Figure 3.1. West Wing and associated Plaza 1 plan of excavated areas.

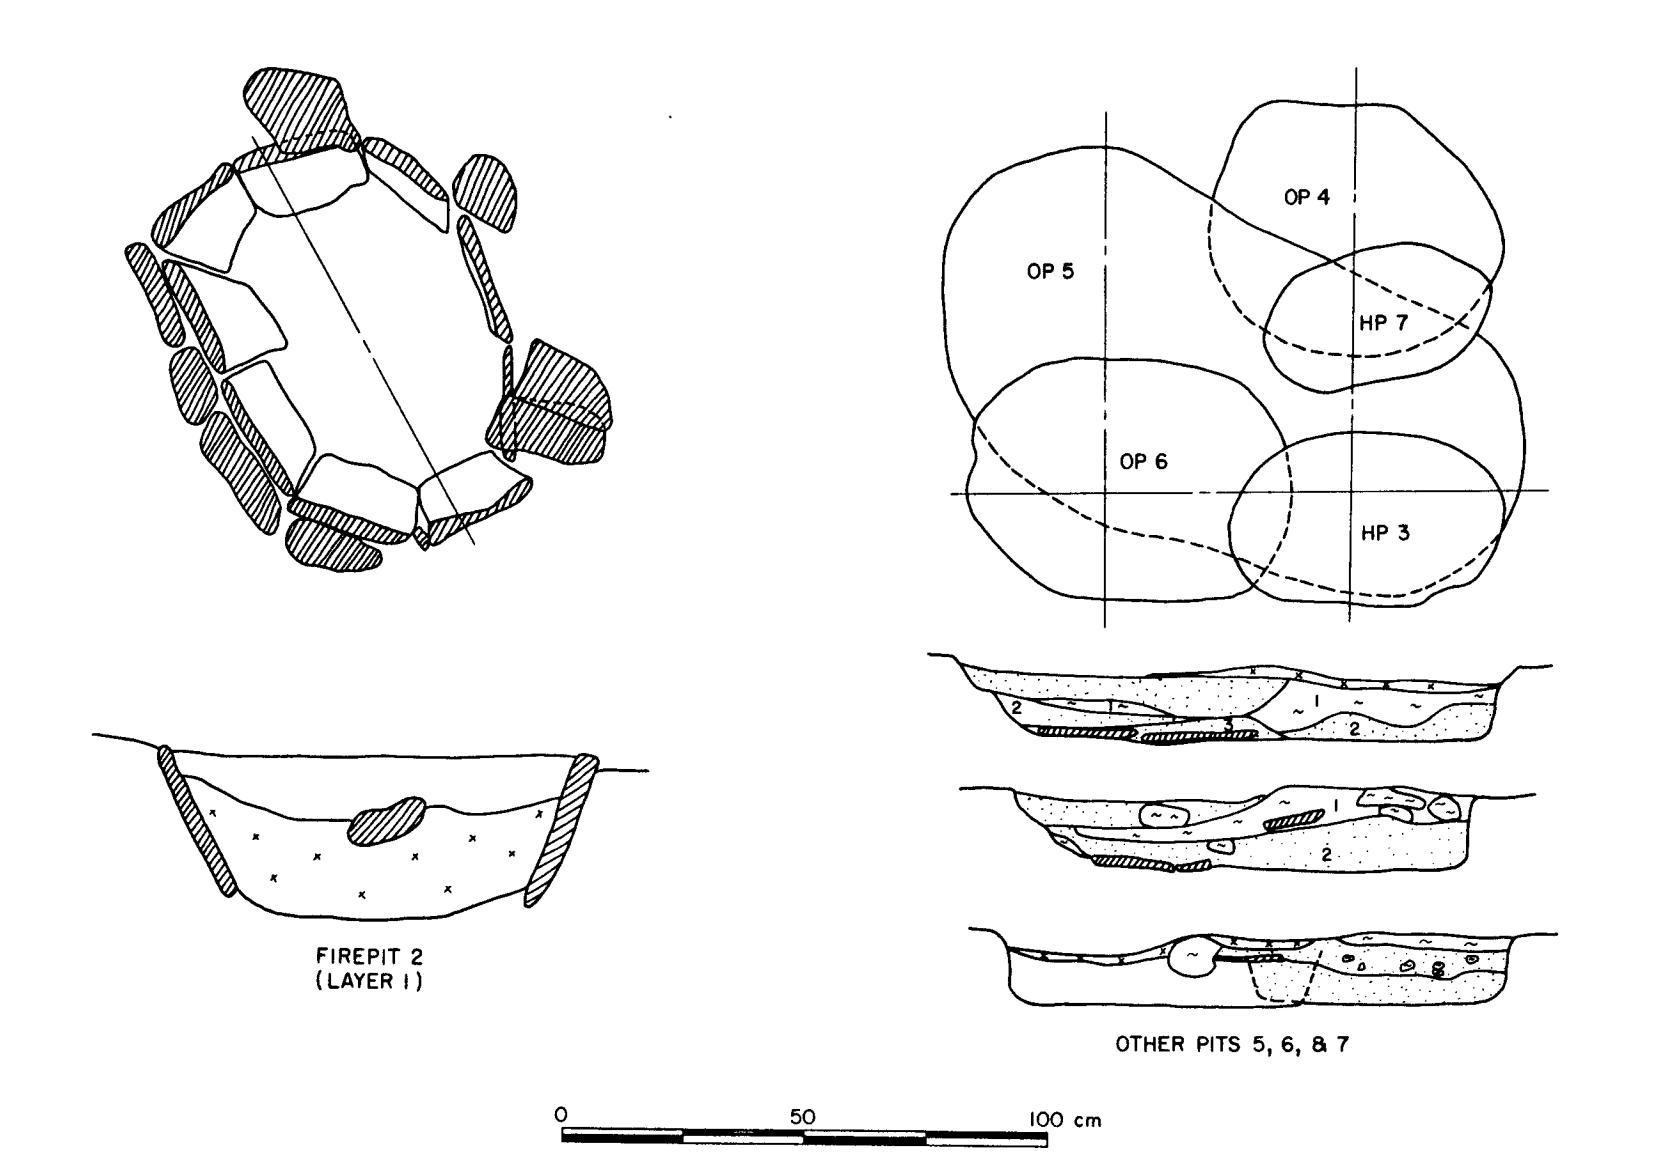
Figure 3.6. Room 103, selected features, plan and profiles. A) Firepit 2 found in the postoccupational wall fall (Layer 1). B) Pit complex in the northwestern corner of Floor 1.

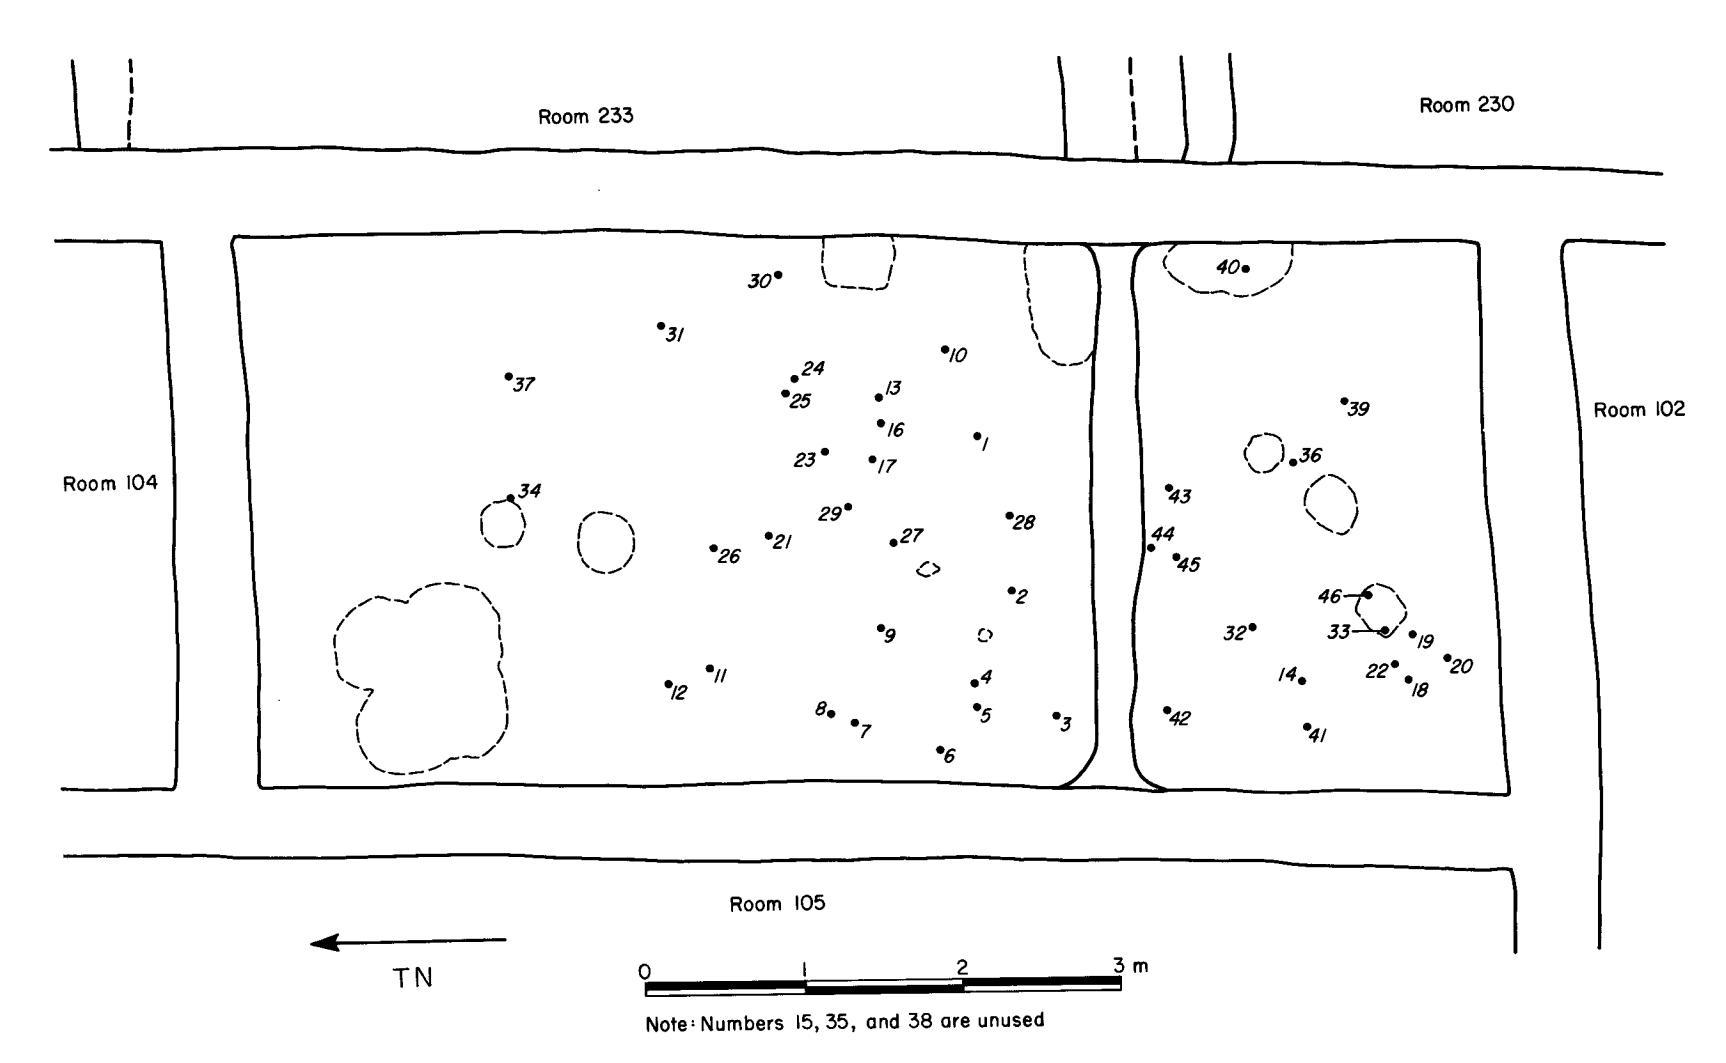
Figure 3.7. Room 103, Floor 1 floor fill. Distribution of artifacts (see Table 3.1 for artifact list). Floor 1 features indicated by dashed lines (except Partition 1).

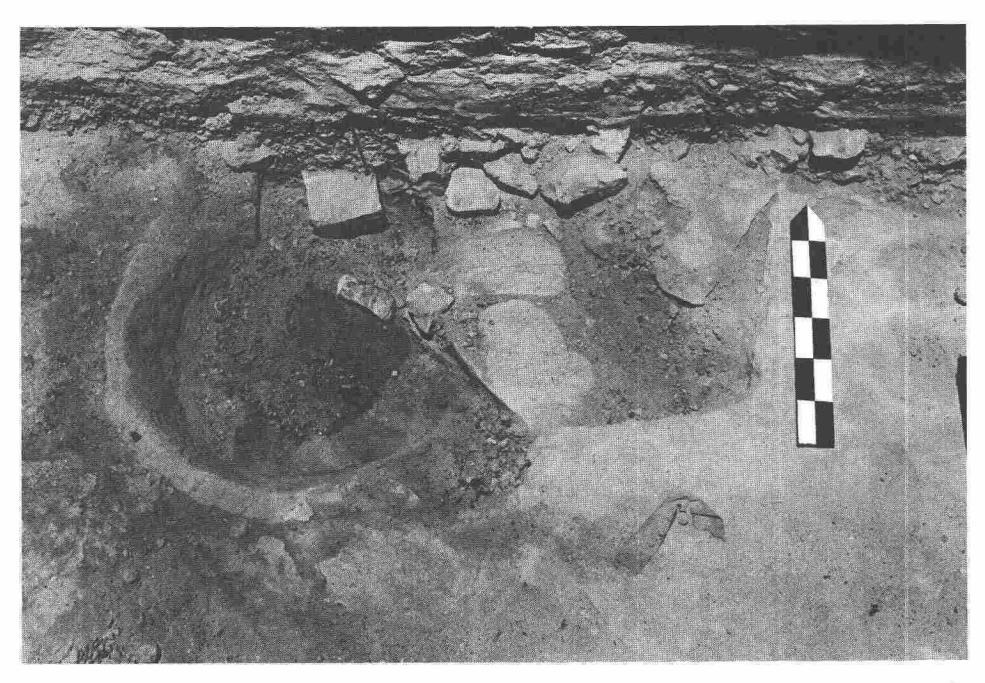
Plate 3.7. Room 103, Floor 3, Hearth 1 and Other Pit 2 underlying partition wall. 30-cm north arrow. (NPS#14492)

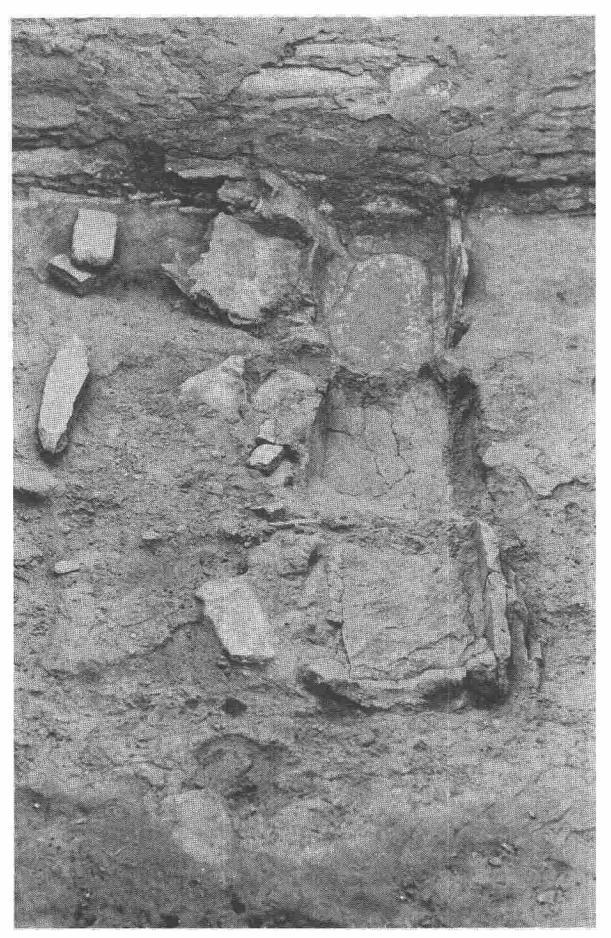
Plate 3.8. Room 103, Floor 3, remains of Mealing Bins 1-3. Metates and bin partitions have been removed leaving catch basins. Looking west. (NPS#14436)

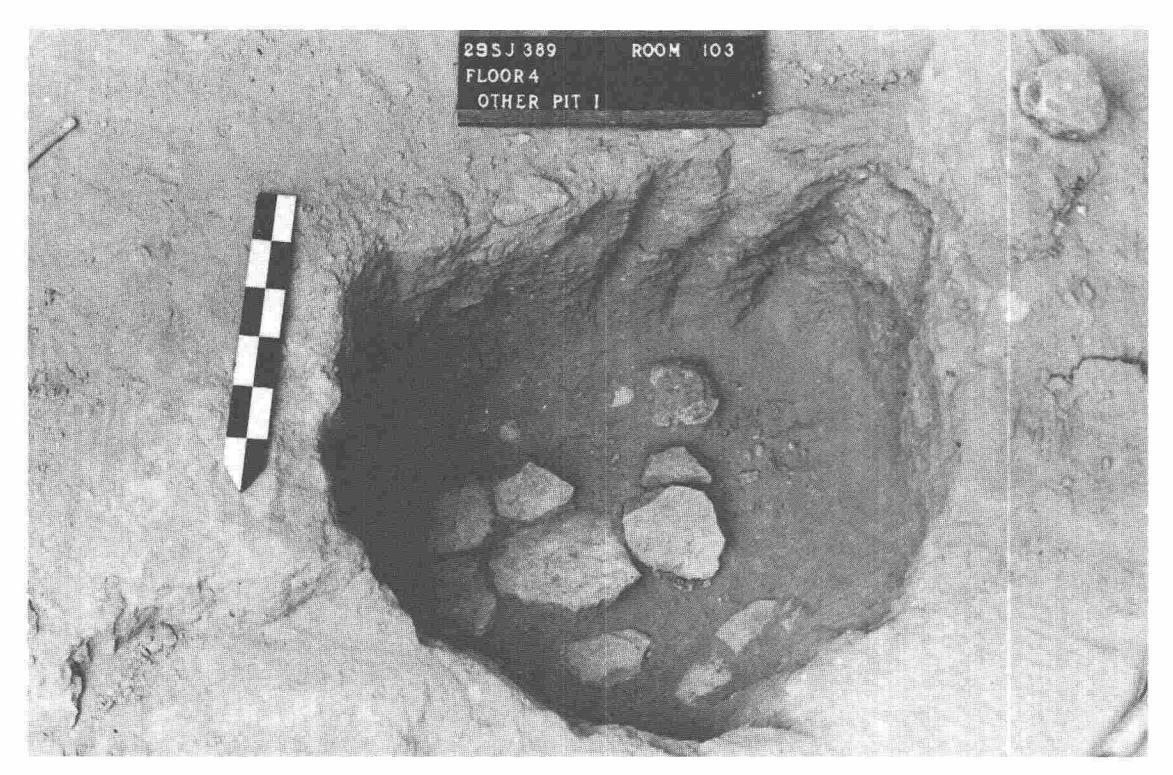
Plate 3.11. Room 103, Floor 4, Other Pit 1. An unlined storage pit with digging stick marks on the sides and construction spalls in fill. 30-cm north arrow. (NPS#14514)

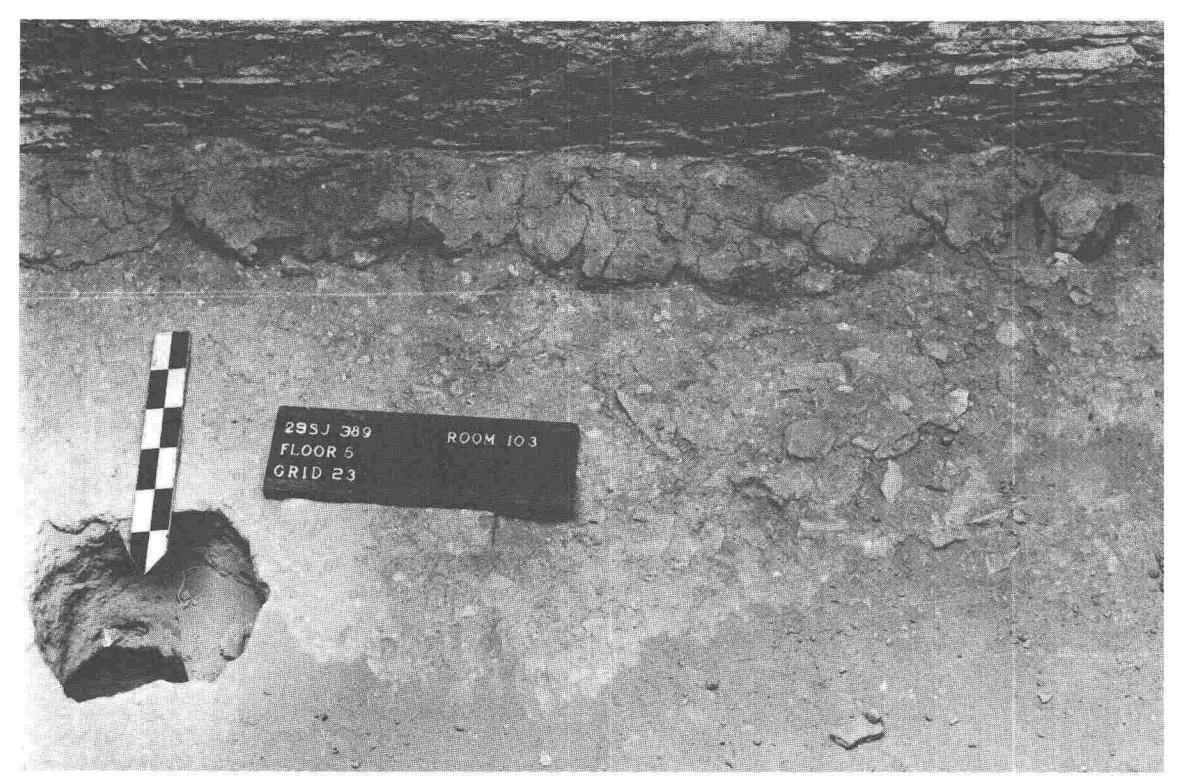
Plate 3.12. Room 103, Floor 5, Grid 23. Mortar from wall foundation extending out from under the south wall, over the floor. Pit is from Floor 4. 30-cm north arrow. (NPS#14751)

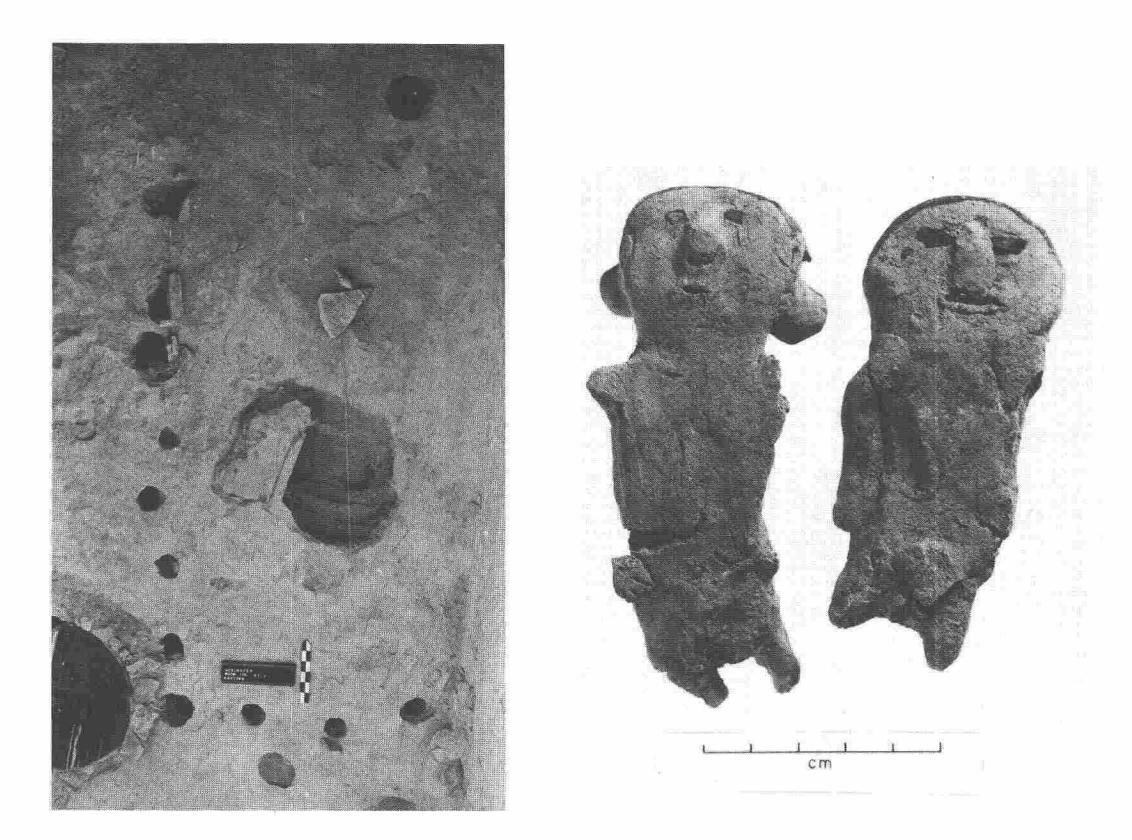
- Plate 3.19. Room 110, Floor 1, Surface 5. Postholes (PH 7-18) mark small pole or jacal enclosure in northwestern corner of room. Large pit (Firepit 2) within enclosure built after poles were removed. Ladder rests in the remains of the Kiva 15 firepit. 30-cm north arrow. (NPS#16325)
- Plate 3.20. Male and female, unfired adobe figurines, embraced together when found in Other Pit 6 (Room 110, Floor 1, Surface 3). Note charcoal fragments for eyes and black sooted hair. Figurines are 11 mm and 9.5 cm tall. (NPS#16241)

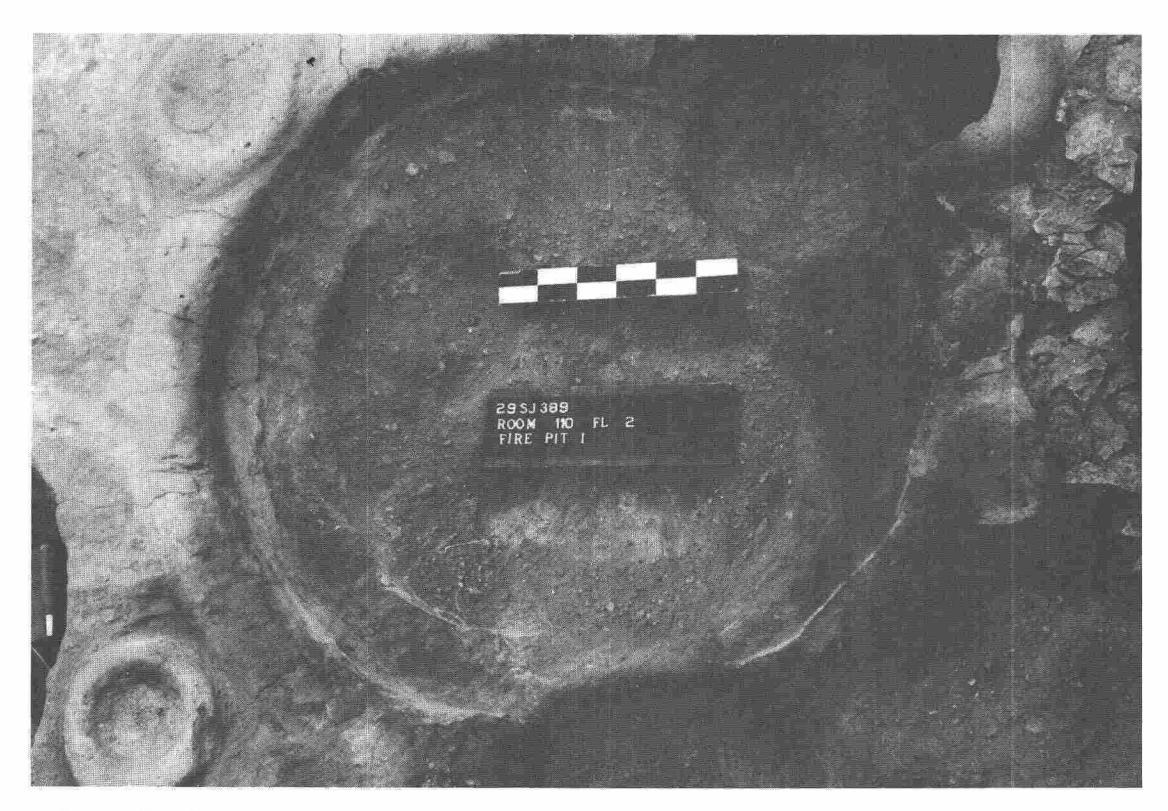
Plate 3.23. Room 110, Floor 2, Firepit 1. Note adobe-lined potrest basins built in or next to adobe firepit rim. Three of the five potrests destroyed by later pits. 30-cm scale. (NPS#17120)

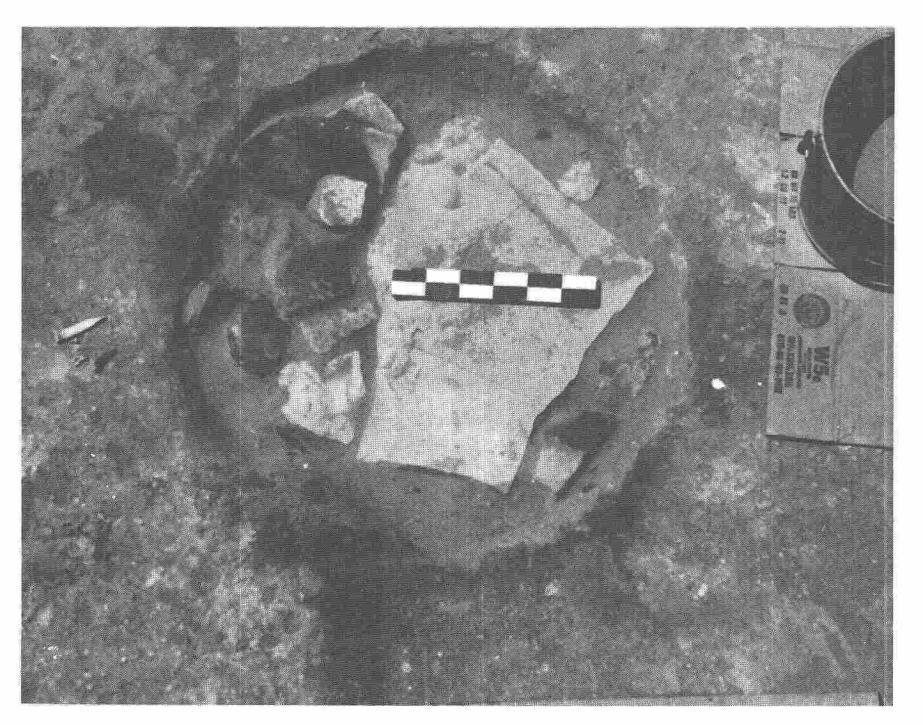
Plate 3.24. Room 110, Floor 2, Firepit 2. Note bottom slab and burned stones. 30-cm scale. (NPS#17118)

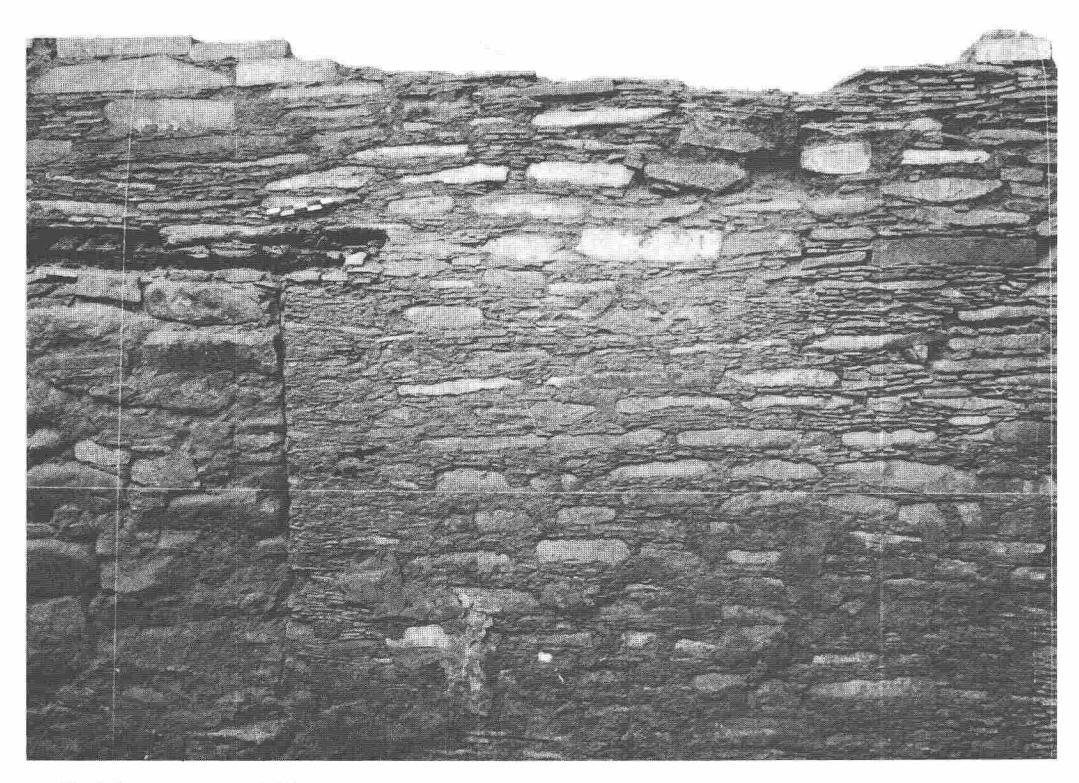
Plate 3.25. Room 110, west wall and Door 2. Note tie holes in jamb above string and contrast between wall masonry and masonry used to fill door when room was replaced by Kiva 15. (NPS#17625)

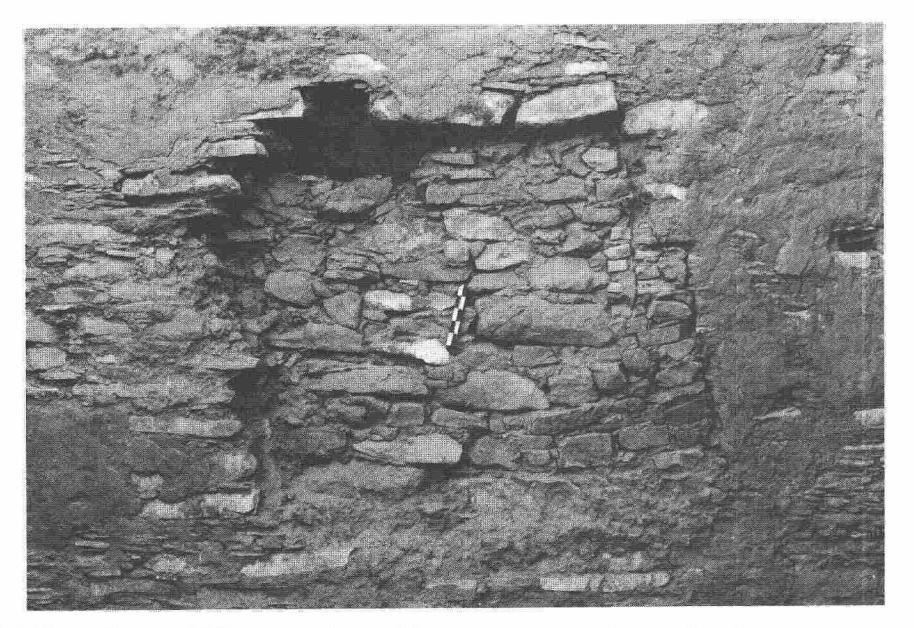
Plate 3.30. Room 110, north wall. Door 6 plugged with masonry. Left side of door formed from masonry filling Niche 16. Small hole in wall to right side of door is Niche 14. 15-cm scale. (NPS#17499) Finally, two doors (3 and 4) were added after the abandonment of Room 110. These are discussed under Room 109.

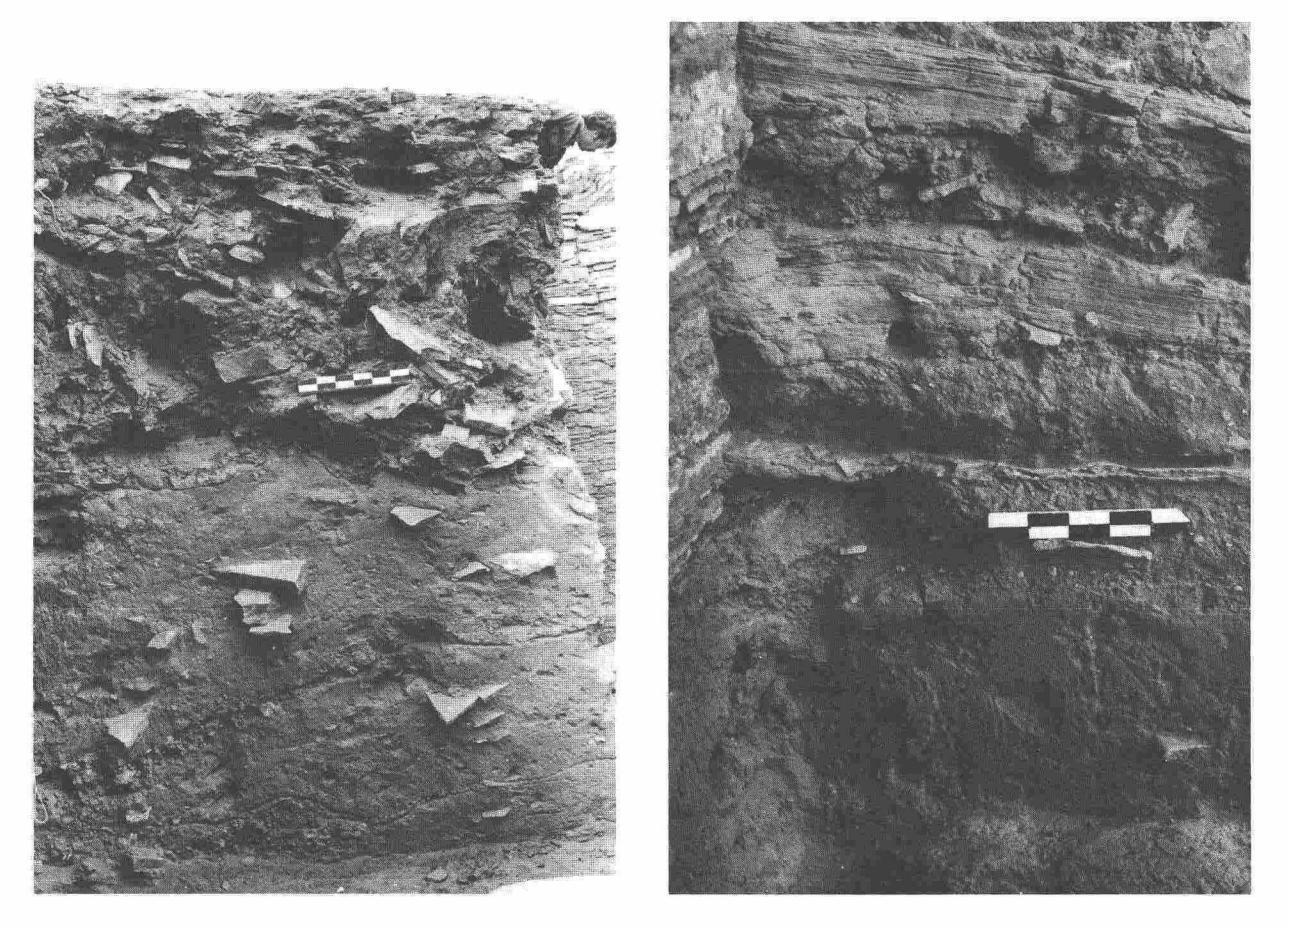
- Plate 3.31. Room 112, postoccupational deposits in the southeastern corner (TT 8 unexcavated). Upper half of fill is wall rubble, lower half primarily of aeolian sands and roofing adobe. 30-cm scale. (NPS#16543)
- Plate 3.32. Room 112, north side of steps, showing detailed units of Layer 5. 15-cm scale lies 4 cm below Floor 1 plaster. (NPS#17149)

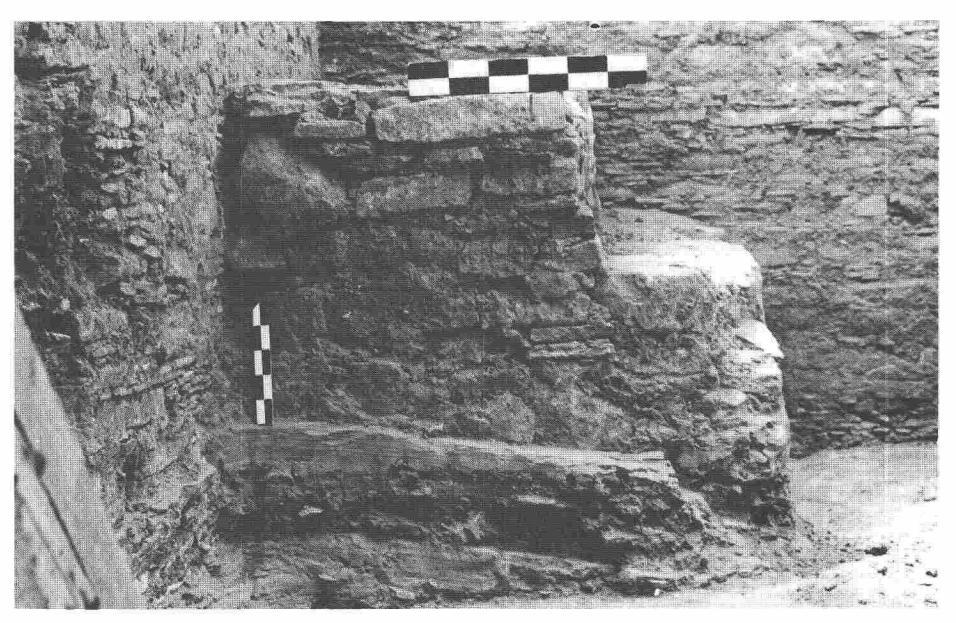
Plate 3.33. Room 112. Masonry step in southeastern corner to provide access to and from the room through Door 4 after habitation suite was abandoned. 15-cm scale rests upon Layer 5 deposits. 30-cm scale on top step. (NPS#16639)

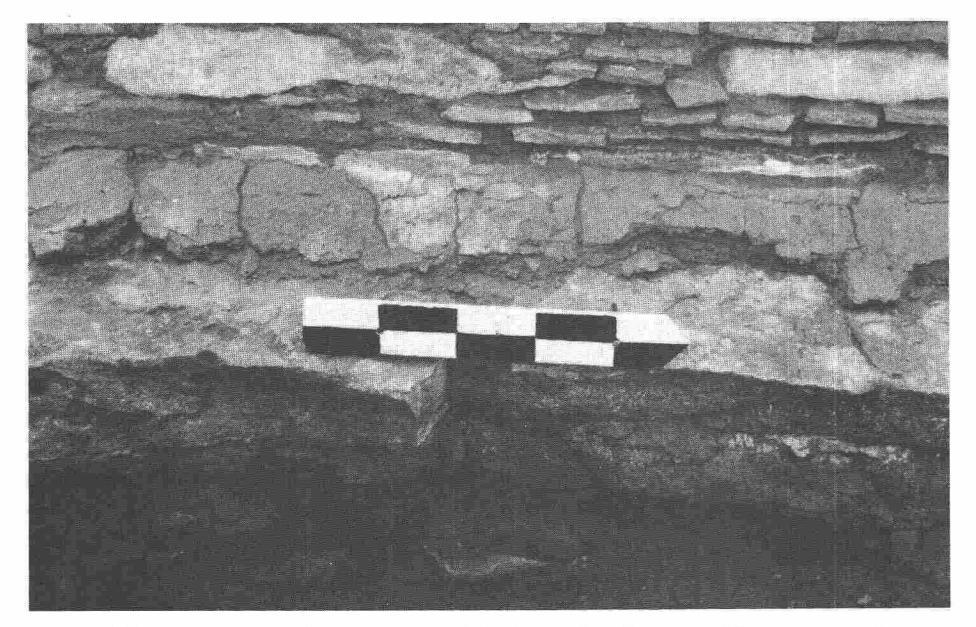
Plate 3.35. Room 112, west wall foundation. 15-cm north arrow. (NPS#17177)
