TECHNICAL INFORMATION CENTER DENVER SERVICE CENTER NATIONAL PARK SERVICE Investigations at the Pueblo Alto Complex

Chaco Canyon

New Mexico 1975-1979

ARCHITECTURE AND STRATIGRAPHY

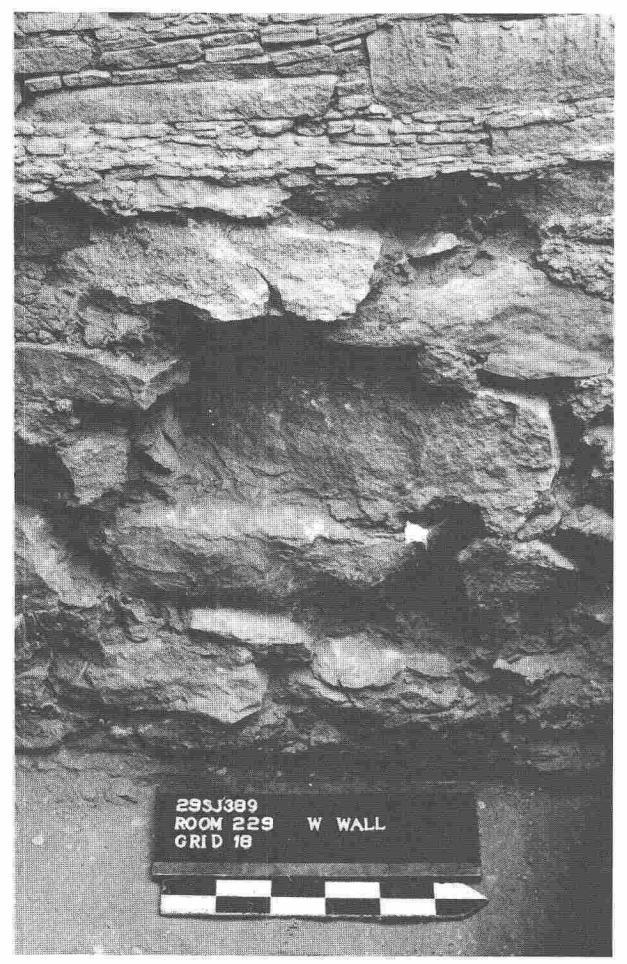
Plate 3.39. Room 229, west wall, Grid 18. Wall veneer underlain by the wall foundation of clay and stone. Exterior coating of clay removed to expose stone. 30-cm north arrow. (NPS#17401)

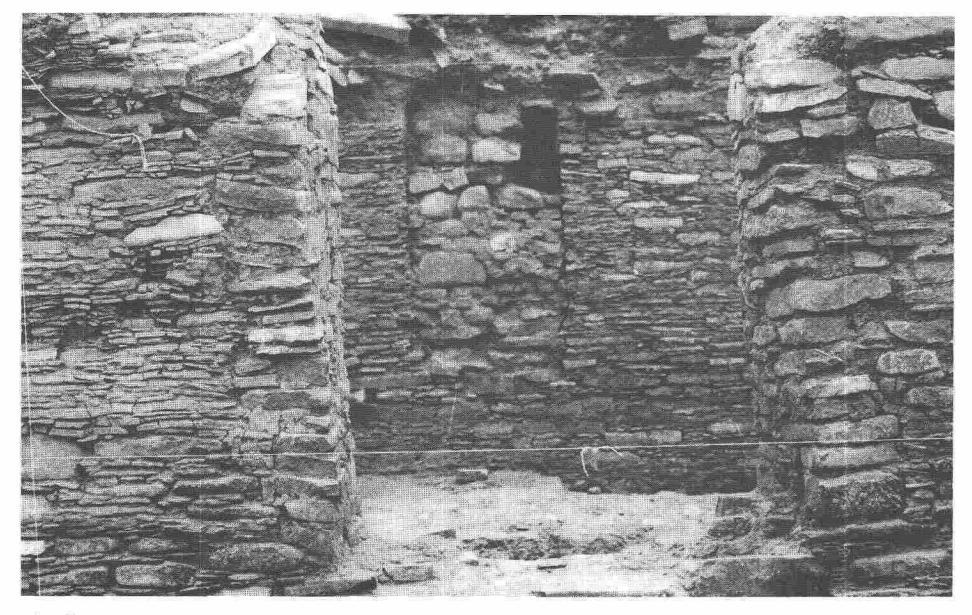
Plate 3.40. Room 229. Looking east through Door 8 at Door 2 in Room 112. Note secondary construction of jambs for Door 8. 15-cm north arrow. (NPS#17400)

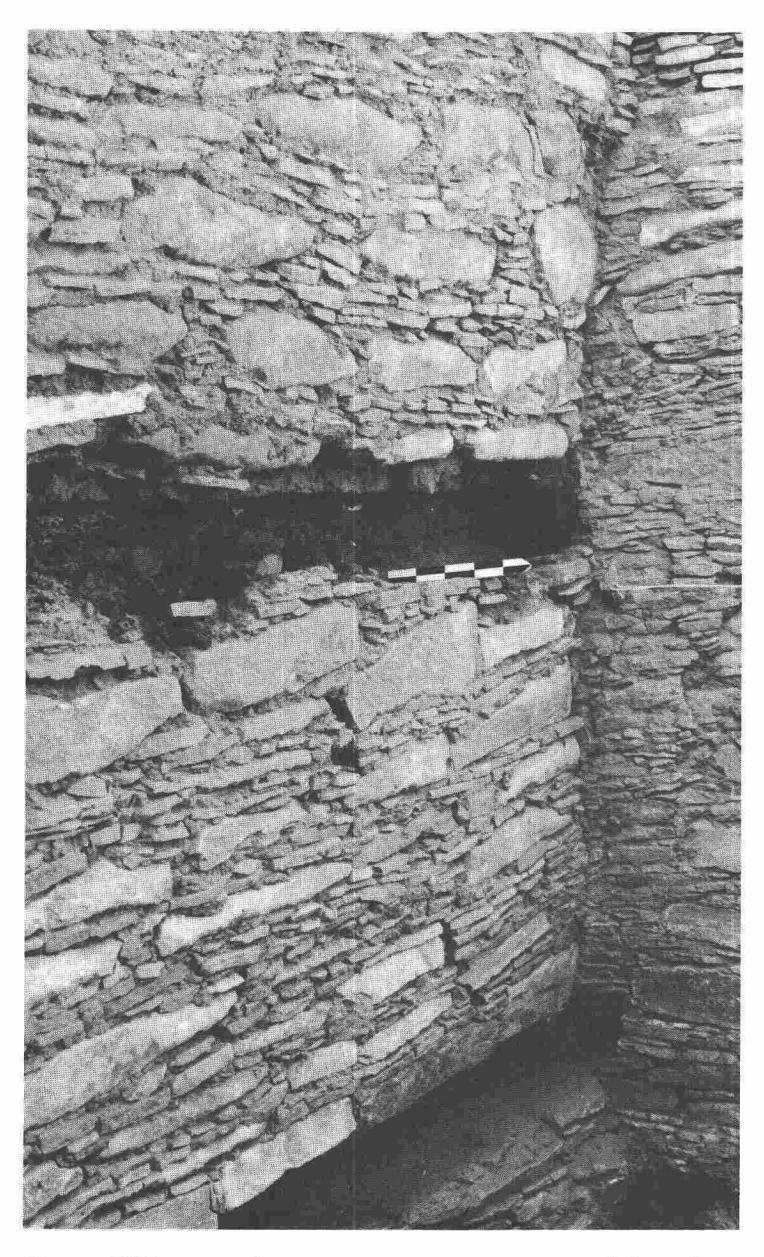
Plate 3.41. Room 229, southwestern corner, revealing intramural beam impressions extending across face of south wall into west wall. 15-cm north arrow. (NPS#17470) investigated. A third pair might have formed the Door 9 lintels, but wall deterioration made it impossible to verify. A disturbed area without veneer in the east wall, just opposite where lintels would have been set, suggested their former presence. Stabilization, unfortunately, has pre-vented further investigation.

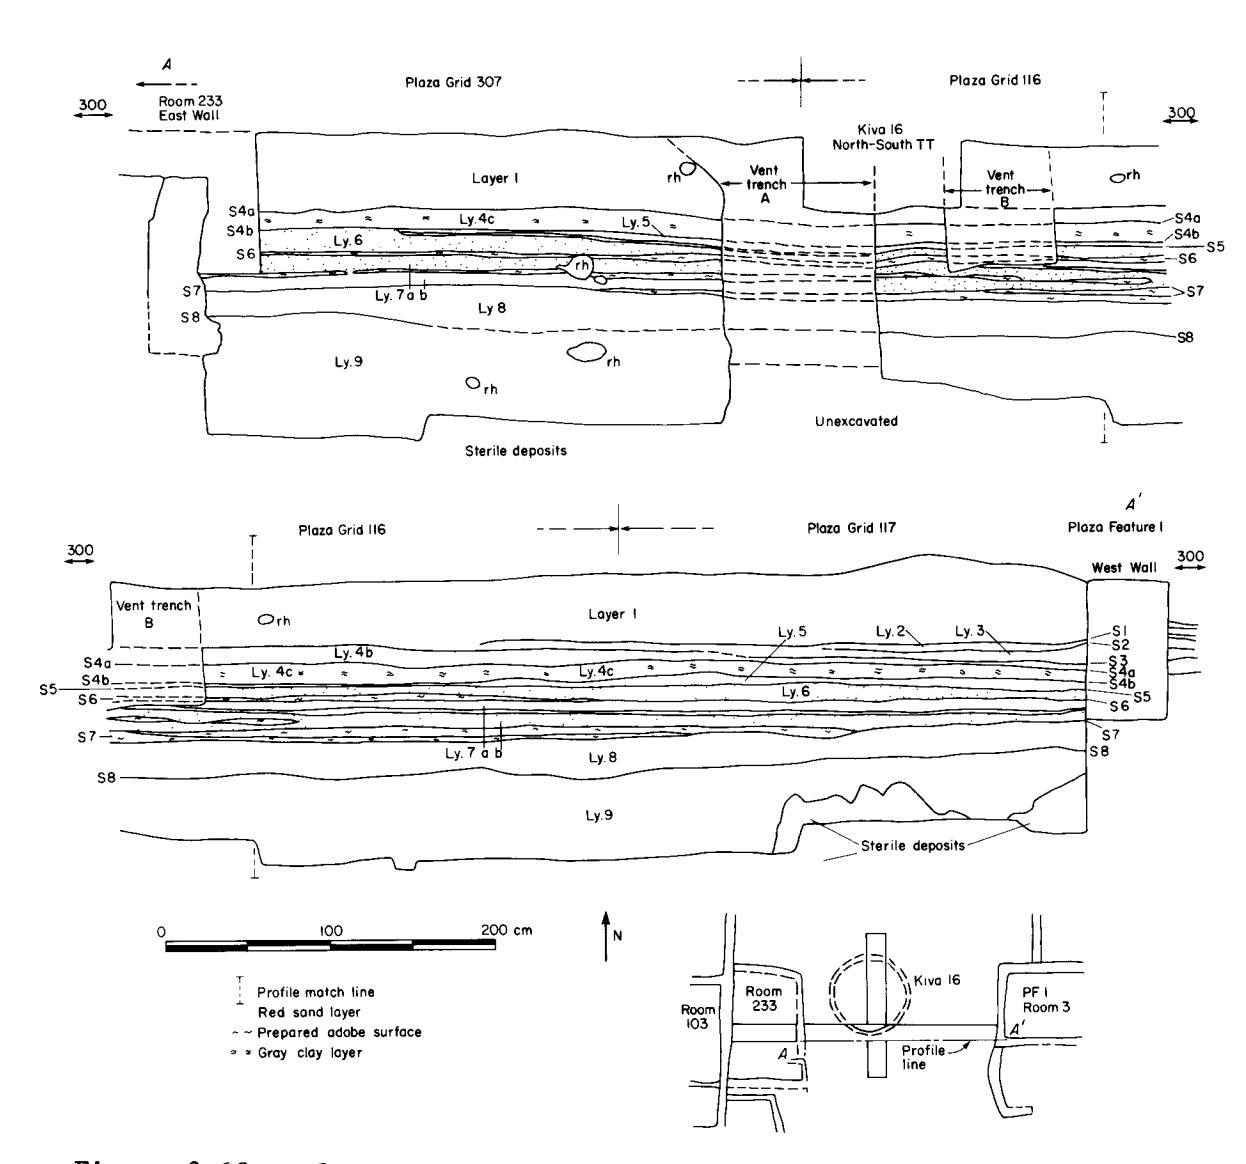
Figure 3.60. Plaza 1, Grids 116-117 and 307, test trench profile.

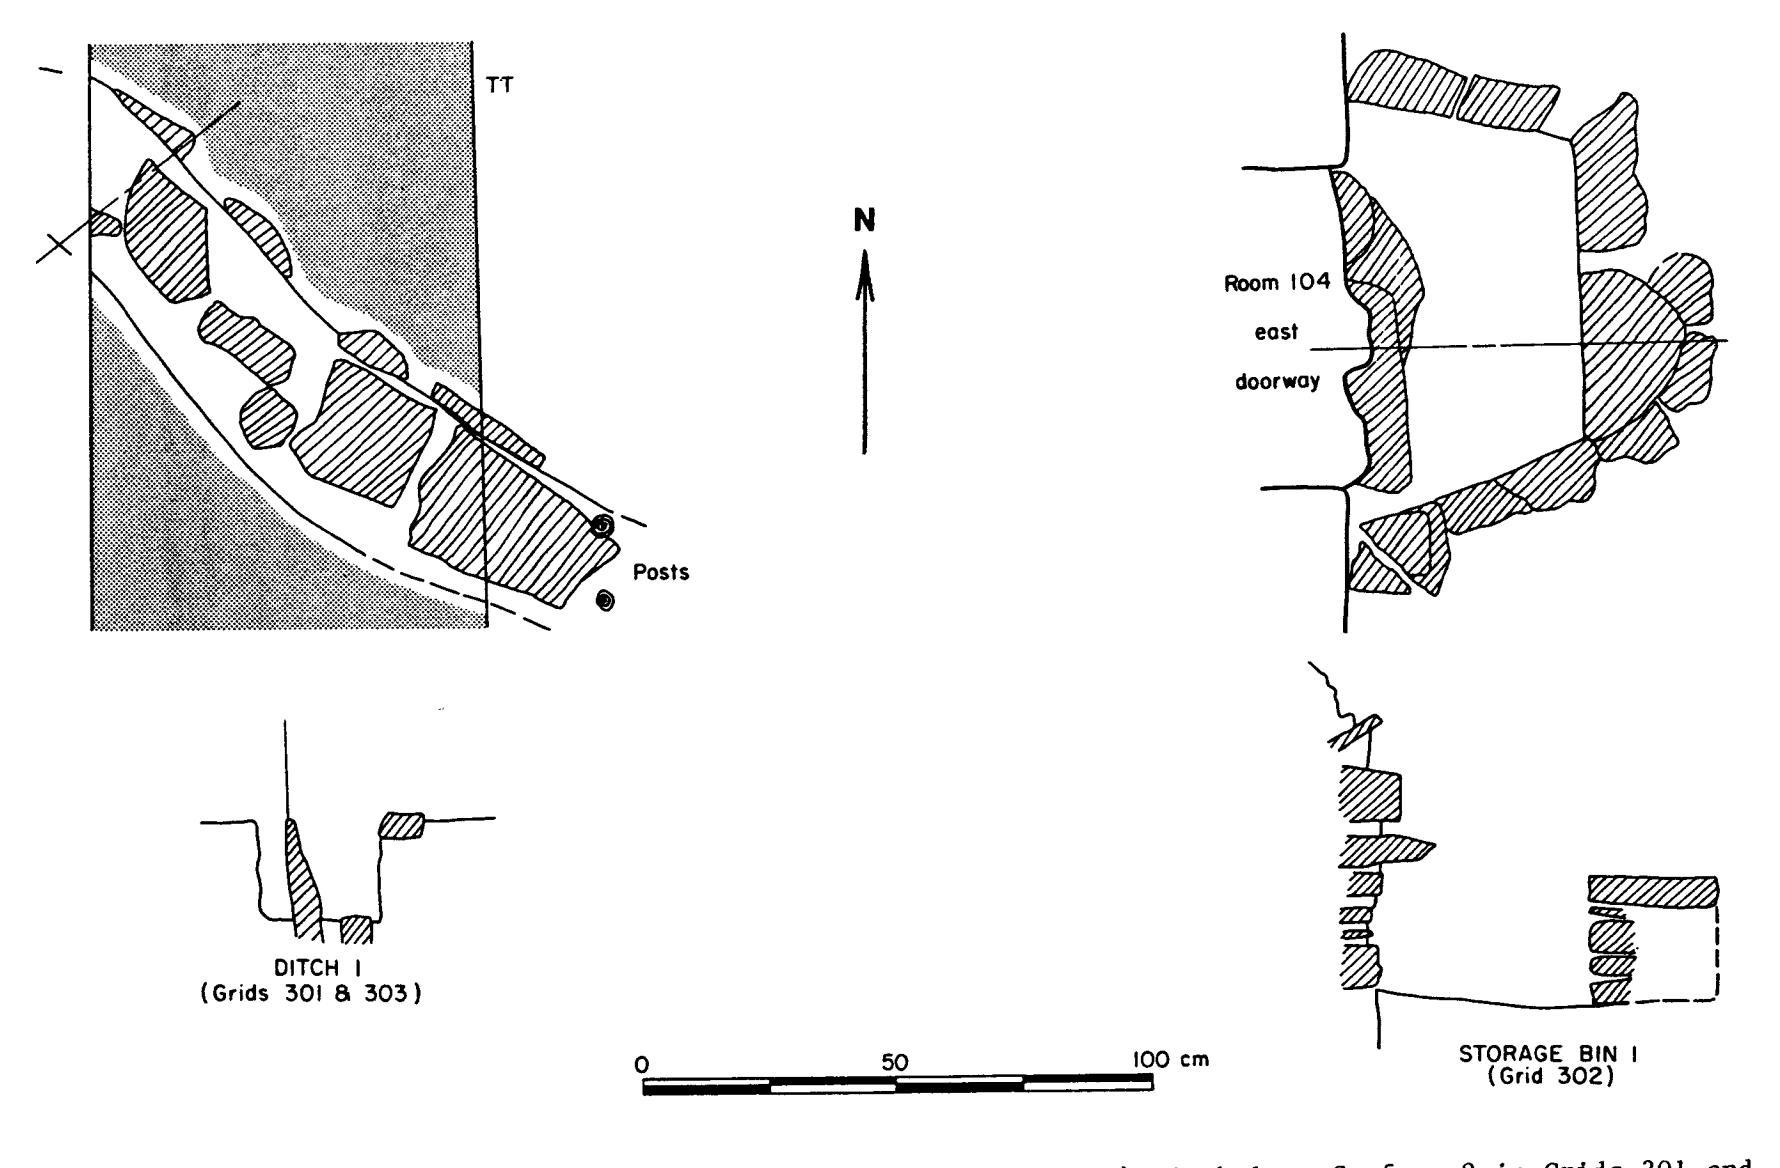
Figure 3.62. Plaza 1, selected features. Plans and profiles. A) Ditch 1 on Surface 8 in Grids 301 and 303. B) Storage Bin 1 built against the plaza door to Room 104. It is probably the ventilator shaft for Kiva 17.
